TMS320VC5509
Digital Signal Processor
Silicon Errata

SPRZ006E
August 2001 – Revised August 2004

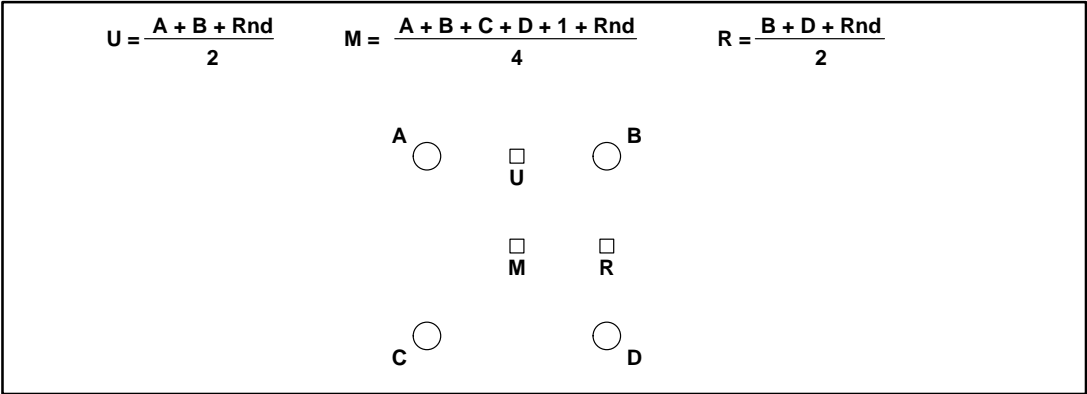
Details: The pixel interpolation computation is wrong by one pixel unit in “Decoder” mode, when “Rounding Mode” is set to zero and when half-pixel interpolation is performed in the middle of four full-resolution pixels (i.e., in the middle of two rows of pixels).

In “Decoder” mode, the Pixel Interpolator data path is configured to deliver two interpolated pixels per cycle. Each section of the data path implements the computations shown below, normalized according to video decoding standards:

U and R results are interpolated from lines and columns, respectively. M is computed from two following full-resolution pixels lines. Two U, R, or M results are computed during each cycle by the data path, according to the instruction being executed by the accelerator for the M results set (the results are denoted as M0 and M1). When “Rounding Mode” (Rnd in the above picture) is set to 1, the faulty data path section is implemented, M0 = (A+B+C+D+2)/4, which is the correct result; but when “Rounding Mode” is set to 0, the data path section implements M0=(A+B+C+D)/4. This is not correct and generates a bit exactness issue. The M1 result is always correct, regardless of the “Rounding Mode” state.
