# **TMS320UC5409/TMS320VC5409**

## **Digital Signal Processors**

### **Silicon Errata**

*SPRZ156E*  
January 2000  
Revised October 2001

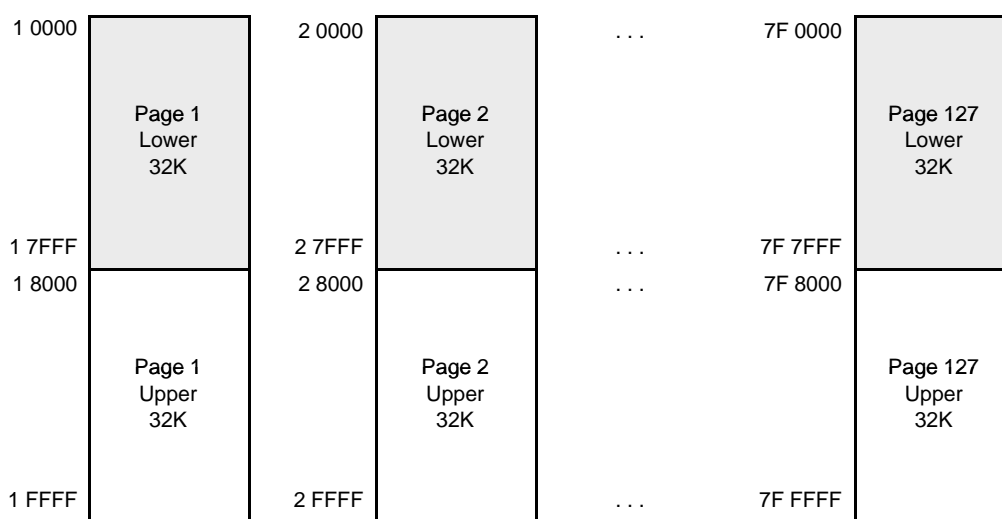
**Figure 3. DMA Memory Map Extended Program/Data Pages**

**Details:** The DMA on the 5409 can access up to 128 pages of data, I/O, and program memory. When DMA write accesses are performed on the lower 32K words of extended data or program pages 1 through 127 (areas shaded in grey in Figure 3), the writes affect both the external memory location on the selected page, and the internal memory location corresponding to the same 16-bit address of page 0.

**Workaround:** The lower 32K words of extended program and data pages 1 through 127 within the DMA memory map should be considered reserved and not used.

This problem is corrected in Revision A silicon.
