# **TMS320F280x, TMS320C280x, TMS320F2801x DSPs Silicon revisions C, B, A, 0**

## **1 Introduction**

This document describes the silicon updates to the functional specifications for the TMS320F2809, TMS320F2808, TMS320F2806, TMS320F2802, TMS320F2801, TMS320C2802, TMS320C2801, TMS320F28016, and TMS320F28015 digital signal processors (DSPs).

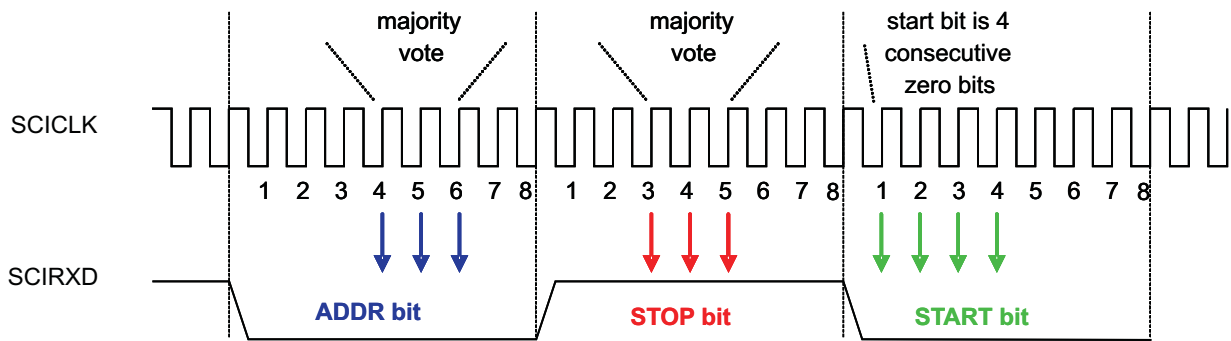
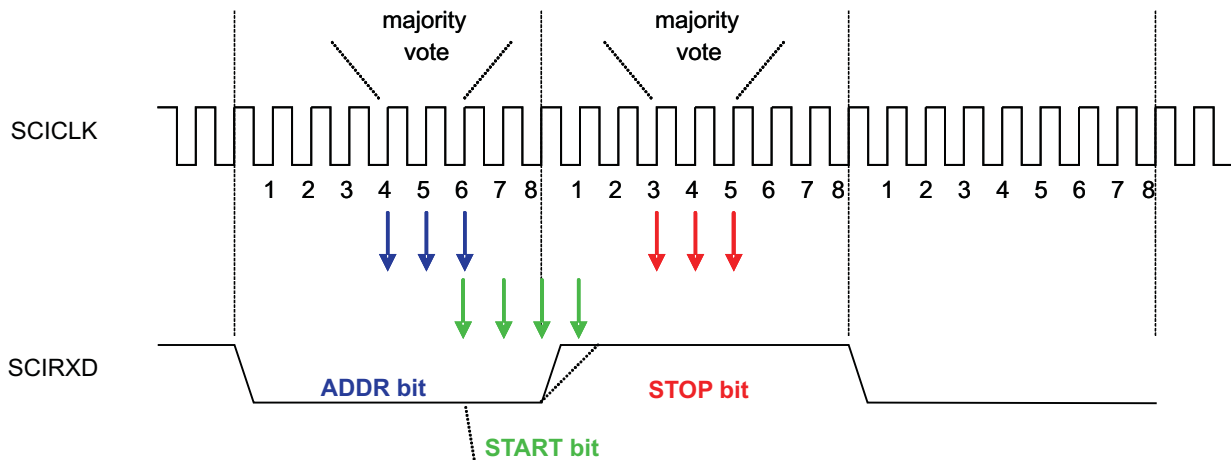
**Figure 3. Difference Between Expected and Erroneous Operation of START Bit**

**Details** SCI does not look for STOP bit after the ADDR bit. Instead, SCI starts looking for the start bit beginning on sub-sample 6 of the ADDR bit. Slow rise-time from ADDR to STOP bit can cause the false START bit to occur since the 4th sub-sample for the start bit may be sensed low.

**Workaround(s)** Program the baud rate of the SCI to be slightly slower than the actual. This will cause the 4th sub-sample of the false START bit to be delayed in time, and therefore occur more towards the middle of the STOP bit (away from the signal transition region). The amount of baud slowing needed depends on the rise-time of the signal in the system. Alternatively, IDLE mode of the SCI module may be used, if applicable.
