TMS320VC5410
Digital Signal Processor
Silicon Errata

SPRZ177A
November 2000
Revised October 2001

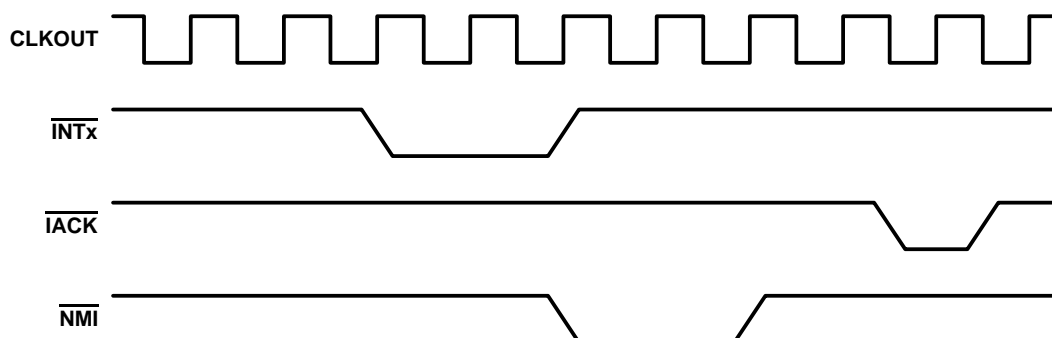
1) Three-and-a-half CLKOUT cycle boundary:

Details: NMI could be missed if the leading (falling) edge of $\overline{\text{NMI}}$ occurs between three-and-a-half and four-and-a-half CLKOUT cycles before the leading (falling) edge of $\overline{\text{IACK}}$. This can occur regardless of the timing of the actual interrupt. The critical timings involved are $\overline{\text{NMI}}$ and $\overline{\text{IACK}}$, as shown in Figure 3.

Workaround: None.
