TMS320C6411
Digital Signal Processor
Silicon Errata

Silicon Revisions 1.1, 2.0

SPRZ194L
February 2003
Revised August 2005

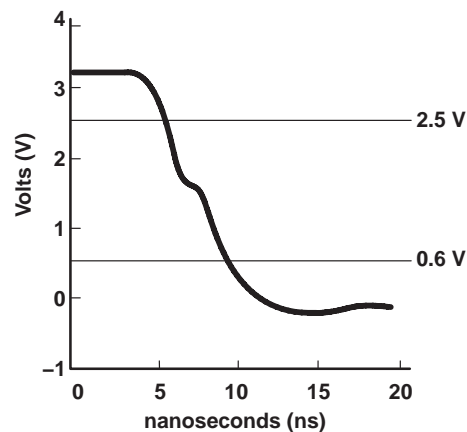
Figure 2. Bad TCK Transition

This phenomenon is observed when an erroneous clock edge is generated from the TCK signal inside the C64x DSP. This can be caused by several factors, acting independently or cumulatively:

A TCK edge that can cause this problem might look similar to the one shown in Figure 2. A TCK edge that does not cause the problem will look similar to the one shown in Figure 3. The key difference between the two figures is that Figure 3 has a clean and sharp transition whereas Figure 2 has a “knee” in the transition zone. Problematic TCK signals may not have a knee that is as pronounced as the one in Figure 2. Due to the TCK signal amplification inside the chip, any perturbation of the signal can create erroneous clock edges.

As a result of the faster edge transition, there is increased ringing in Figure 3. As long as the ringing does not cross logic input thresholds (0.6 V for falling edges, and 2.5 V for rising edges), this ringing is acceptable.
