TMS320TCI6482

Digital Signal Processor

Silicon Revisions 3.1, 2.1, 2.0, 1.1

Silicon Errata

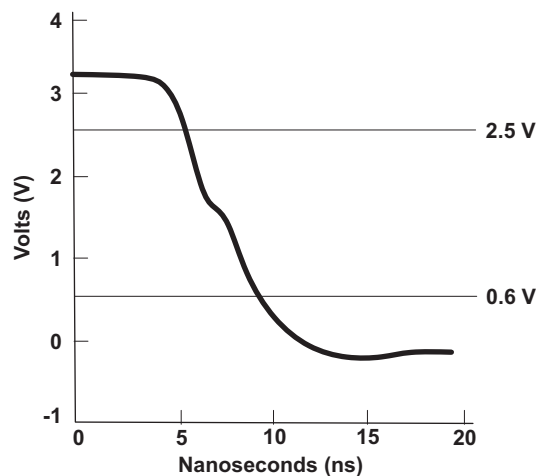
Figure 3. Bad TCK Transition

A TCK edge that can cause this problem might look similar to the one shown in [Figure 3](#). A TCK edge that does not cause the problem will look similar to the one shown in [Figure 4](#). The key difference between the two figures is that [Figure 4](#) has a clean and sharp transition whereas [Figure 3](#) has a "knee" in the transition zone. Problematic TCK signals may not have a knee that is as pronounced as the one in [Figure 3](#). Due to the TCK signal amplification inside the chip, any perturbation of the signal can create erroneous clock edges.

When examining a TCK signal for this issue, either in board simulation or on an actual board, it is very important to probe the TCK line as close to the DSP input pin as possible. In simulation, it should not be difficult to probe right at the DSP input. For most physical boards, this means using the via for the TCK pad on the back side of the board. Similarly, ground for the probe should come from one of the nearby ground pad vias to minimize EMI noise picked up by the probe.

As the problem may be caused by one or more of the above factors, one or more of the steps outlined below may be necessary to fix it:

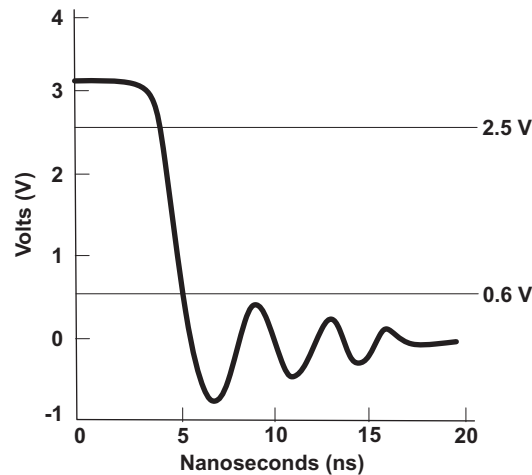
Figure 4. Good TCK Transition

As a result of the faster edge transition, there is increased ringing in [Figure 4](#). As long as the ringing does not cross logic input thresholds (0.6 V for falling edges, and 2.5 V for rising edges), this ringing is acceptable.

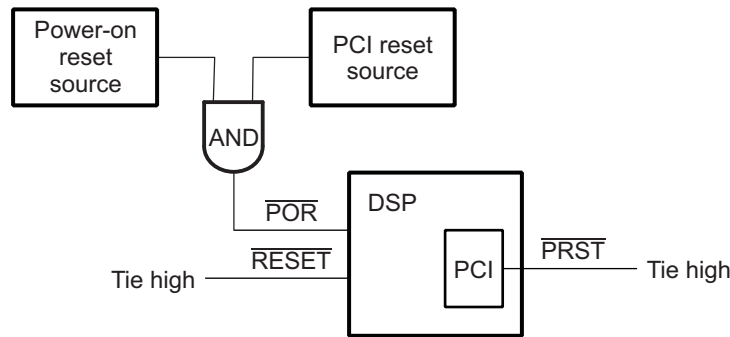
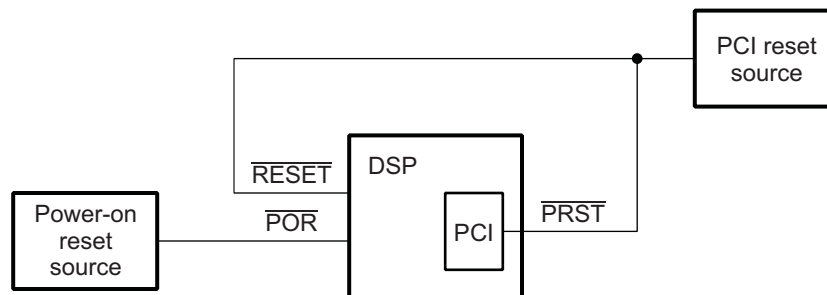
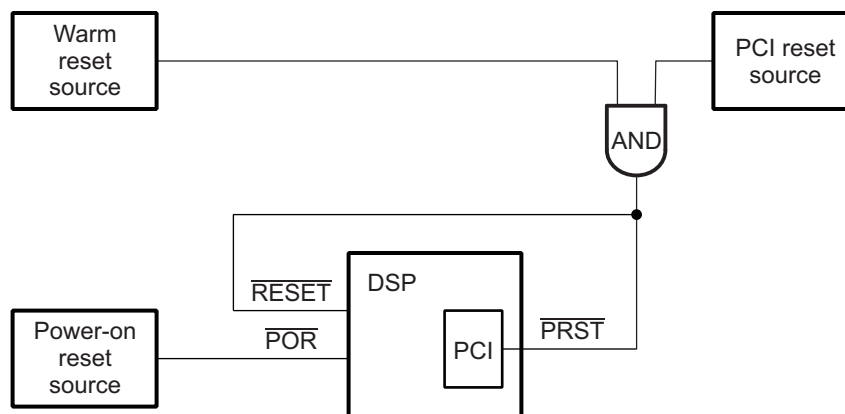
The PCI module can lock up or go into a bad state if its internal and external resets are asserted independently, meaning one is asserted and the other is not. Power-on and warm reset are controlled differently from system to system and, therefore, the effect of this issue is system specific.

Workaround(s): Systems should be designed such that a power-on or warm reset always generates the PCI reset and vice versa. Example circuits that ensure both the chip resets and the PCI reset are asserted together are shown in Figure 6, Figure 7, and Figure 8. Note that asserting power-on reset also asserts PCI reset internally. Also, since a PCI reset will cause a chip reset, the configuration pins of the device will also be latched on a PCI reset. Therefore, these pins must be at valid levels to ensure the device is taken out of reset in the desired mode.

Note that in the above circuits a power-on or warm reset will reset the DSP and its PCI only; other devices on the PCI bus will not be reset. To avoid interrupting an ongoing PCI transaction to/from the DSP, the DSP PCI should be *disconnected* from the PCI system. The sequence below ensures that the DSP PCI is *disconnected* from the PCI system. This sequence can be executed by the DSP itself or by an external host. Note that resetting the DSP PCI in the middle of a master or slave transaction can cause a PCI bus fault at the system level.

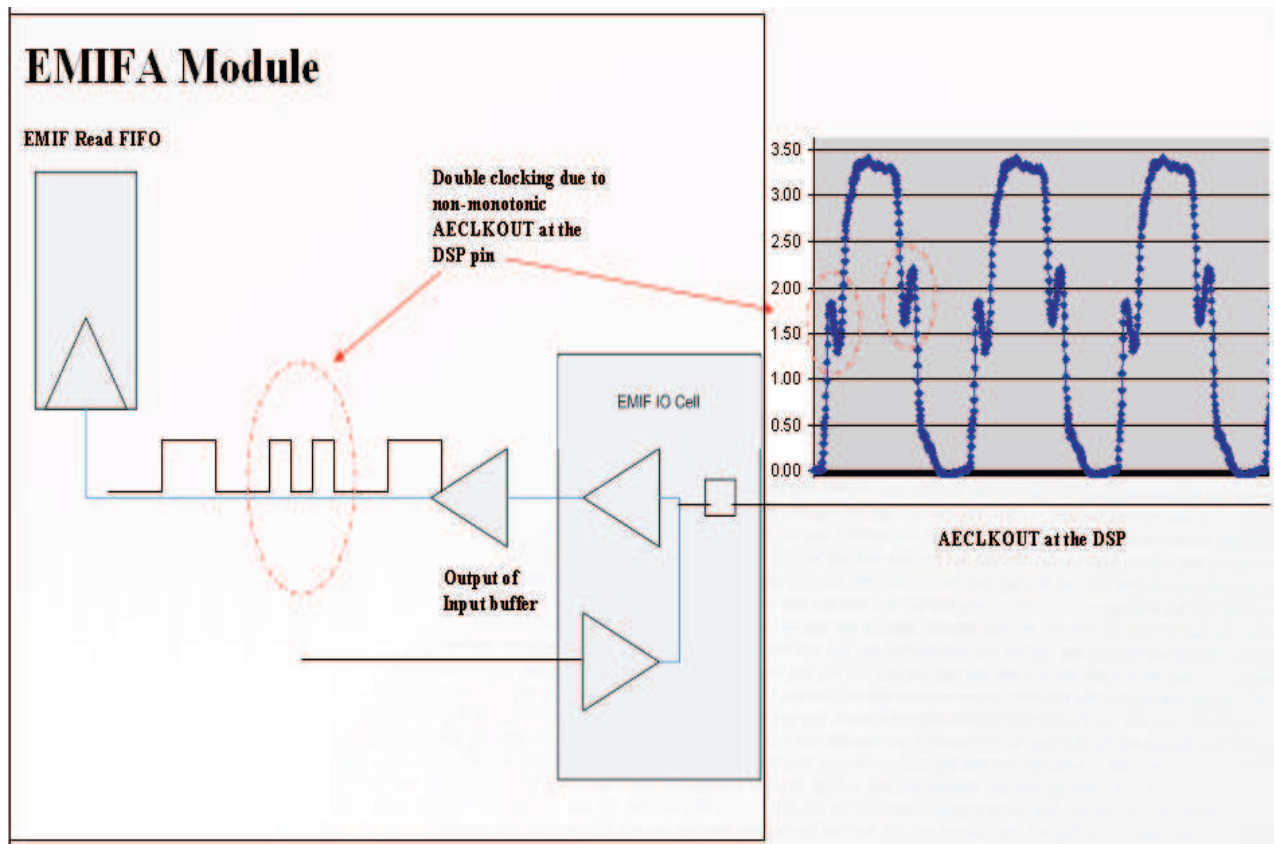
Figure 10. AECLKOUT at the DSP

- Minimize reflections at the DSP and external device.
- Over/undershoot within the device-specific data manual specification.
- The AECLKOUT is monotonic at the DSP and the external device between V_{IL}/V_{IH} for the rising/falling edge with respect to weak/strong buffers.

If the above conditions are not within specification — as defined in the *TMS320TC16482 Communications Infrastructure Digital Signal Processor* data manual (literature number [SPRS246](#)) — then read data corruption can occur. If the signal quality is not achievable with the proper termination, then external buffering may be required. This ensures that the AECLKOUT is monotonic at the DSP and at the external device between V_{IL}/V_{IH} . In all cases, techniques for high-speed digital design should be applied to the EMIFA interface. Since the AECLKOUT is looped back for read data latch, it is very important to terminate the AECLKOUT at the DSP to ensure clock signal integrity. There is an inherent "shelf" near the switch point at the driver, which causes the transition to be non-monotonic at the DSP. The impact of this issue depends on where the AECLKOUT is non-monotonic at the DSP. The AECLKOUT topology must ensure that the AECLKOUT signal at the DSP and the load is monotonic between V_{IL}/V_{IH} .

Workaround(s): The workaround provides details on how to select the correct series termination values at the driver and loads to minimize reflections and over/undershoot. The workaround must also ensure that the AECLKOUT signal is always monotonic between V_{IL}/V_{IH} at the driver and the loads for weak and strong conditions.

In this example we assume trace impedance = 50 Ω (typical impedance range is 50-75 Ω). In this example, use the following formulas to calculate the driver switch voltage, V_{OUT} , with respect to the chosen series termination resistor at the DSP. Note that the switch point is the voltage where the far-end reflection causes the AECLKOUT to be non-monotonic at the DSP. The goal here is to ensure that the switch-point voltage is always above V_{IH} and below V_{IL} for weak and strong buffers.
