TMS320TCI6487/8

Digital Signal Processor

Silicon Revisions 2.1, 2.0, 1.3, 1.2, 1.1, 1.0

Silicon Errata

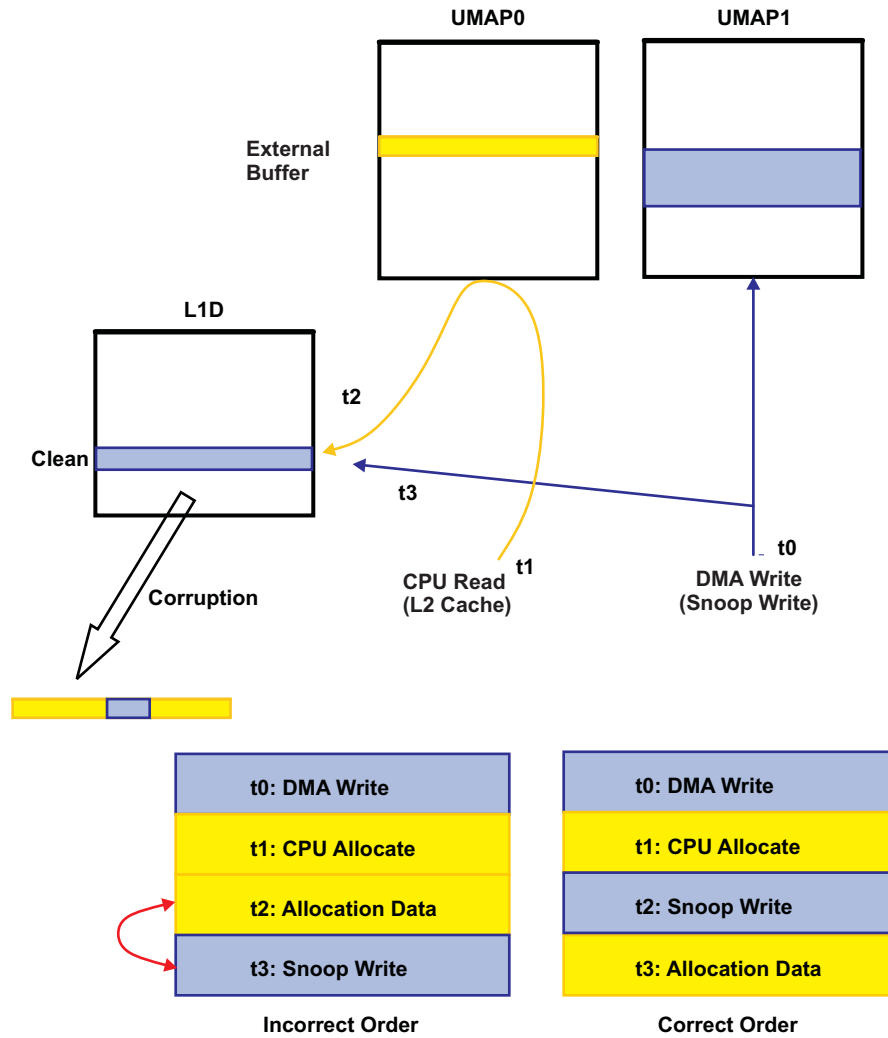
Figure 4. Cache Line Operations Flow

One can identify this issue unambiguously by examining the corrupted memory range in CCStudio using the cache tag viewer. The corrupted data shows up in the include L1D view in a memory window, but not in the exclude L1D view. The cache tag viewer should indicate that the line is also "clean" and the corrupt data should also be visible in its intended destination, which must be in UMAP1 and map to the same L1D set as the corrupted line.

[Figure 4](#) shows the flow of these operations, the incorrect order that causes the issue, and the correct order. The blue line is Cache Line A and the yellow line is Cache line B.

In the issue described above, all of the conditions must be true for the issue to occur. The workarounds focus on picking one of the conditions and removing it so that you do not need to worry about the other conditions.

To prevent this sort of race condition, programs should discard inbound DMA buffers in UMAP1 immediately after use and keep a strict policy of "buffer ownership" such that a given buffer is owned only by the CPU or the DMA at any given time.

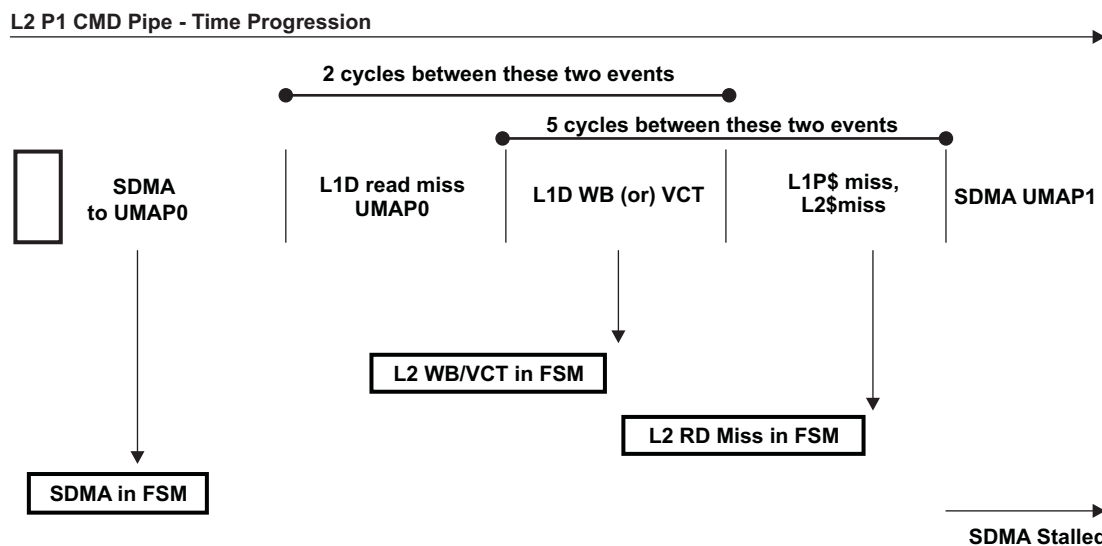
Figure 5. Timing Between Transactions

The SDMA in item 1 sets up a bank conflict for the L1D\$ read in item 2. (Note that this transfer is not needed to see a fail on the device. A fail may occur only with transactions 2-5.) The L1D\$ allocate in item 2 prevents the L1D\$ write/victim (item 3) from advancing, so it is stuck in the pipeline. This occurs at the same time as an L1P\$ allocate that also results in an L2 access to external memory (item 4), which is also in the same pipeline stage as the L1D\$ write/victim (item 3). At this point, the L1P\$ allocate (item 4) advances to the next pipeline stage but the L1D\$ write/victim (item 3) is still stuck waiting on the L1D\$ allocate (item 2). This now sets up the pipeline for the stall condition, which is actually triggered by an SDMA to UMAP1 (item 5). This is what causes further SDMAs to stall. After the L1P\$ allocate (item 4) is complete, item 2 resolves, allowing item 3 to resolve, thus, freeing the SDMA pipeline again. Therefore, the stall is effectively for the length of the L1P\$ allocate in item 4.

Note that the above four conditions do not guarantee that you will see a stall; it may stall depending on the timing between the transactions. Items 2 and 3 must occur within two CPU cycles of each other and items 3 and 4 must occur within five CPU cycles of each other. [Figure 5](#) shows the timing relationship.

For silicon revisions 1.0, 1.1, 1.2, and 1.3 that were already affected with the other four conditions of the SDMA/IDMA stall issue from [Advisory 1.3.1](#), there is no additional workaround needed. If all of the deadlock avoidance steps listed in [Advisory 1.3.1](#) have been followed, there is no risk for a deadlock because of this issue. Methods to reduce stalling due to this issue are also already covered in [Advisory 1.3.1](#).

For silicon revision 2.0 that fixed the initial four conditions of SDMA/IDMA stall issue, the deadlock avoidance steps that are already listed in [Advisory 1.3.1](#) for previous revisions of silicon should be followed to ensure that there is no chance of a deadlock. The workarounds to avoid stalls are also the same as communicated in previous revisions of the device with the issue.

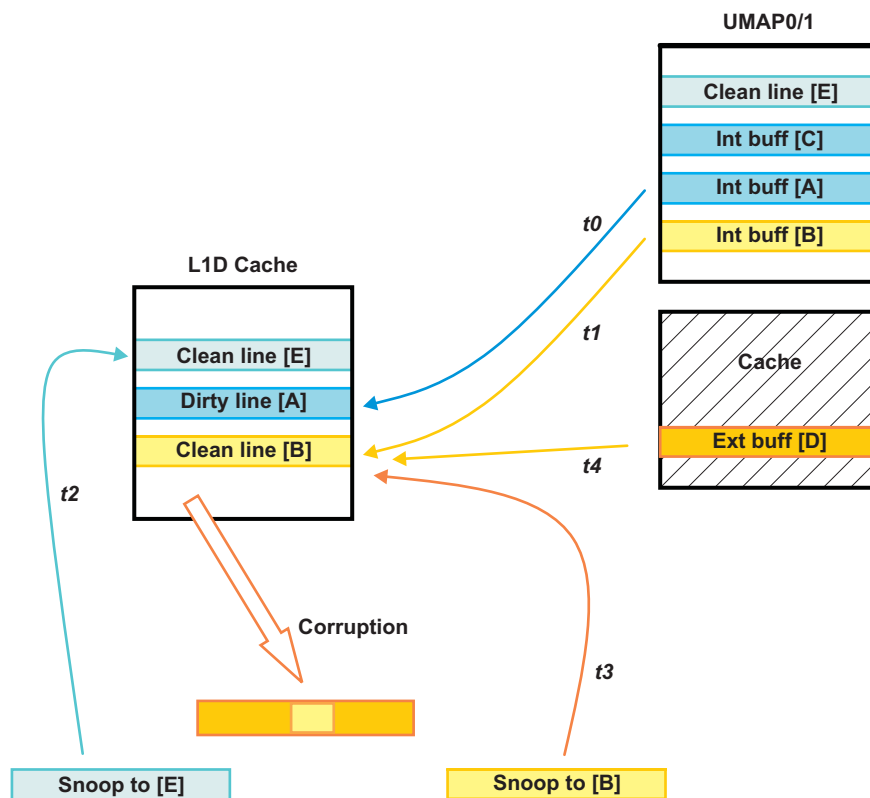
Figure 7. Sequence of Events

- (A) The snoop-write to Cache Line E, from Step 1 above, is now in process and blocking the snoop-write to Cache Line B from Step 2.
- (B) While Step A is going on, Cache Line A has either now been evicted and/or replaced by Cache Line C from Step 4 above and Cache Line B (the intended target of the delayed snoop-write) is now replaced with Cache Line D from Step 3 above.
- (C) Once the first snoop-write from operation C1 completes, the second (delayed) snoop-write mentioned in Step A to Cache Line B should be killed since Cache Line B was replaced in the operation in Step B. Instead, it is not killed and the line cached (which is now actually Cache Line D) is now updated incorrectly.

1. Cache Line D now holds data that was corrupted by the operation in Step C above (as a result of Step 2 above).
 - A subsequent read of this data returns a corrupted value.
 - Subsequent writes to this cache line also cause the corrupted values to be committed to lower levels of memory.

A compiler flag (`--c64p_dma_l1d_workaround`) has been added to the latest Code Generation Tools to resolve this potential issue. This flag can be utilized for all code in the system or used on particular files/functions that may be susceptible to the conditions listed in this advisory.

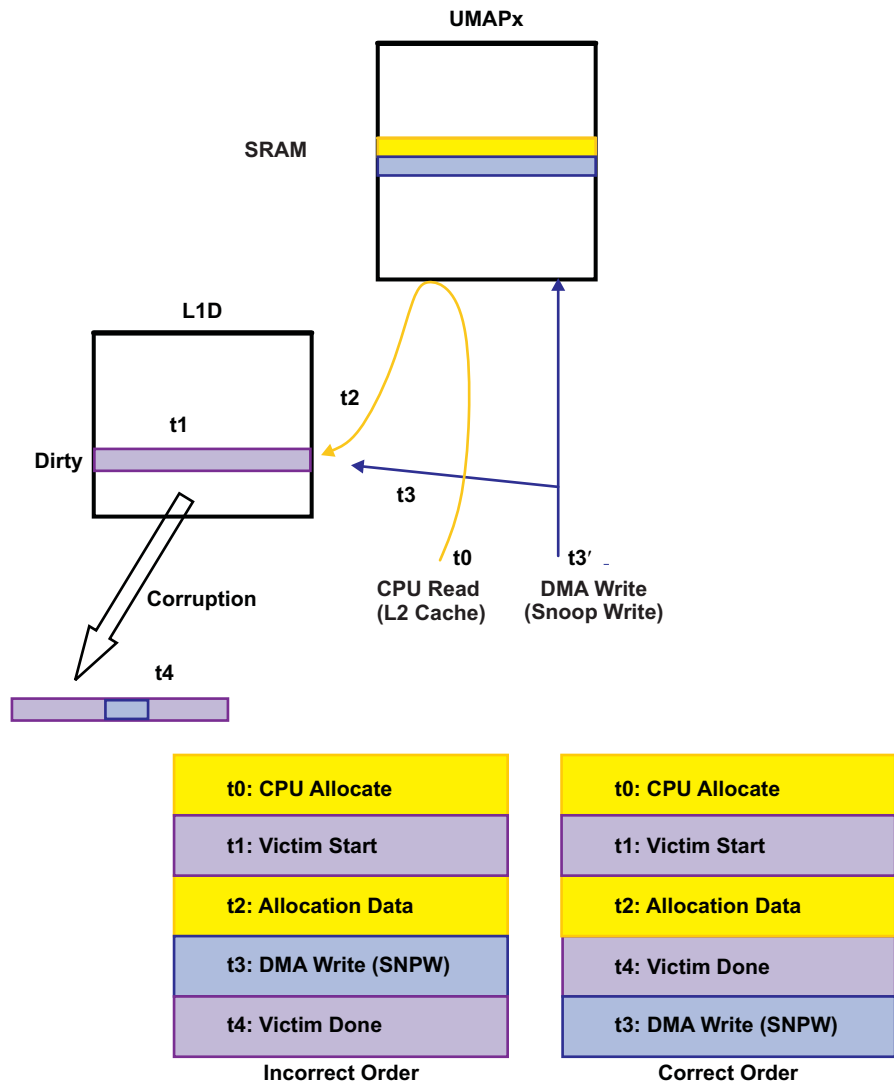
Figure 10. Sequence of Events

Corruption only happens when the DMA accesses an L1D cache line that the CPU also writes to. This results in DMAs that may match victim lines leaving L1D. Thus, it can affect buffers that the CPU fills with writes and the DMA reads, as well as buffers where both the DMA and CPU write. It does not affect DMA buffers that the CPU only reads.

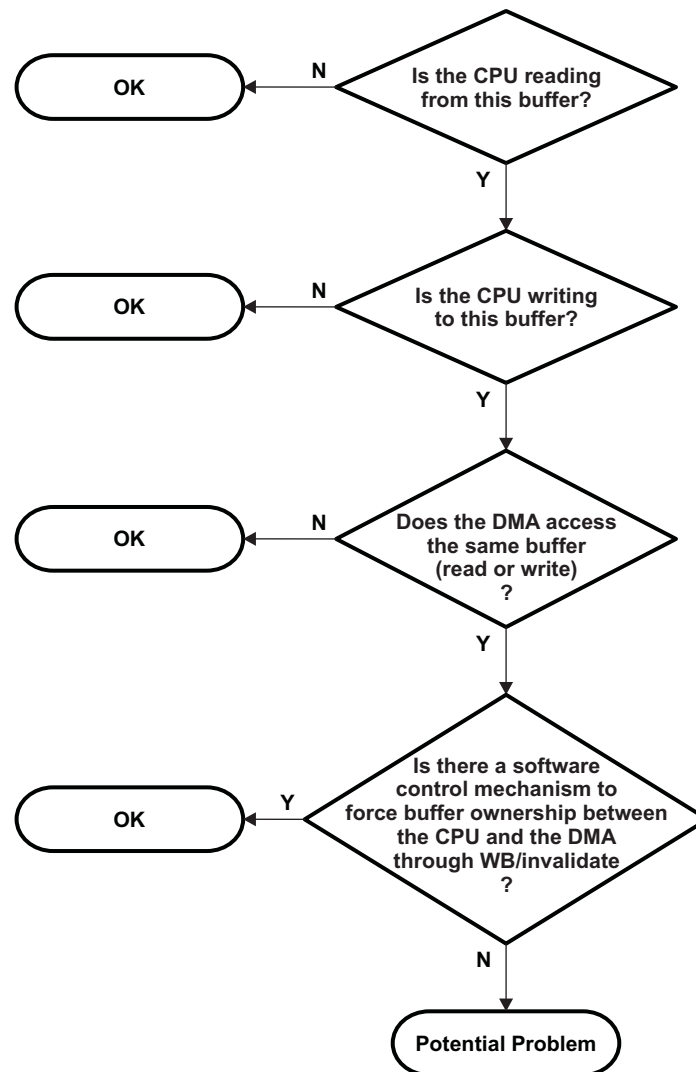
Figure 11. Decision Tree

With all the steps above, it is fairly painful to determine if a particular buffer has the potential to see this issue. [Figure 11](#) is a simple decision tree to help make a determination for a particular buffer.

If you approach one of the "OK" fields, then the buffer should not have a potential of being affected. If you arrive at "Potential Problem," see the workarounds below.

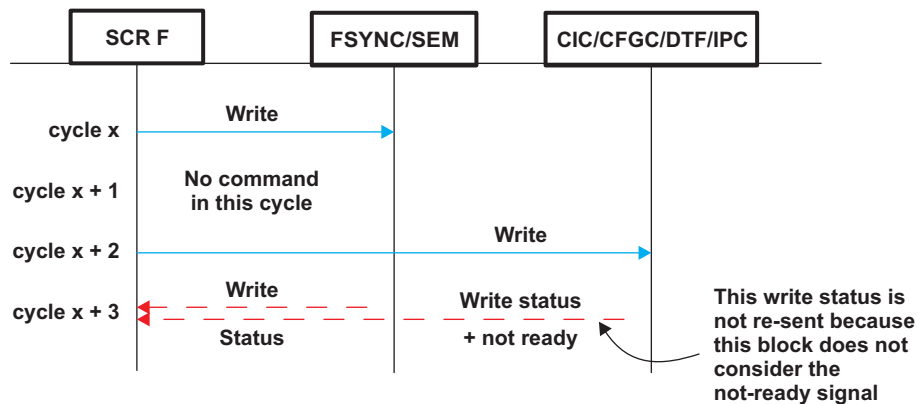
Figure 13. SCR F Write Requests/Write Status

Figure 13 shows the SCR F write requests to and write status from the modules. The following describes the actions shown in the figure:

- On cycle x , there is a write request from SCR F to FSYNC/SEM. Its write status is expected to come after three cycles.
- On cycle $x + 1$, no command is issued in this cycle.
- On cycle $x + 2$, there is one write request from SCR F to CIC/CFG/DTF/IPC. The SCR F sends a not-ready signal to the CIC/CFG/DTF/IPC, but the CIC/CFG/DTF/IPC sends write status irrespective of the not-ready signal, assuming that it responded to the write request and SCR F received it properly.
- The SCR F accepts the write status from the FSYNC/SEM and the write status from the CIC/CFG/DTF/IPC is lost.

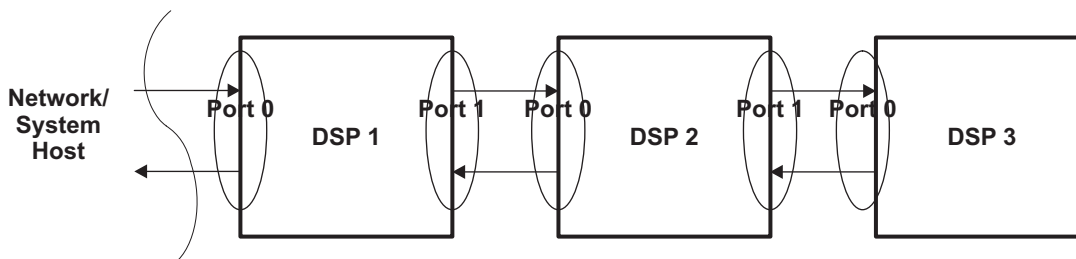
Figure 16. Daisy-Chain Example

In this example, assume that DSP3 is down and the system host wants to do a large NREAD of DSP3 to examine the core dump. The issue discussed above prohibits the NREAD from completing correctly because, as the response packets from DSP3 are sent back, they are corrupted by DSP2 and DSP1 packet forwarding. Instead, the system host needs to request that the adjacent DSP (DSP2) generates the NREAD request to DSP3. The NREAD responses are sent to DSP2 and temporarily stored in memory. Then, DSP2 can generate NWRITE/NWRITE_R/SWRITE packets to the system host with the needed payload. These packets are correctly forwarded by DSP1 to the system host since they are request packets and not responses.

Workaround 2: Two options exist if NREAD response packets cannot be avoided; for example, when reading core dump information from an unresponsive processor which is unable to initiate traffic by itself. The first option is to use software to segment read requests into 16-byte NREADs. Note that this option will work functionally, but may take too much time.

The second option is illustrated in [Figure 16](#).
