Errata

TMS320C2834x Delfino MCUs Silicon Revision 0

1 Introduction

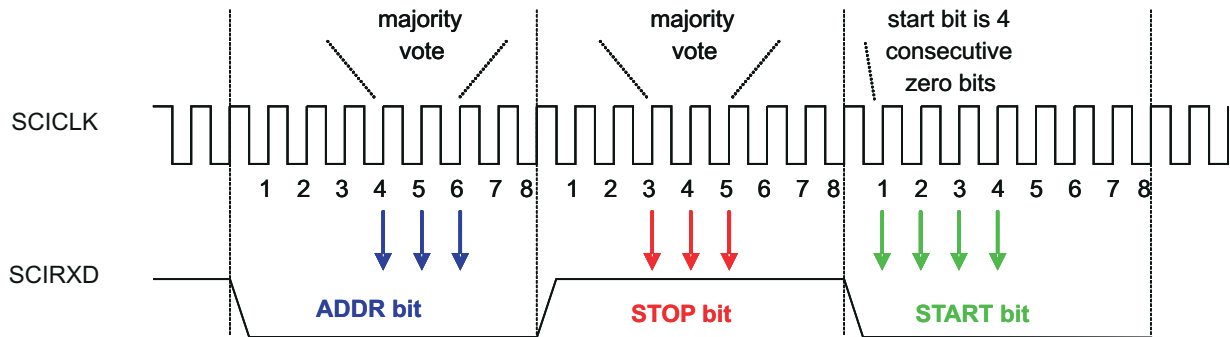
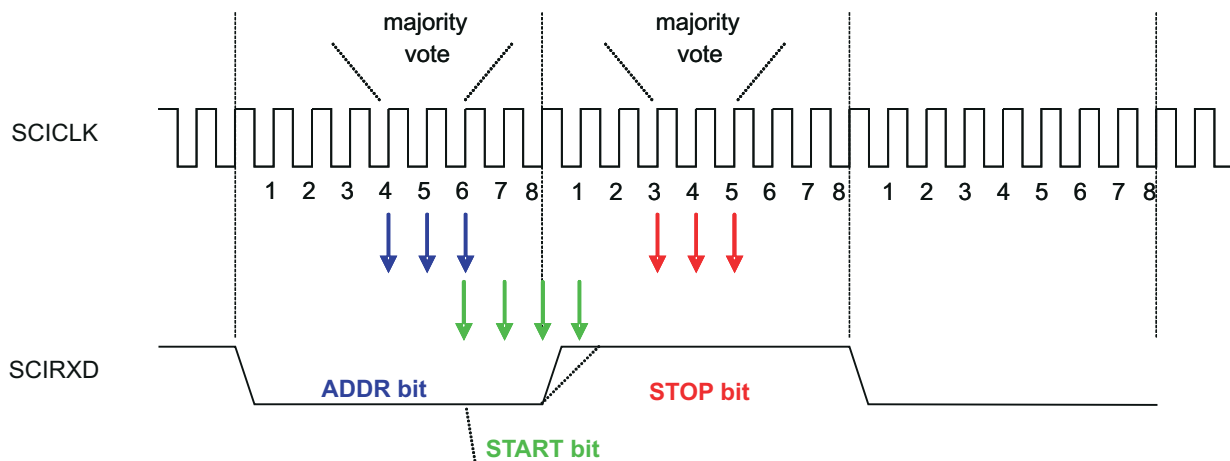
Figure 4-1. Difference Between Expected and Erroneous Operation of START Bit

Details SCI does not look for STOP bit after the ADDR bit. Instead, SCI starts looking for the start bit beginning on sub-sample 6 of the ADDR bit. Slow rise-time from ADDR to STOP bit can cause the false START bit to occur since the 4th sub-sample for the start bit may be sensed low.

Workaround(s) Program the baud rate of the SCI to be slightly slower than the actual. This will cause the 4th sub-sample of the false START bit to be delayed in time, and therefore occur more towards the middle of the STOP bit (away from the signal transition region). The amount of baud slowing needed depends on the rise-time of the signal in the system. Alternatively, IDLE mode of the SCI module may be used, if applicable.
