# TMS320C6452 Digital Media Processor

## Silicon Errata

Literature Number: SPRZ279D  
June 2008–Revised November 2011

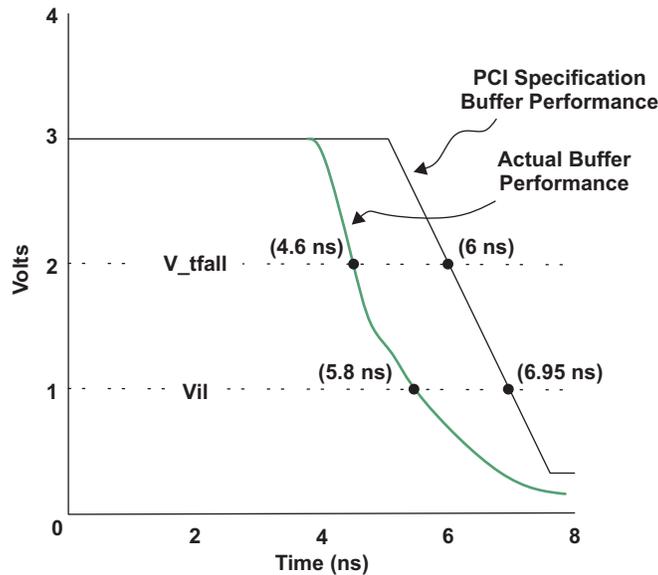
**Figure 3. 66-MHz Buffer Slew and Timing Performance vs Specification Performance**

**Advisory 1.1.10 PCI AC Timings Differ From Specifications**

Details: The device's PCI signals' slew rate differs from that specified in the *PCI Local Bus Specification* revision 2.3, as shown in [Table 4](#).

[Table 6](#) shows the system timing budget for 66-MHz PCI with values from the specification and values in a system where the device is driving with reduced slew rate.
