TMS320DM357

Digital Media System-on-Chip

Silicon Revision 2.1

Silicon Errata

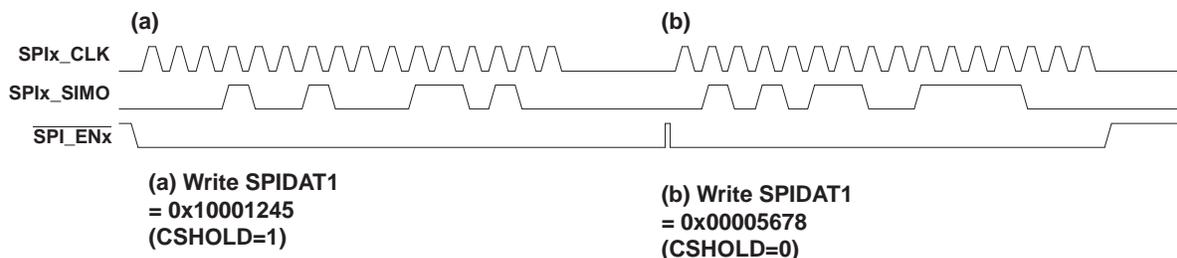
Figure 3. Actual CSHOLD Behavior—32-Bit Writes to SPIDAT1

Instead, what actually occurs is that $\overline{\text{SPI_ENx}}$ is momentarily de-asserted at the beginning of the second write, as illustrated in [Figure 3](#).

Workaround(s): For each word in the sequence of words during which $\overline{\text{SPI_ENx}}$ should be held low, write to the SPIDAT1 register with the CSHOLD bit set to '1'. Follow this by a write to only the CSHOLD field of SPIDAT1, setting CSHOLD = 0 to de-assert $\overline{\text{SPI_ENx}}$. See [Figure 5](#) for an illustration.

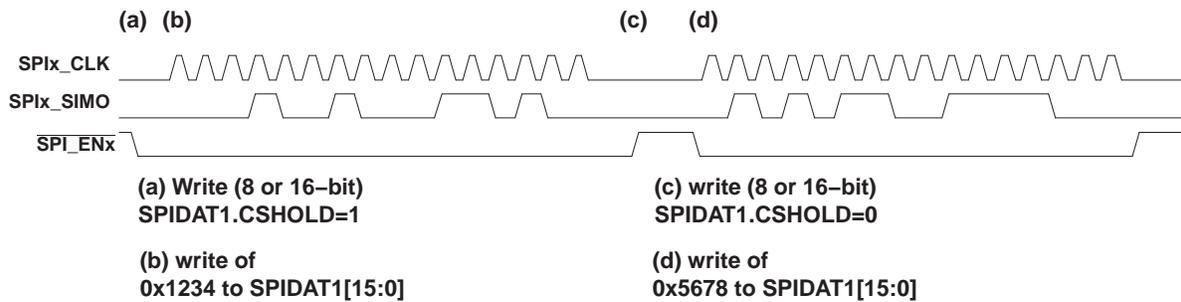
Figure 4. Actual CSHOLD Behavior—Halfword Writes to SPIDAT1

Both [Figure 2](#) and [Figure 3](#) assume that SPIDAT1 is written using a single 32-bit write instruction. If SPIDAT1 is instead written using an 8-bit or 16-bit instruction to write to the CSHOLD field, followed by a 16-bit write to the transmit shift register field of SPIDAT1, then what actually occurs is illustrated in [Figure 4](#). This is the same case illustrated in [Figure 3](#) except that the de-assertion of $\overline{\text{SPI_ENx}}$ lasts for the duration between writing a '0' to the CSHOLD field and writing new data to the transmit shift register.

Alternatively, only write to the SPIDAT1 CSHOLD field before and after the transfer to toggle the $\overline{\text{SPI_ENx}}$ pin. During the transfer, write only to the data field of SPIDAT1[15:0] using 16-bit (halfword) write commands. For an illustration, see [Figure 6](#).
