TMS320TCI6484

Fixed-Point Digital Signal Processor

Silicon Revisions 1.0, 1.1, 1.2, 1.3, 1.4

Silicon Errata

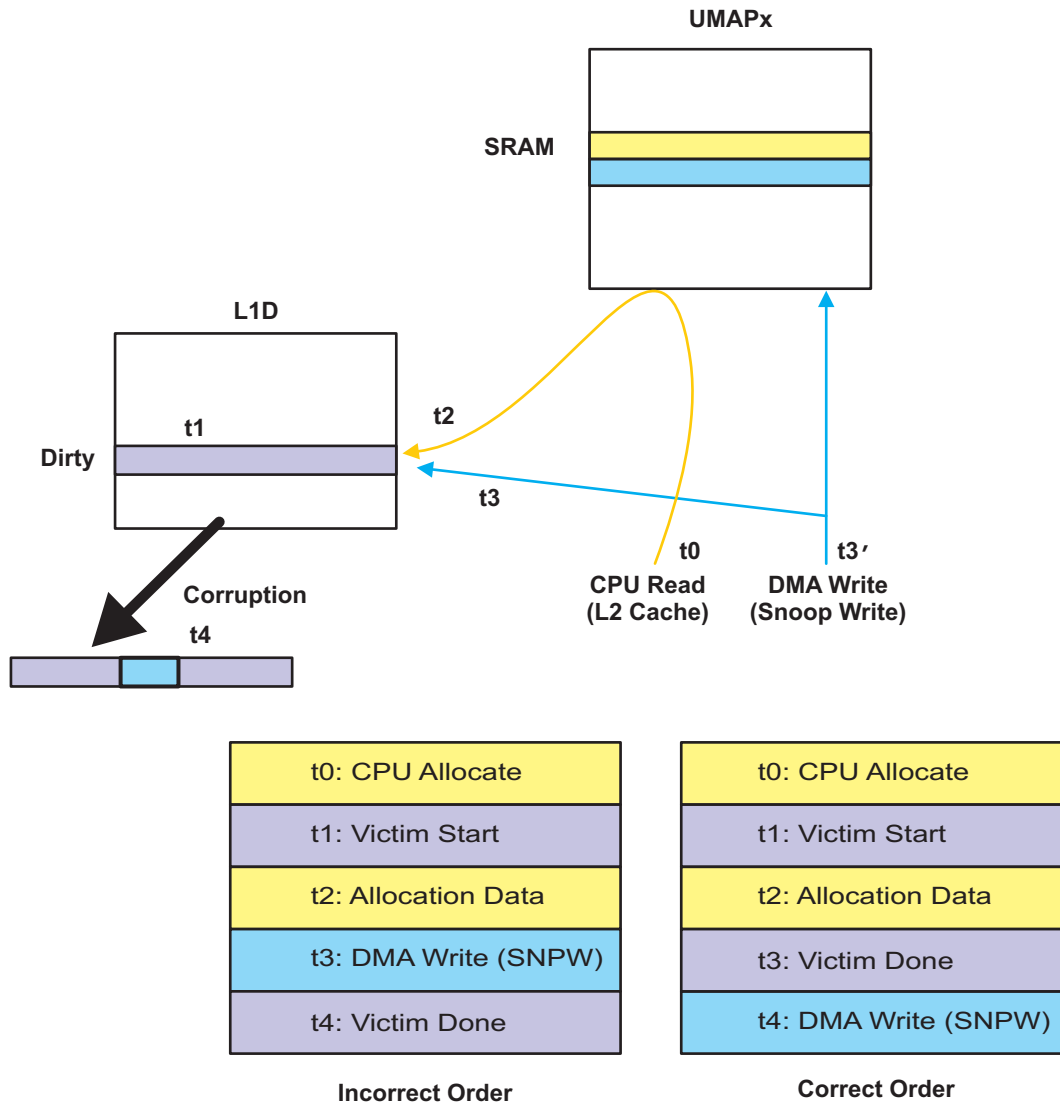
Figure 3 Sequence of Events

Figure 3 shows the sequence of events.

Table 7 shows the expected data values after this sequence completes and the actual values that are now present because of this issue.

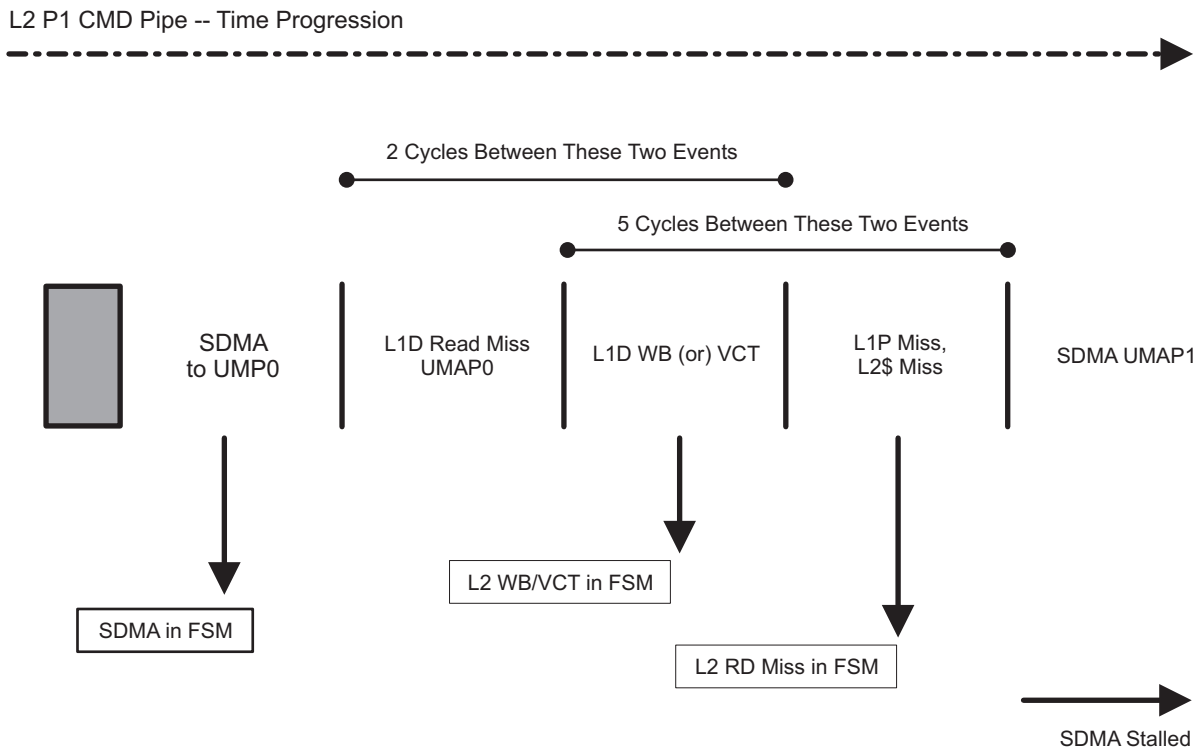
Figure 6 L2 P1 CMD Pipe – Time Progression

The SDMA in item 1 sets up a bank conflict for the L1D\$ read in item 2. The L1D\$ allocate in item 2 prevents the L1D\$ write/victim (3) from advancing, so it is stuck in the pipeline. This occurs at the same time as an L1P\$ allocate that also results in an L2 access to external memory (4), which is also in the same pipeline stage as the L1D\$ write/victim (3). At this point, the L1P\$ allocate (4) advances to the next pipeline stage but the L1D\$ write/victim (3) is still stuck waiting on the L1D\$ allocate (2). This now sets up the pipeline for the stall condition, which is actually triggered by an SDMA to UMAP1 (5). This is what causes further SDMAs to stall. After the L1P\$ allocate (4) is complete, (2) resolves, allowing (3) to resolve thus freeing the SDMA pipeline again. Therefore, the stall is effectively for the length of the L1P\$ allocate in item (4).

Please note that the above four conditions do not guarantee that a stall will occur, it may stall depending on the timing between the transactions. Steps 2 and 3 must occur within two CPU cycles of each other and steps 3 and 4 must occur within five CPU cycles of each other.

Figure 6 shows this timing relationship.

Workaround 1: Leave in previous SDMA/IDMA stall workarounds (for devices with the original SDMA/IDMA stall).

For silicon versions 1.0, 1.1, and 1.2 that were already affected with the first SDMA/IDMA stall issue from [Advisory 9](#), there is no additional workaround needed.

For silicon version 1.3 that fixed the initial condition of SDMA/IDMA stall issue, the deadlock avoidance steps that are already listed in [Advisory 9](#) for previous revisions of silicon should be followed to ensure there is no chance of a deadlock. The workarounds to avoid stalls are also the same as communicated in previous revisions of the device with the issue.
