TMS320DM6467T
Digital Media System-on-Chip (DMSoC)
Silicon Revision 3.0

Silicon Errata

Literature Number: SPRZ307A
January 2010–Revised July 2010

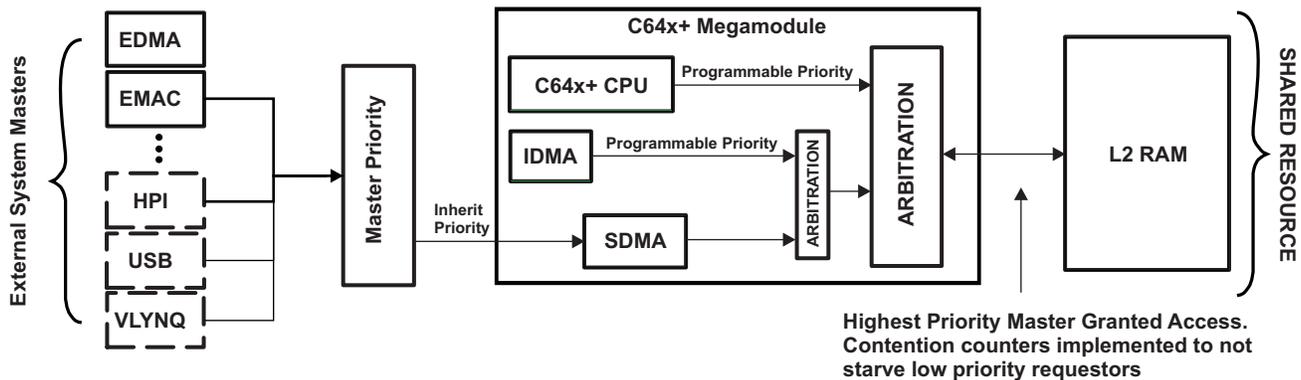
Figure 3. Priority Arbitration Scheme for L2 RAM

Ideally, the BWM arbitration will grant equal L2 bandwidth between equal priority DMA and CPU requests. Instead, when requests arrive at the BWM such that the CPU priority is *lower than or equal to* the DMA priority, the bandwidth is always granted in favor of the CPU over the DMA. In the case of successive CPU requests, it is possible for the CPU to block all DMA requests until the CPU traffic subsides. [Figure 3](#) shows a high-level diagram of the arbitration scheme used for L2 RAM requests.

When the SDMA has finished sending all of its commands to the L2 controller, the C64x+ Megamodule drops the effective transfer priority to seven. The L2 Controller uses this effective priority to arbitrate the SDMA command with the CPU.

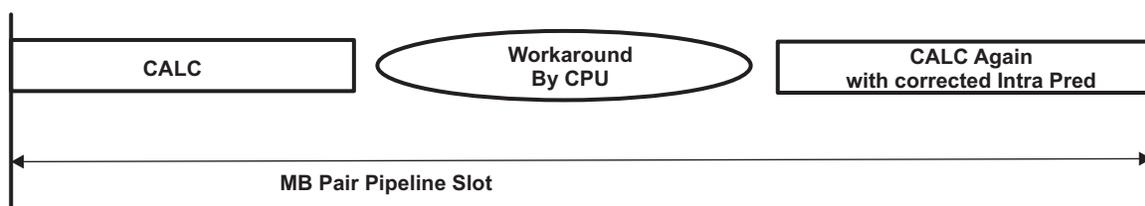
Figure 4. MB Pair Pipeline Slot Example

- In Encode, an incorrect (but legal) bitstream will be generated, and a mismatch will happen between the Encoder and Decoder resulting in significant quality degradation.
- In Decode, the reconstructed macroblock will be incorrect.
- If the following MBs are intra referring to this MB, the error is propagated spatially within the picture.
- If the following pictures refer to this MB, the error is propagated temporally to the following pictures.

During a MB pipeline slot, a CALC is done, a workaround by CPU, and CALC again with corrected intra prediction macroblock (see [Figure 4](#)).

If the MB is of intra 16x16 plane mode, perform the following steps:
