TMS320DM368
Digital Media System-on-Chip (DMSoC)
Silicon Revision 1.1 and 1.2

Silicon Errata

Literature Number: SPRZ316B
April 2010–Revised July 2011

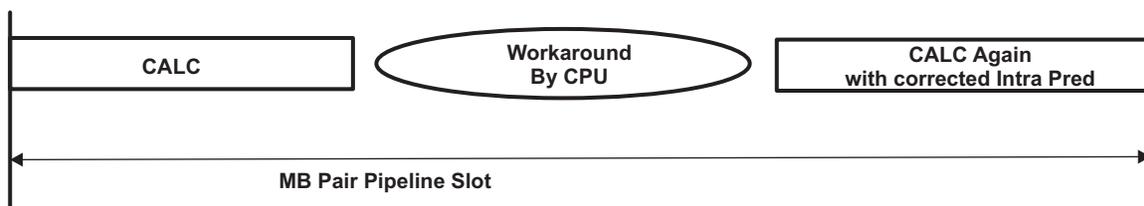
Figure 3. MB Pair Pipeline Slot Example

Advisory 1.2.3 HDVICP—H.264 Encode/Decode: Intra 16 x 16 Plane MB Values \geq 512 are Incorrect
Revision(s) Affected: 1.2 and earlier

Details: During the calculation of the intra prediction block, pixel values can reach 512 or higher. However, the computation engine has precision only enough to hold values equal to 511 or less.

During a MB pipeline slot, a CALC is done, a workaround by CPU, and CALC again with corrected intra prediction macroblock (see [Figure 3](#)).

If the MB is of intra 16x16 plane mode, perform the following steps:

1. Let CALC run.
2. Wait for CALC to complete
3. After CALC completes, switch BFSW for iprdbuf : CALC → DMA
4. Check and correct Intra Prediction (for more details, see the *Check and Correct Intra Prediction* section below)
5. Switch BFSW for iprdbuf : DMA → CALC
6. Switch BFSW for calcmbuf : CALC → DMA
7. Set up CALC commands with intra mode for IQ/IT and inter mode for prediction (for more details, see the *Set up CALC Commands with Intra mode for IQ/IT and Inter Mode for Prediction* section below)
8. If MBAFF, retrigger DMA for upper row data
9. Switch BFSW for calcmbuf : DMA → CALC
10. Switch BFSW for reconbuf : LPF → DMA
11. Read left reconstructed column
12. Switch BFSW for reconbuf : DMA → LPF
13. Switch BFSW for calcsbuf : CALC → DMA
14. Set back left reconstructed column
15. Switch BFSW for calcsbuf : DMA → CALC
16. Re-run CALC
17. Wait for CALC to complete
