# AM3715, AM3703 Sitara ARM Microprocessors Silicon Revisions 1.2, 1.1, 1.0

## Silicon Errata

Literature Number: SPRZ318F  
June 2010–Revised April 2014

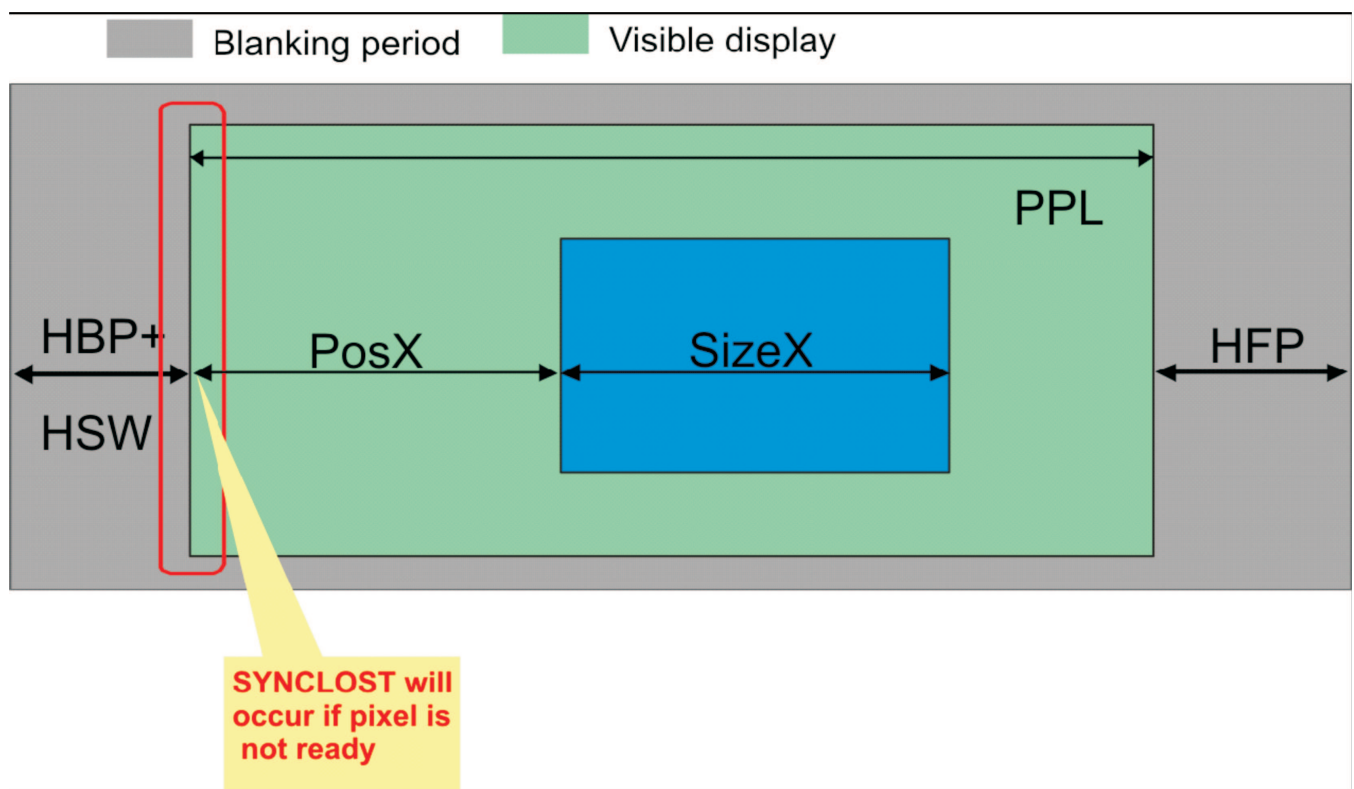
**Figure 2. Synclost Interrupt**

**Details**     Synclost interrupts are observed when performing downscaling and shifting resulting windows on the right of the LCD panel. This interrupt occurs because there is not sufficient time to load the necessary lines buffer before performing a downscaling operation. DISPC video pipeline is expected to be ready with the pixels at the end of HSW+HBP period as shown in Figure 2. This limitation is applicable on 3 and 5 taps configuration.

**Workaround(s)**     To ensure proper downscaling operation, the following conditions should be met:

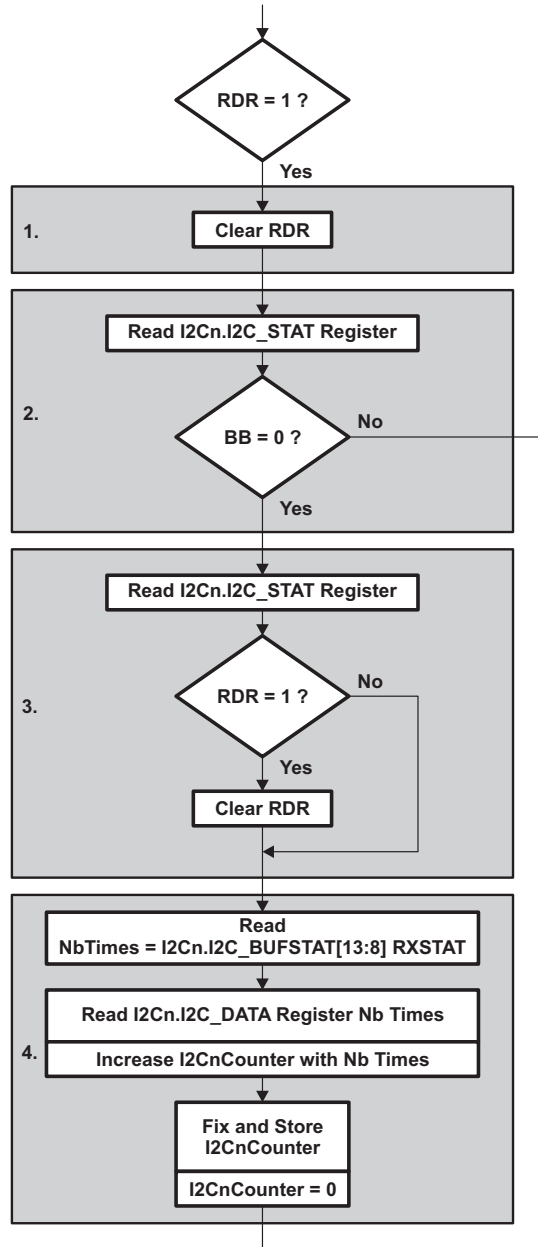
Figure 8. I2C Flowchart

**Details** Under certain rare conditions, the I2C\_STAT[13].RDR bit may be set as well as the corresponding interrupt fire, even when there is no data in the receive FIFO, or the I2C data transfer is still ongoing. These spurious RDR events must be ignored by the software.

**Workaround(s)** Software must filter out unexpected RDR pulses, using the flowchart illustrated in [Figure 8](#) when receiving an I2C RDR interrupt.
