TMS320TCI6608
Multicore Fixed and Floating-Point Digital
Signal Processor
Silicon Revision 1.0, 2.0

Silicon Errata

Literature Number: SPRZ333H
January 2011–Revised July 2015

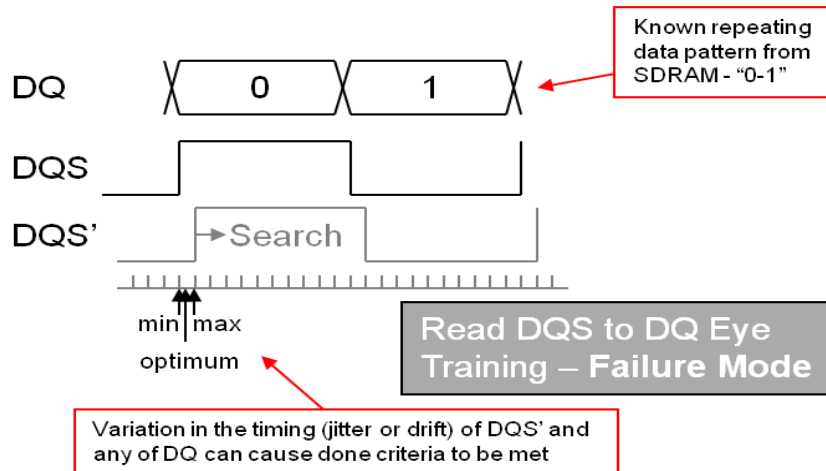
Figure 4. Read DQS to DQ Eye Training - Failure Mode

The leveling feature with the problem is the Read Data Eye Training. Depending on the jitter seen on the DQ and DQS signals, this leveling feature will fail to converge on a good data eye, resulting in corrupted DSP to DDR3 SDRAM reads.

However, if too much jitter is present on the DQ or DQS signals, the search can converge to a false edge as shown in Figure 4.

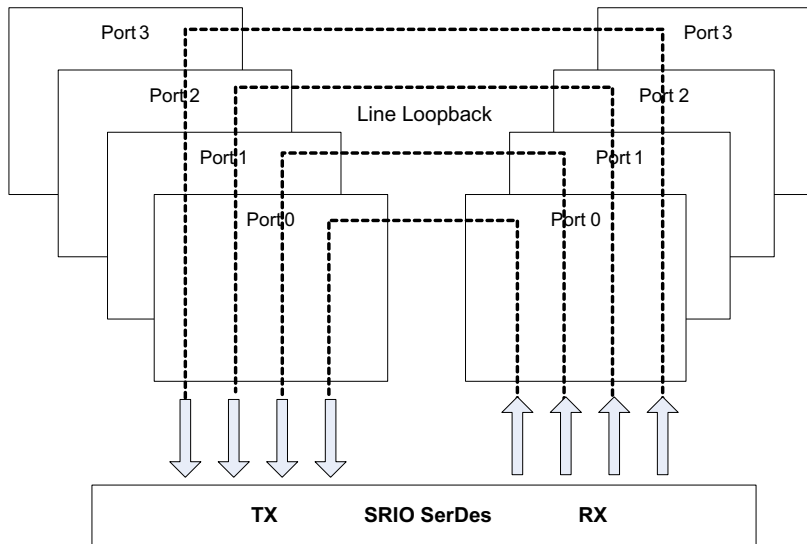
Figure 5. SRIO SerDes in Loopback Mode

The port does not provide any clock compensation when line loopback is enabled. The transmit clock must be externally synchronized with the receive clock. There is only a small FIFO that can compensate for PLL jitter or wander. Hence, correct operation of line loopback requires that the link partners use the same reference clock for the SRIO physical layer, in order to avoid overruns or underruns due to clock frequency mismatch between the link partners. As a result, line loopback mode is generally restricted to validation and qualification of board signal integrity in a lab environment.

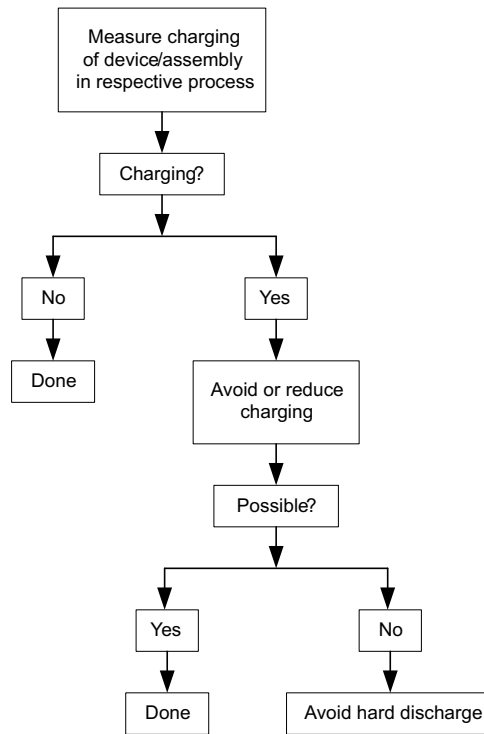
Figure 6. The Basic Flow to Analyzing the Risk

Due to the sensitive nature of the SerDes high-speed pins, exceeding component ESD CDM stress pulses of 150V on the functional pins listed below may cause permanent changes to the output swing and the de-emphasis behavior associated with these pins.

While there is no strict workaround for this issue, there are several ways to analyze the risk with regards to CDM. [Figure 6](#) shows the basic flow for analyzing this risk:

Using generally accepted *good practices* during the assembly process can help to minimize the likelihood of a hard discharge. These practices include:

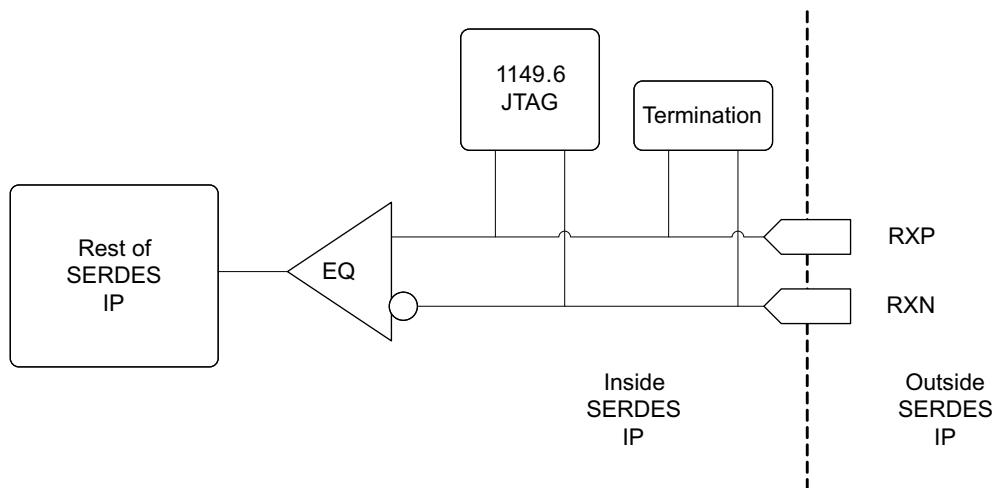
Figure 7. Simplified SerDes Receiver Block Diagram Depicting Relative Placement of Major Receiver Components

A problem has been identified in some cases where the AC-JTAG (IEEE 1149.6, edge-sensitive) input cells on Rincewind and Draco receivers do not reliably respond to input edge transitions from an associated transmitter. Because of this failure, the 1149.6 scan-chain users can receive faulty signal levels transitions or no transitions at all.

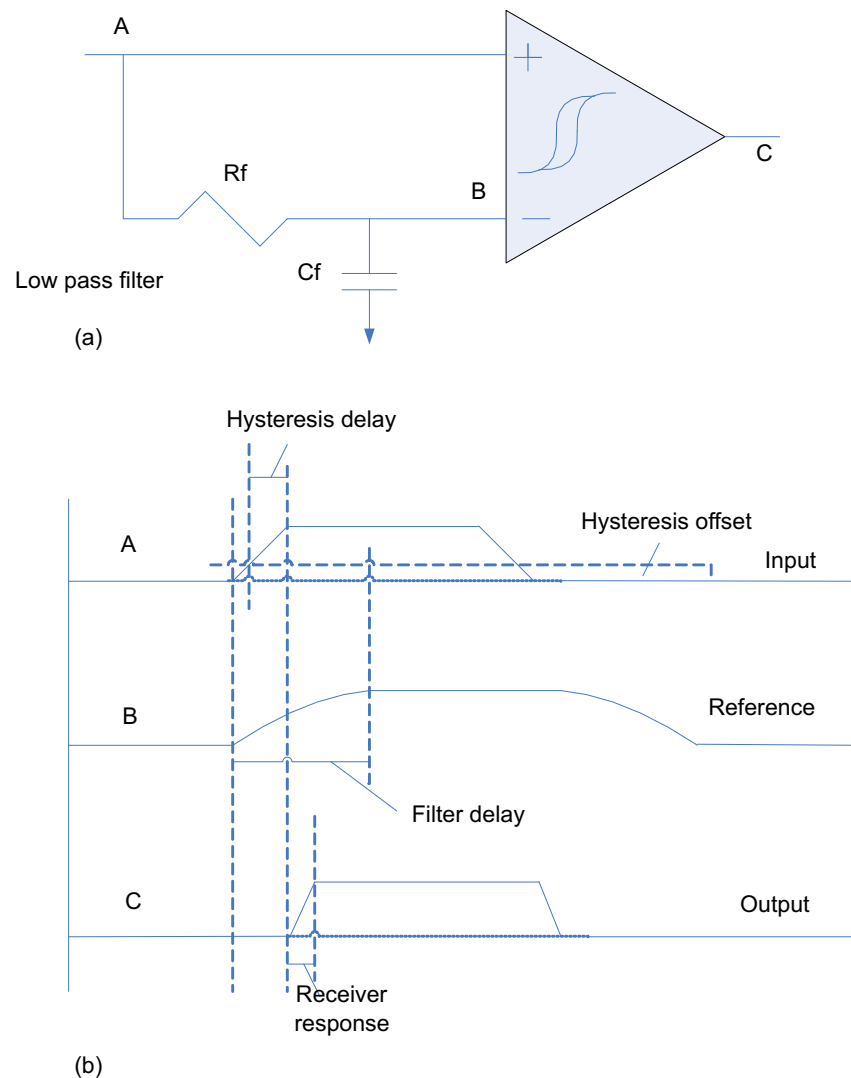
Figure 8. Self-referenced Comparator and Response

The AC-JTAG input cell is based on a self-referenced, hysteretic comparator. See Figure 8. If the SerDes receiver pins are idle (no transitions are applied), the voltage of the pins will settle to the programmed, receiver common-mode voltage (0.80V nominally). From this idle state a single edge transition applied to the AC-JTAG input cell can push both terminals of the AC-JTAG comparator inputs past the VDDT (1.0V) supply voltage level.

When the comparator inputs are saturated the comparator gain is minimized and under certain PVT conditions (strong silicon, 125C junction temperature, minimum VDDT), the comparator can fail to switch to the proper state, or not respond at all.

One potential workaround has been identified. The failure mode of the AC-JTAG comparator is most pronounced by single edge transitions at low frequency as this creates the highest likelihood of the comparator inputs being saturated and switching incorrectly. More frequent transitions can result in proper switching of the comparator output.

The basic procedure is to initiate multiple edge transitions and then read the state of the RX input cell in question. However, due to the nature of the failure, the exact number would have to be determined experimentally for a given device.

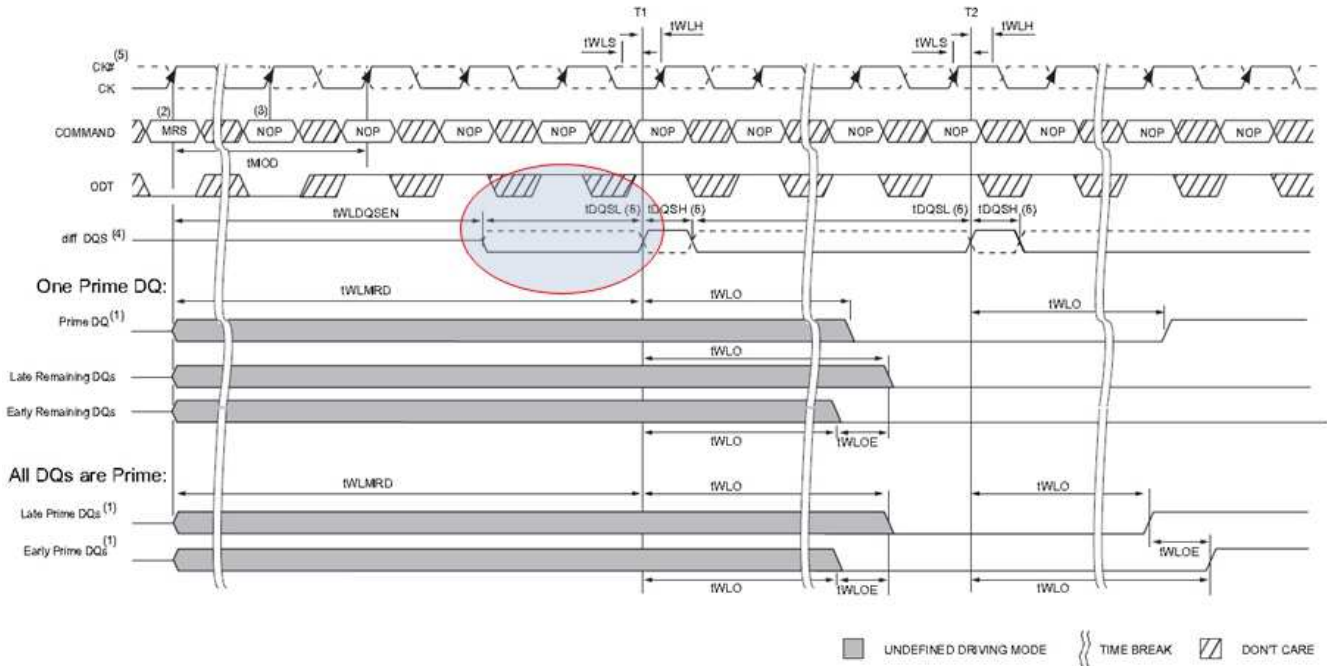
Figure 9. Timing Details of Writing Leveling Sequence

As shown in Figure 9, the DDR3 JEDEC standard requires that the DQS strobe be sent with a preamble (DQS=0) for at least tDQSL during write leveling, prior to the first rising edge of the DQS strobe (DQS=1). It was observed in simulations that the first DQS strobe is sent immediately following the high impedance state of the DQS line and without a preamble. This Z->1 transition on the DQS line may allow incremental write leveling to fail. Note that this issue impacts only the incremental write leveling feature of the DDR3 Memory controller. No issue is expected with automatic write leveling.

At this time, incremental write leveling is not supported on this device and we recommend that the incremental write leveling intervals in RDWR_LVL_CTRL and RDWR_LVL_RMP_CTRL be programmed to 0 to disable this feature.

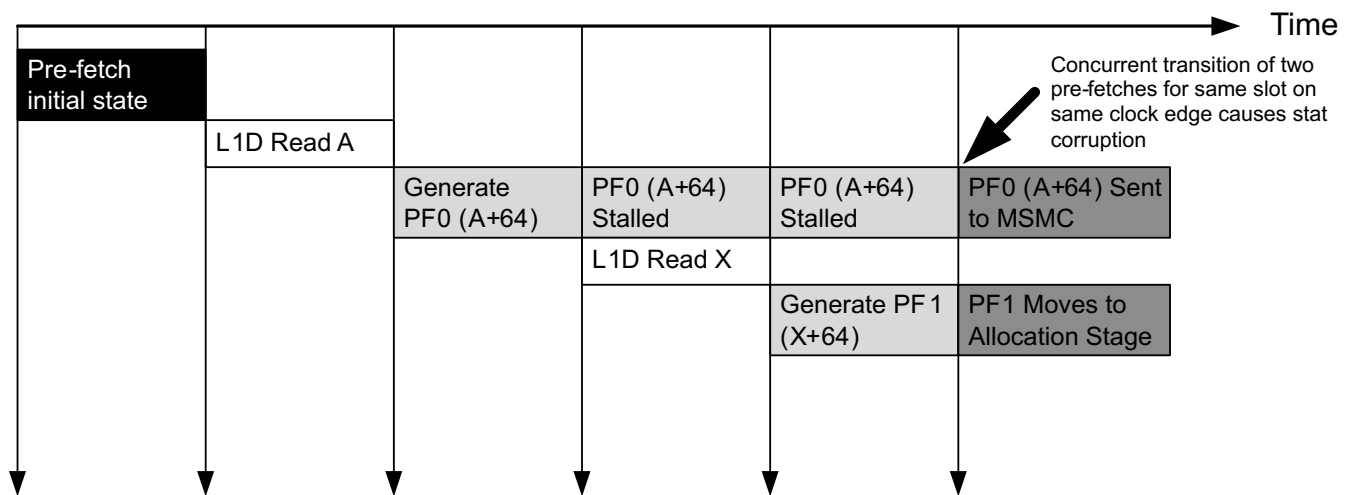
Figure 11. Sequence diagram

The fault lies in the 'sorting' hardware which can lead to the first pre-fetch not being marked stale under certain boundary conditions (see pathological sequence below). The subsequent fetch access when the pre-fetch access wasn't marked stale will access the stale data that has been cleared (but not yet marked as stale.) This results in the read exception and/or incorrect data being fetched. Thus, the issue occurs only when the re-fetch feature is triggered and only L1D accesses use the re-fetch feature.

7. PF0 transitions to the XMC output (to MSMC) on the exact same clock edge that PF1 is transitioning to the buffer allocation pipeline stage

8. Instead of PF0 being marked stale and thrown away when returned, both PF0 and PF1 are marked valid and outstanding.
9. This leads to two valid outstanding pre-fetches for the same data buffer slot which is an invalid state and can result in unexpected behavior for a subsequent pre-fetchable data access to address X+64.
