TMS320TCI6614

Communications Infrastructure KeyStone SOC

Silicon Revisions 1.0, 1.1, 1.3

Silicon Errata

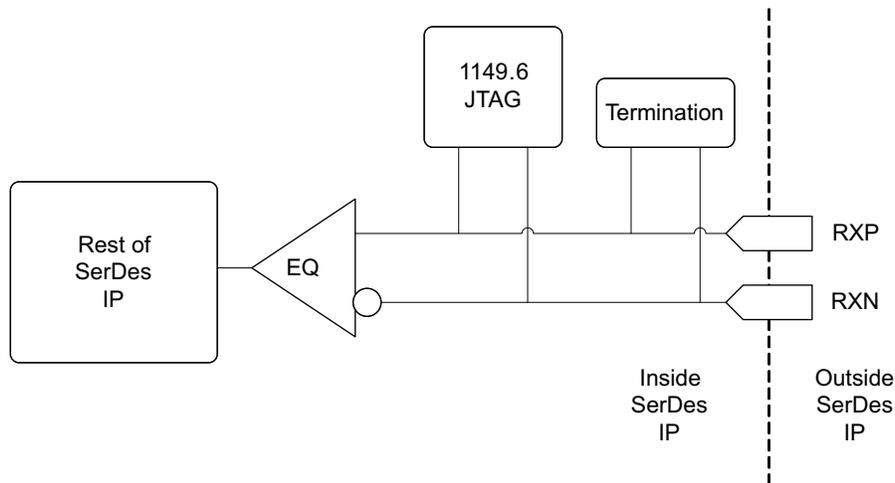
Figure 4. Simplified SerDes Receiver Block Diagram Depicting Relative Placement of Major Receiver Components

A problem has been identified in some cases where the AC-JTAG (IEEE 1149.6, edge-sensitive) input cells on Rincewind and Draco receivers do not reliably respond to input edge transitions from an associated transmitter. Because of this failure, the 1149.6 scan-chain users can receive faulty signal levels transitions or no transitions at all.

IEEE 1149.1, level-sensitive, input cells show no issue and normal operation of the SerDes receivers is also unaffected by this problem.

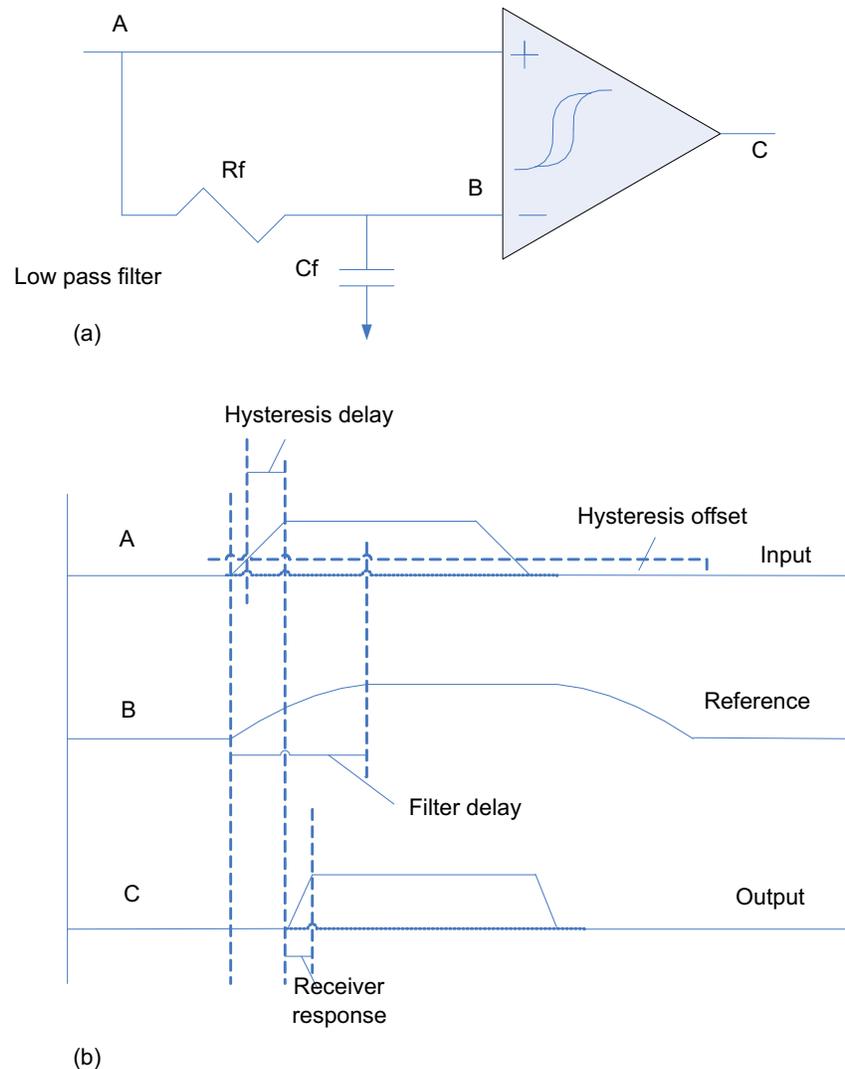
Figure 5. Self-referenced Comparator and Response (See Note Below)

The AC-JTAG input cell is based on a self-referenced, hysteretic comparator. See Figure 5. If the SerDes receiver pins are idle (no transitions are applied), the voltage of the pins will settle to the programmed, receiver common-mode voltage (0.80V nominally). From this idle state a single edge transition applied to the AC-JTAG input cell can push both terminals of the AC-JTAG comparator inputs past the VDDT (1.0V) supply voltage level.

When the comparator inputs are saturated the comparator gain is minimized and under certain PVT conditions (strong silicon, 125C junction temperature, minimum VDDT), the comparator can fail to switch to the proper state, or not respond at all.

One potential workaround has been identified. The failure mode of the AC-JTAG comparator is most pronounced by single edge transitions at low frequency as this creates the highest likelihood of the comparator inputs being saturated and switching incorrectly. More frequent transitions can result in proper switching of the comparator output.

The basic procedure is to initiate multiple edge transitions and then read the state of the RX input cell in question. However, due to the nature of the failure, the exact number would have to be determined experimentally for a given device.

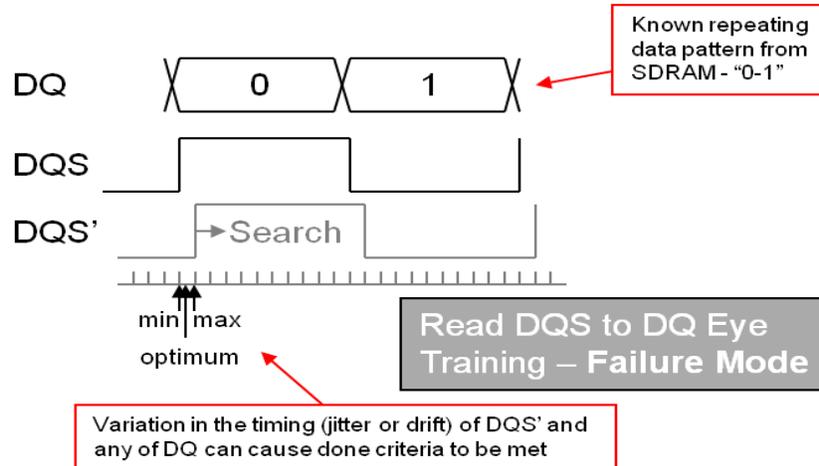
Figure 8. Read DQS to DQ Eye Training - Failure Mode

The leveling feature with the problem is the Read Data Eye Training. Depending on the jitter seen on the DQ and DQS signals, this leveling feature will fail to converge on a good data eye, resulting in corrupted DSP to DDR3 SDRAM reads.

However, if too much jitter is present on the DQ or DQS signals, the search can converge to a false edge as shown in [Figure 8](#).

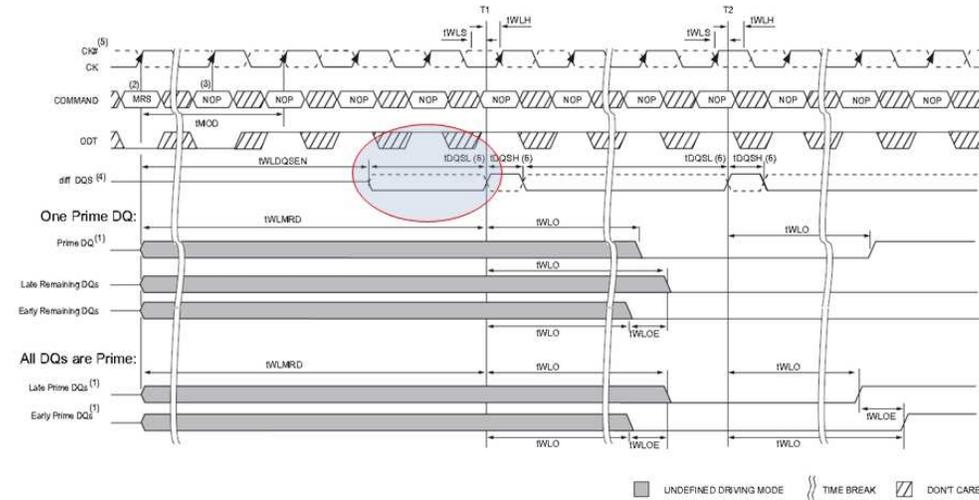
Figure 9. Timing Details of Writing Leveling Sequence

As shown in [Figure 9](#), the DDR3 JEDEC standard requires that the DQS strobe be sent with a preamble (DQS=0) for at least tDQSL during write leveling, prior to the first rising edge of the DQS strobe (DQS=1). It was observed in simulations that the first DQS strobe is sent immediately following the high impedance state of the DQS line and without a preamble. This Z->1 transition on the DQS line may allow incremental write leveling to fail. Note that this issue impacts only the incremental write leveling feature of the DDR3 Memory controller. No issue is expected with automatic write leveling.

At this time, incremental write leveling is not supported on this device and we recommend that the incremental write leveling intervals in RDWR_LVL_CTRL and RDWR_LVL_RMP_CTRL be programmed to 0 to disable this feature.

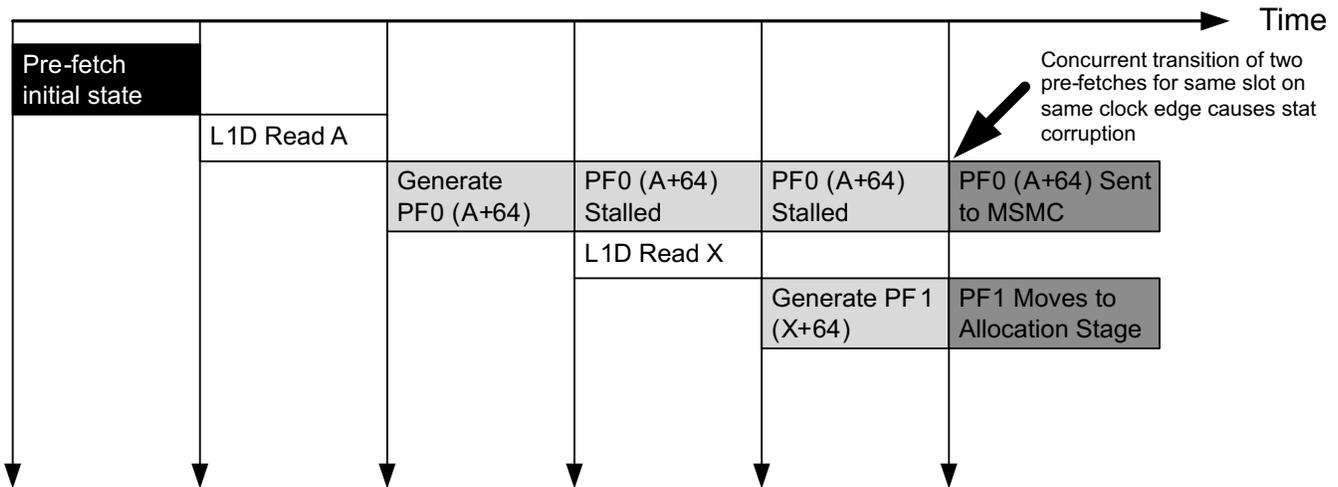
Figure 11. Sequence diagram

The fault lies in the 'sorting' hardware which can lead to the first pre-fetch not being marked stale under certain boundary conditions (see pathological sequence below). The subsequent fetch access when the pre-fetch access wasn't marked stale will access the stale data that has been cleared (but not yet marked as stale.) This results in the read exception and/or incorrect data being fetched. Thus, the issue occurs only when the re-fetch feature is triggered and only L1D accesses use the re-fetch feature.

7. PF0 transitions to the XMC output (to MSMC) on the exact same clock edge that PF1 is transitioning to the buffer allocation pipeline stage

8. Instead of PF0 being marked stale and thrown away when returned, both PF0 and PF1 are marked valid and outstanding.
9. This leads to two valid outstanding pre-fetches for the same data buffer slot which is an invalid state and can result in unexpected behavior for a subsequent pre-fetchable data access to address X+64.

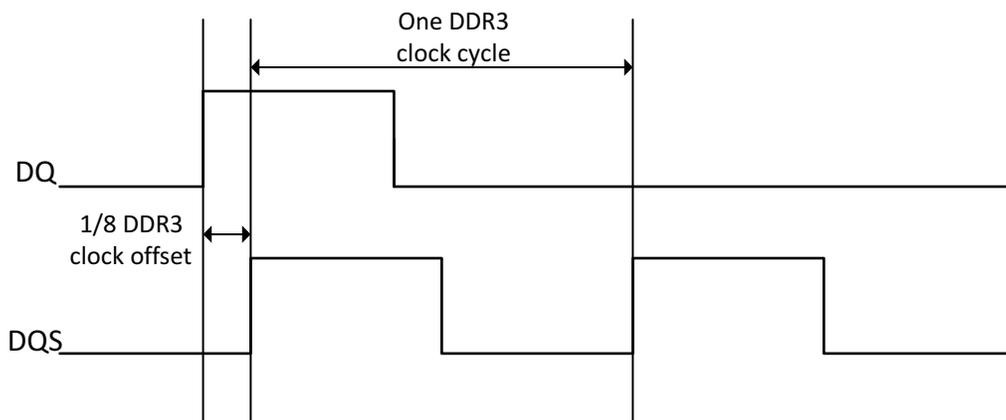
Figure 12. DQ to DQS offset with default incorrect value (0x20) for DATA_REG_PHY_DQ_OFFSET in DDR3_CONFIG_REG_1

//Correct DQS-DQ write timing offset
DDR3_CONFIG_REG_1 = 0x01000000;

//Do a PHY reset. Toggle DDR_PHY_CTRL_1 bit 15 0->1->0
DDR_DDRPHYC &= ~(0x00008000);
DDR_DDRPHYC |= (0x00008000);
DDR_DDRPHYC &= ~(0x00008000);
```

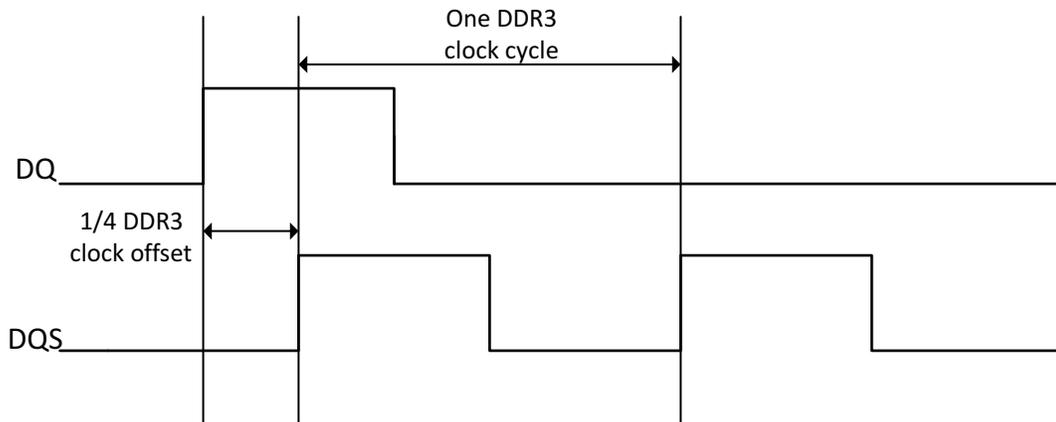
Figure 13. DQ to DQS offset with correctly programmed value (0x40) for DATA_REG_PHY_DQ_OFFSET in DDR3_CONFIG_REG_1
