F28M36x Concerto™ MCUs Silicon Errata

Silicon Revisions F, E, B, A, 0

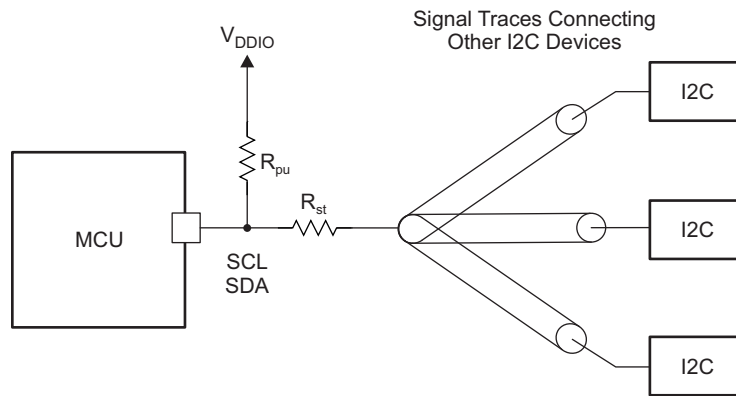
Figure 8. Placement of Series Termination Resistor and Pullup Resistor

The SDA and SCL outputs are implemented with push-pull 3-state output buffers rather than open-drain output buffers as required by I2C. While it is possible for the push-pull 3-state output buffers to behave as open-drain outputs, an internal timing skew issue causes the outputs to drive a logic-high for a duration of 0–5 ns before the outputs are disabled. The unexpected high-level pulse will only occur when the SCL or SDA outputs transition from a driven low state to a high-impedance state and there is sufficient internal timing skew on the respective I2C output.

This short high-level pulse injects energy in the I2C signals traces, which causes the I2C signals to sustain a period of ringing as a result of multiple transmission line reflections. This ringing should not cause an issue on the SDA signal because it only occurs at times when SDA is expected to be changing logic levels and the ringing will have time to damp before data is latched by the receiving device. The ringing may have enough amplitude to cross the SCL input buffer switching threshold several times during the first few nanoseconds of this ringing period, which may cause clock glitches. This ringing should not cause a problem if the amplitude is damped within the first 50 ns because I2C devices are required to filter their SCL inputs to remove clock glitches. Therefore, it is important to design the PCB signal traces to limit the duration of the ringing to less than 50 ns. One possible solution is to insert series termination resistors near the SCL and SDA terminals to attenuate transmission line reflections.

This issue may also cause the SDA output to be in contention with the slave SDA output for the duration of the unexpected high-level pulse when the slave begins its ACK cycle. This occurs because the slave may already be driving SDA low before the unexpected high-level pulse occurs. The glitch that occurs on SDA as a result of this short period of contention does not cause any I2C protocol issue but the peak current applies unwanted stress to both I2C devices and potentially increases power supply noise. Therefore, a series termination resistor located near the respective SDA terminal is required to limit the current during the short period of contention.

Insert series termination resistors on the SCL and SDA signals and locate them near the SCL and SDA terminals. The SCL and SDA pullup resistors should also be located near the SCL and SDA terminals. The placement of the series termination resistor and pullup resistor should be connected as shown in [Figure 8](#).
