***TDA2x SoC for Advanced Driver Assistance Systems
(ADAS)
Silicon Revision 2.0, 1.1***

This document describes the known exceptions to the functional specifications for the device.

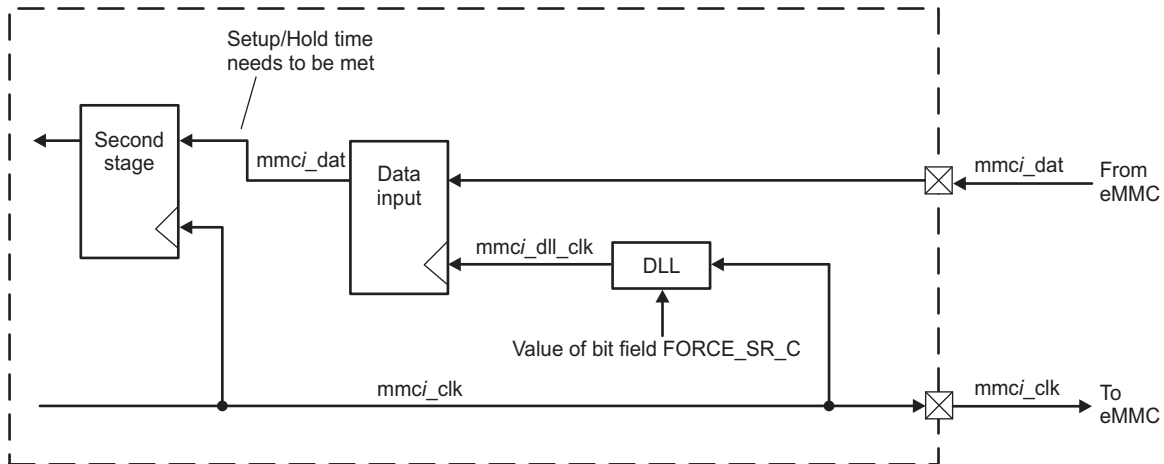
Figure 2. Simplified SoC 192-MHz Mode DLL Block Diagram

DESCRIPTION Internal to the MMC module, a second stage latch is used to recapture data captured by DLL delayed CLK, MMC_DLL_CLK. The second stage latch captures with the original transmitting clock, MMC_CLK.

MMC_DLL_CLK and MMC_CLK both run at the same clock frequency. This results in a narrow range of tuning ratio elements, where the delayed MMC_DLL_CLK comes in phase with MMC_CLK. If the clocks are in phase, the data captured by the first clock violates the setup and hold time requirements needed for the second stage latch, resulting in incorrectly read data. This is known as tuning re-timing errors.

A DLL tuning algorithm has been implemented that can avoid the tuning re-timing errors. More details on this can be found in App Note [SPRACA9](#). The following notes summarize the updated algorithm:

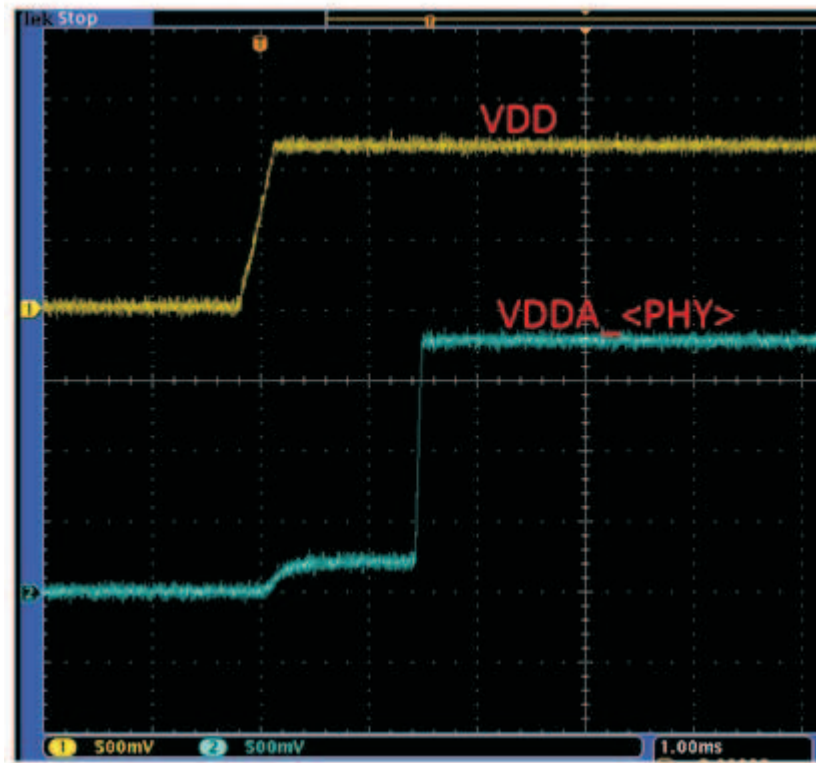
Figure 4. Leakage Voltage

The device-specific Data Manual requires Core AVS rail (VDD) to power up before the 1.8 V high speed analog PHY domain(s). When this sequence is followed, the high speed analog PHY domain will have a small step-up to a voltage plateau (< 0.5 V) that aligns to the beginning of the VDD ramp-up, and is maintained until the ramp-up of high speed analog PHY rail, as shown in Figure 4. Note the leakage value will differ from system to system, but will be less than 500 mV. The leakage voltage in the provided capture is approximately 250 mV.

The reverse is true on the power down sequence. The high speed analog PHY domain(s) are required to be powered down prior to Core AVS rail (VDD), and such sequence may cause a small plateau to exist during the period.

The root cause of the plateau is related to the parasitic diodes in logic blocks which have multiple power sources. This leakage path is not a reliability concern for this device.
