DRA75x, DRA74x SoC for Automotive Infotainment Silicon Revision 2.0, 1.1

Errata

Literature Number: SPRZ398J
NOVEMBER 2012 – REVISED FEBRUARY 2021

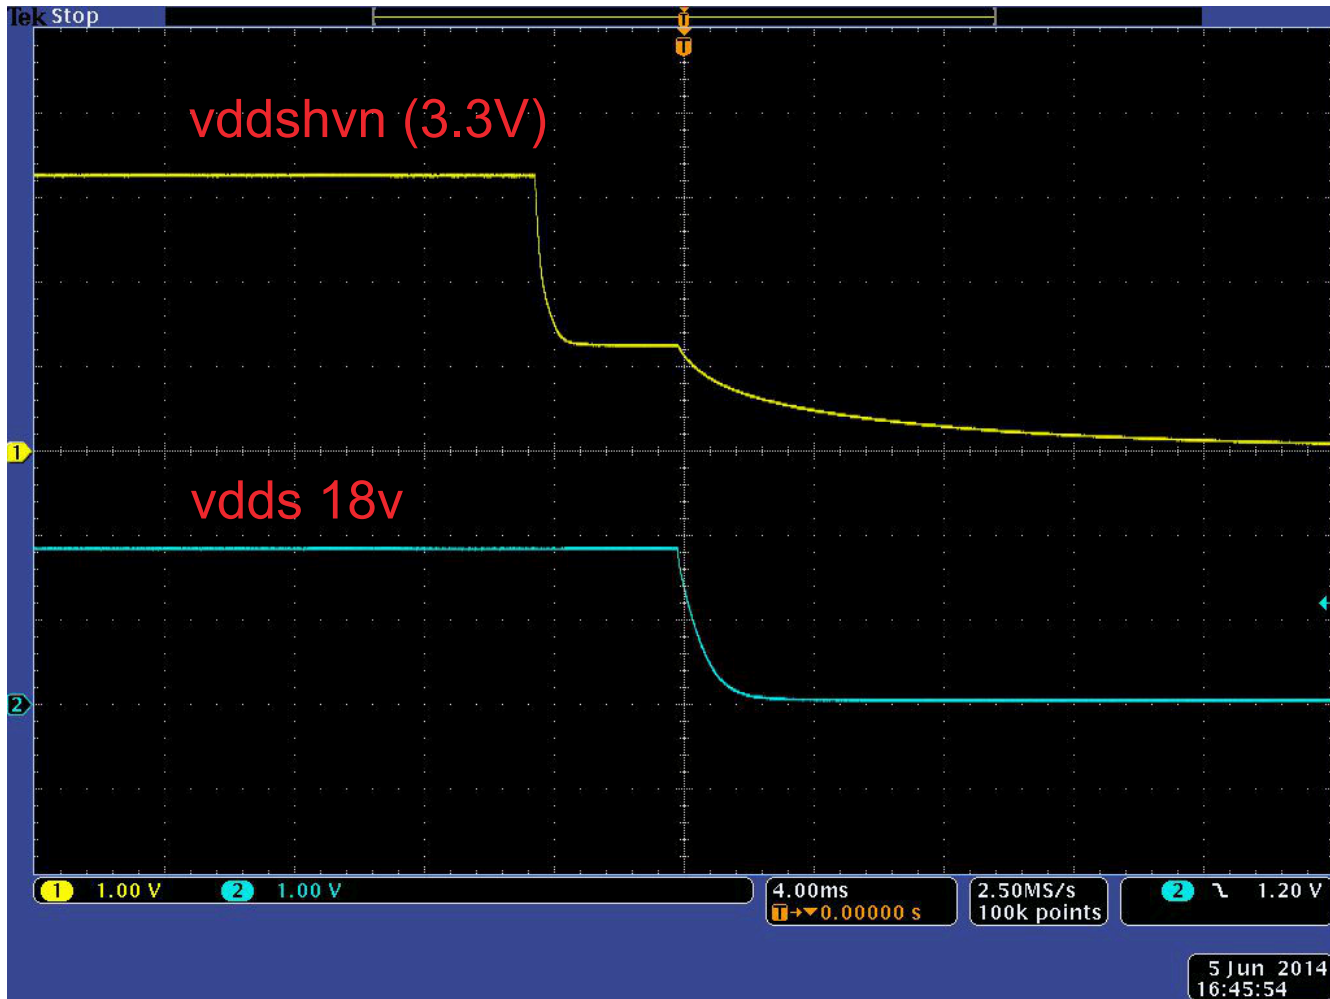
Figure 4-1. PAB_RevA

The Data Manual allows the vddshvn rail (in either 3.3V or 1.8V mode) to power down at the same time or before the vdds18v rail. When the vddshvn rail is powered down before the vdds18v rail, the vddshvn rail stays at Plateau Level (<1.5V) until the vdds18v rail is disabled, as shown in the waveform below.

A subset of the SOC's LVCMOS IOs (refer to DM for details) have a pull-up resistor that is active by default, including during reset and power-down. The SOC's IOs that have internal or external pull-ups will stay at Plateau Level (<1.5V) during the power-down. If other ICs on the board that are interfaced to the SOC's LVCMOS signals use a separate supply then it's possible that the other IC's signals can be pulled to the Plateau Level while its power supply is off.

The root cause of the plateau is related to the LVCMOS IO buffer Dual Voltage detection circuitry. The LVCMOS Dual Voltage IO includes voltage comparator circuitry to determine if the IO is in 3.3V mode or 1.8V mode. During powerdown of vddshvn domains, a current path in the internal bias transistors results in the vddshvn rail being held to an

In general, TI recommends using the same supply source for connected components. E.g., a single LDO should drive vddshvn and the related 3.3V external components.
