Errata

AM437x Sitara™ Processors Silicon Revisions 1.1, 1.2

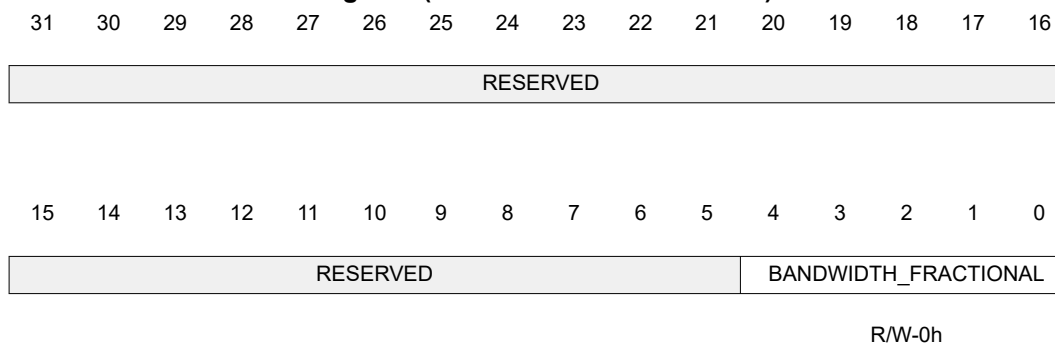
Figure 3-1. NOC_200F_BWLIMITER_MODENA_INIT0_BANDWIDTH_FRACTIONAL Register (Address Offset: 0x00 5208)

Details Under certain system-level conditions where bandwidth usage is high or spikes, the DSS can experience a FIFO underflow condition causing screen tearing, flickering, or otherwise corrupted LCD data output. Each pipeline in the DSS has its own dedicated 1KB FIFO which, in certain conditions, is not large enough to sustain constant LCD data output when concurrent continuous writes to memory are being performed by other device peripherals. Therefore, system-level peak bandwidth usage must be taken into consideration in order to avoid frequent FIFO underflows from occurring. In the case of high resolution displays, typically for resolutions over 1024x768, FIFO underflows can occur regularly if no steps are taken to properly manage the DSS memory bandwidth requirements. It is recommended to perform system-level stress tests based on the end-application requirements to determine if the worst-case bandwidth consumption causes the DSS FIFO to underflow, especially when using the DSS to drive LCD panels over 1024x768 resolution. In the case where frequent FIFO underflows occur, the following workaround is required for stable operation.

The L3 interconnect can be configured to place a bandwidth limit on the A9 core in order to prevent high-load tasks or sudden spikes in processors activity from consuming too much memory bandwidth which could result in a DSS FIFO underflow. There are two registers within the L3Fast interconnect register space that must be configured to set the A9 bandwidth limit: the NOC_200F_BWLIMITER_MODENA_INIT0_BANDWIDTH_FRACTIONAL and NOC_200F_BWLIMITER_MODENA_INIT0_BANDWIDTH_INTEGER registers. The configuration values required for a given bandwidth limit can be calculated using the following equation where x is the desired maximum A9 bandwidth on the L3 interconnect and y is resulting bandwidth factor.

The least significant 5 bits of the bandwidth factor (y), [4:0], should be programmed into the BANDWIDTH_FRACTIONAL field of the NOC_200F_BWLIMITER_MODENA_INIT0_BANDWIDTH_FRACTIONAL register and the remaining most significant bits should be programmed into BANDWIDTH_INTEGER field of the NOC_200F_BWLIMITER_MODENA_INIT0_BANDWIDTH_INTEGER register.

For example, if $y = 0x30$

BANDWIDTH_FRACTIONAL = 0x10

BANDWIDTH_INTEGER = 0x1

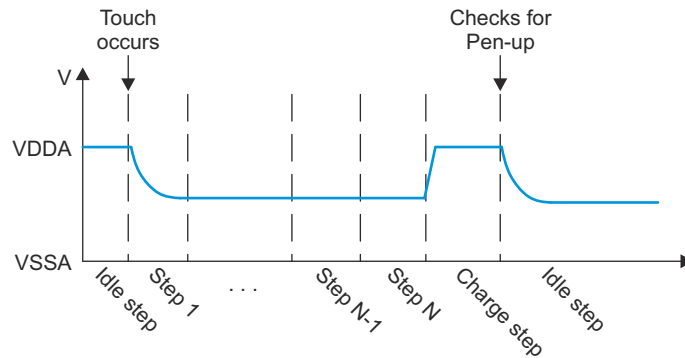
Figure 3-4. TSC Generates False Pen-up Interrupt

Details The touchscreen controller (TSC) determines the pen state (up or down) by checking the respective analog input (AIN0 for 4-wire or AIN4 for 5-wire) voltage level immediately after the Charge step. This does not provide enough time for the analog input voltage to return to the normal Pen-down voltage before testing the pen state. This will cause the TSC to generate a false Pen-up interrupt if the Charge step is enabled with the strong pull-up turned on when using hardware synchronized steps. Figure 3-4 illustrates the effect on the analog voltage when constant pen pressure is applied to the touchscreen and held through the Charge step.

Workarounds

There are two possible workarounds for this problem:

- The first workaround is implemented by configuring the Charge step exactly like the Idle step, where the internal strong pull-up is not turned on. This workaround will remove the strong pull-up on the analog input during the Charge step and leave only the internal weak pull-up. The weak pull-up is not strong enough to effect the normal Pen-down voltage. Therefore, the voltage applied to the analog input will not rise and cause the TSC to generate a false Pen-up interrupt. There is a drawback to this approach; this workaround will cause the Pen-down event to remain active until the weak pull-up turned on in the Idle step charges the touchscreen capacitance, as shown in Figure 3-5.
