# **TMS320F2837xD Dual-Core MCUs**

## **Silicon Revisions C, B, A, 0**

### **1 Introduction**

This document describes the silicon updates to the functional specifications for the TMS320F2837xD microcontrollers (MCUs).

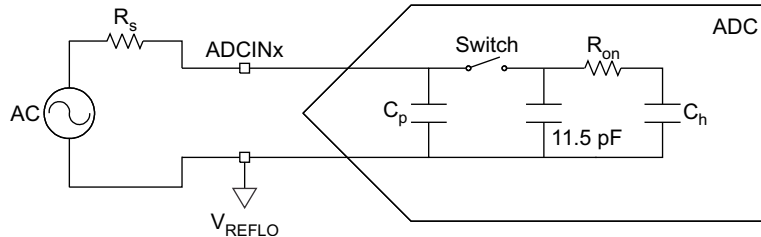
**Figure 3. Single-Ended Input Model**

**Details** The ADC input model should be used to select the sample-and-hold (S+H) duration for each ADC input. For the revisions affected, if the currently converting channel is an even-numbered channel and the previously converted channel was an odd-numbered channel (or vice versa), then the 12-bit input model will not accurately predict ADC input performance. Under these conditions, an additional capacitance should be added to the model. This capacitance has a value of 11.5 pF and should be placed between the S+H switch and  $R_{on}$  as shown in [Figure 3](#).

**Workaround(s)** For the revisions affected, when subsequent conversions switch between channel groups, the S+H duration should be chosen to account for the additional capacitance.

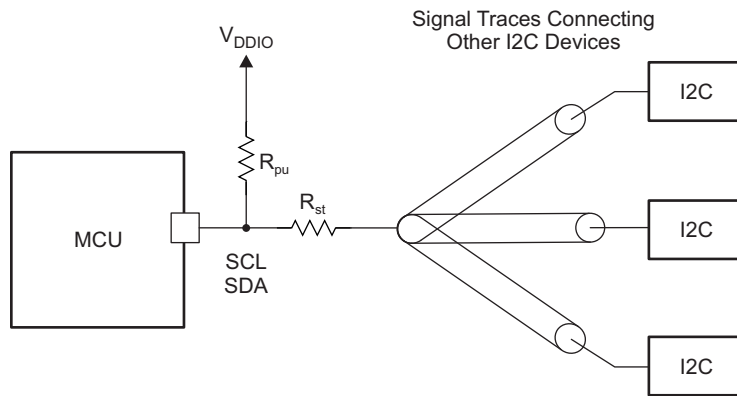
**Figure 7. Placement of Series Termination Resistor and Pullup Resistor**

The SDA and SCL outputs are implemented with push-pull 3-state output buffers rather than open-drain output buffers as required by I2C. While it is possible for the push-pull 3-state output buffers to behave as open-drain outputs, an internal timing skew issue causes the outputs to drive a logic-high for a duration of 0–5 ns before the outputs are disabled. The unexpected high-level pulse will only occur when the SCL or SDA outputs transition from a driven low state to a high-impedance state and there is sufficient internal timing skew on the respective I2C output.

This short high-level pulse injects energy in the I2C signals traces, which causes the I2C signals to sustain a period of ringing as a result of multiple transmission line reflections. This ringing should not cause an issue on the SDA signal because it only occurs at times when SDA is expected to be changing logic levels and the ringing will have time to damp before data is latched by the receiving device. The ringing may have enough amplitude to cross the SCL input buffer switching threshold several times during the first few nanoseconds of this ringing period, which may cause clock glitches. This ringing should not cause a problem if the amplitude is damped within the first 50 ns because I2C devices are required to filter their SCL inputs to remove clock glitches. Therefore, it is important to design the PCB signal traces to limit the duration of the ringing to less than 50 ns. One possible solution is to insert series termination resistors near the SCL and SDA terminals to attenuate transmission line reflections.

This issue may also cause the SDA output to be in contention with the slave SDA output for the duration of the unexpected high-level pulse when the slave begins its ACK cycle. This occurs because the slave may already be driving SDA low before the unexpected high-level pulse occurs. The glitch that occurs on SDA as a result of this short period of contention does not cause any I2C protocol issue but the peak current applies unwanted stress to both I2C devices and potentially increases power supply noise. Therefore, a series termination resistor located near the respective SDA terminal is required to limit the current during the short period of contention.

Insert series termination resistors on the SCL and SDA signals and locate them near the SCL and SDA terminals. The SCL and SDA pullup resistors should also be located near the SCL and SDA terminals. The placement of the series termination resistor and pullup resistor should be connected as shown in [Figure 7](#).

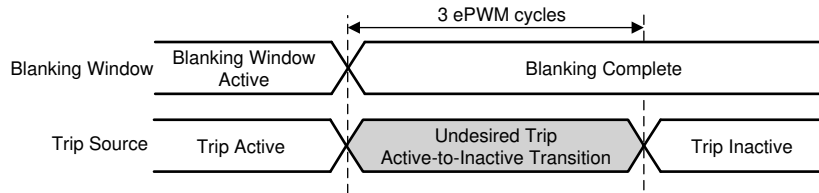
**Figure 8. Undesired Trip Event and Blanking Window Expiration**

**Details** The blanking window is typically used to mask any PWM trip events during transitions which would be false trips to the system. If an ePWM trip event remains active for less than three ePWM clocks after the end of the blanking window cycles, there can be an undesired glitch at the ePWM output.

Figure 8 illustrates the time period which could result in an undesired ePWM output.
