# **TCI6630K2L**

## **Multicore DSP+ARM KeyStone II SOC**

### **Silicon Revision 1.0**

## **Silicon Errata**

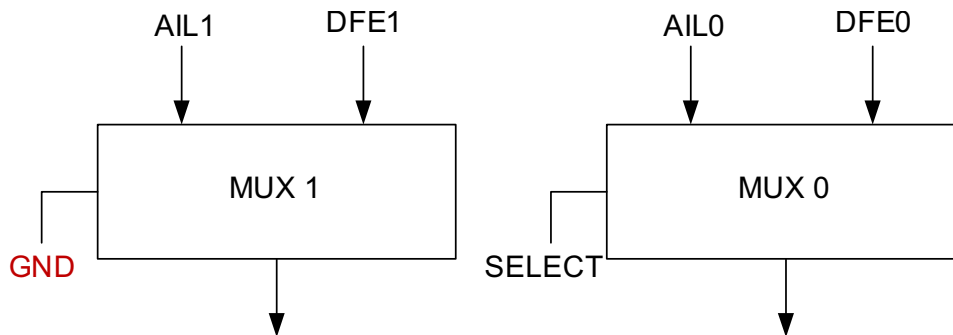
**Figure 2. AIL Lanes**
**Workaround**

IQN2 has two AIL lanes (AIL0 and AIL1). AIL1 lane does not transmit or receive any data. AIL0 lane can transmit or receive data without showing any problem.

As shown in [Figure 2](#) below, the AIL0 and AIL1 lanes are connected to a SERDES MUX with respect DFE lanes. This SERDES MUX is used to select data path between IQN2 and DFE. The mux select for the AIL1 and DFE1 mux is not connected correctly and is connected to Ground. So DFE1 lane is always selected irrespective of the configuration selected by mux pins.

There is no SW workaround for this problem.

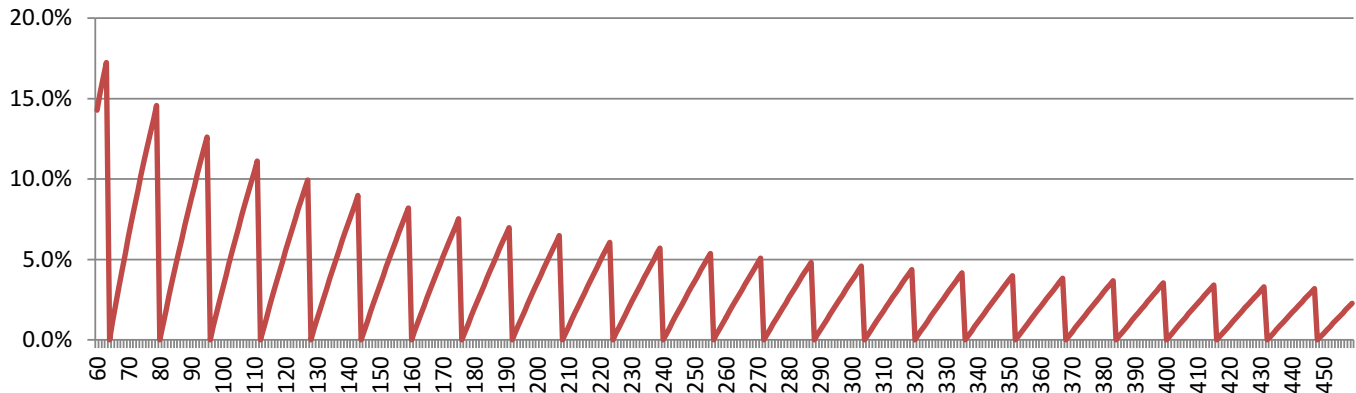
**Figure 3. NSS Rate Limit Error % For Small Packets**

**Problem Summary:** It has been observed that the Rate Limit block allows more traffic than desired for small size packets. In a particular test case, the rate limit is set to 100Mbps and the CPU is trying to generate 150Mbps of traffic comprised of 60-byte packets. The observed bandwidth of packets received will be 116Mbps.

$$\text{Rate error} = (((\text{FrameSize} \% 16) == 0) ? (16) : (\text{FrameSize} \% 16)) / (\text{FrameSize} + 24)$$

This results in the possibility of error rate as high as 10% with small packet sizes around 64 bytes that diminishes to less than 2% as packet sizes exceed 1K bytes. This can be seen in the graph below:
