TCI6631K2L

Multicore DSP+ARM KeyStone II SOC

Silicon Errata

Literature Number: SPRZ419A
May 2014–Revised June 2015

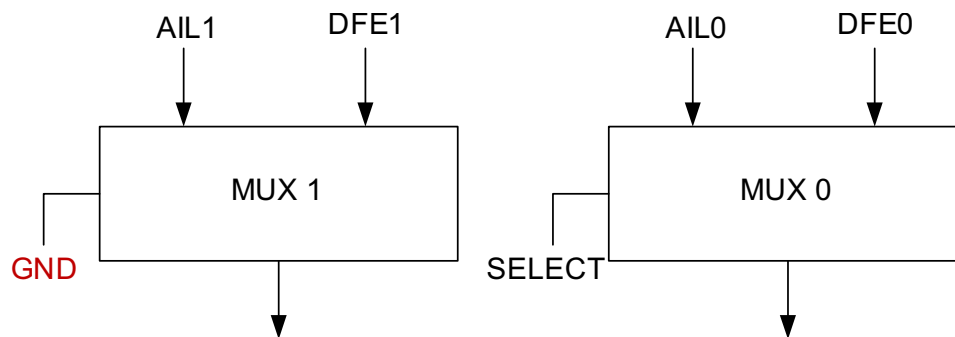
Figure 2. AIL Lanes

IQN2 has two AIL lanes (AIL0 and AIL1). AIL1 lane does not transmit or receive any data. AIL0 lane can transmit or receive data without showing any problem.

As shown in [Figure 2](#) below, the AIL0 and AIL1 lanes are connected to a SERDES MUX with respect DFE lanes. This SERDES MUX is used to select data path between IQN2 and DFE. The mux select for the AIL1 and DFE1 mux is not connected correctly and is connected to Ground. So DFE1 lane is always selected irrespective of the configuration selected by mux pins.

Workaround

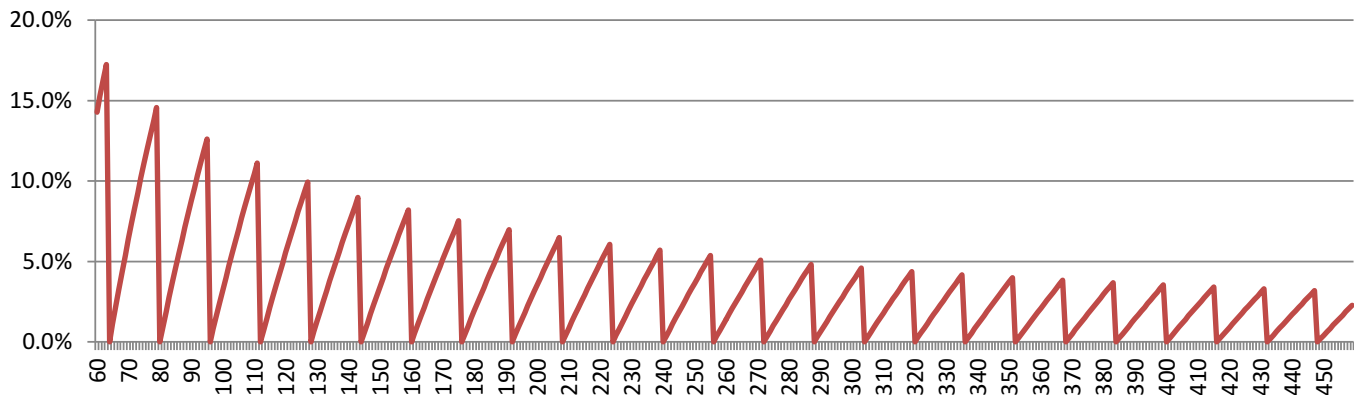
Figure 3. NSS Rate Limit Error % For Small Packets

Problem Summary: It has been observed that the Rate Limit block allows more traffic than desired for small size packets. In a particular test case, the rate limit is set to 100Mbps and the CPU is trying to generate 150Mbps of traffic comprised of 60-byte packets. The observed bandwidth of packets received will be 116Mbps.

$$\text{Rate error} = (((\text{FrameSize} \% 16) == 0) ? (16) : (\text{FrameSize} \% 16)) / (\text{FrameSize} + 24)$$

This results in the possibility of error rate as high as 10% with small packet sizes around 64 bytes that diminishes to less than 2% as packet sizes exceed 1K bytes. This can be seen in the graph below:

Workaround Since the rate-error is known, at least for fixed packet sizes, a software workaround can be implemented by calculating the “effective” packet-size to compensate for the calculation error in hardware. It is not possible to establish this workaround for streams with varying packet-sizes. It will only be meaningful when it is known that a port will mostly carry short length packets.
