TMS320F2807x MCUs Silicon Revisions C, B

This document describes the silicon updates to the functional specifications for the TMS320F2807x microcontrollers (MCUs).

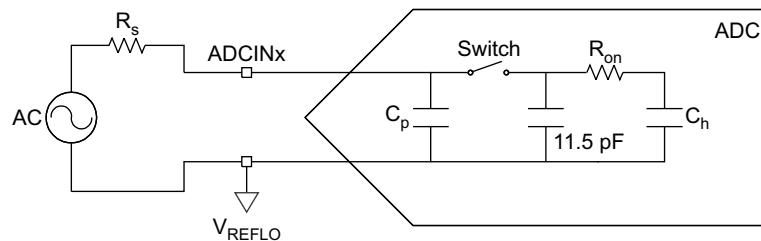
Figure 3. Single-Ended Input Model

Details The ADC input model should be used to select the sample-and-hold (S+H) duration for each ADC input. For the revisions affected, if the currently converting channel is an even-numbered channel and the previously converted channel was an odd-numbered channel (or vice versa), then the 12-bit input model will not accurately predict ADC input performance. Under these conditions, an additional capacitance should be added to the model. This capacitance has a value of 11.5 pF and should be placed between the S+H switch and R_{on} as shown in [Figure 3](#).

Workaround(s) For the revisions affected, when subsequent conversions switch between channel groups, the S+H duration should be chosen to account for the additional capacitance.

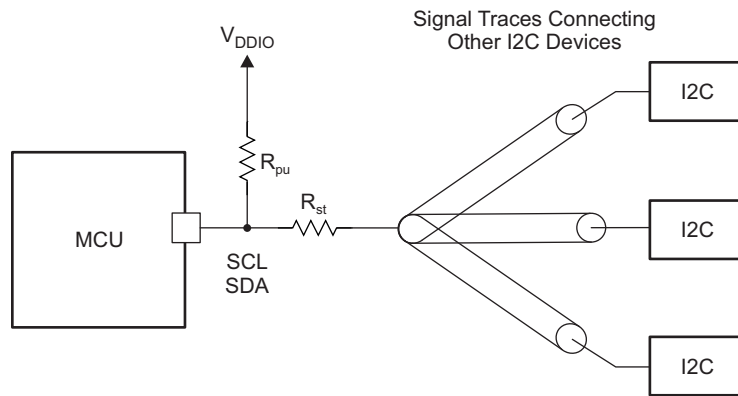
Figure 7. Placement of Series Termination Resistor and Pullup Resistor

The SDA and SCL outputs are implemented with push-pull 3-state output buffers rather than open-drain output buffers as required by I2C. While it is possible for the push-pull 3-state output buffers to behave as open-drain outputs, an internal timing skew issue causes the outputs to drive a logic-high for a duration of 0–5 ns before the outputs are disabled. The unexpected high-level pulse will only occur when the SCL or SDA outputs transition from a driven low state to a high-impedance state and there is sufficient internal timing skew on the respective I2C output.

This short high-level pulse injects energy in the I2C signals traces, which causes the I2C signals to sustain a period of ringing as a result of multiple transmission line reflections. This ringing should not cause an issue on the SDA signal because it only occurs at times when SDA is expected to be changing logic levels and the ringing will have time to damp before data is latched by the receiving device. The ringing may have enough amplitude to cross the SCL input buffer switching threshold several times during the first few nanoseconds of this ringing period, which may cause clock glitches. This ringing should not cause a problem if the amplitude is damped within the first 50 ns because I2C devices are required to filter their SCL inputs to remove clock glitches. Therefore, it is important to design the PCB signal traces to limit the duration of the ringing to less than 50 ns. One possible solution is to insert series termination resistors near the SCL and SDA terminals to attenuate transmission line reflections.

This issue may also cause the SDA output to be in contention with the slave SDA output for the duration of the unexpected high-level pulse when the slave begins its ACK cycle. This occurs because the slave may already be driving SDA low before the unexpected high-level pulse occurs. The glitch that occurs on SDA as a result of this short period of contention does not cause any I2C protocol issue but the peak current applies unwanted stress to both I2C devices and potentially increases power supply noise. Therefore, a series termination resistor located near the respective SDA terminal is required to limit the current during the short period of contention.

Insert series termination resistors on the SCL and SDA signals and locate them near the SCL and SDA terminals. The SCL and SDA pullup resistors should also be located near the SCL and SDA terminals. The placement of the series termination resistor and pullup resistor should be connected as shown in [Figure 7](#).

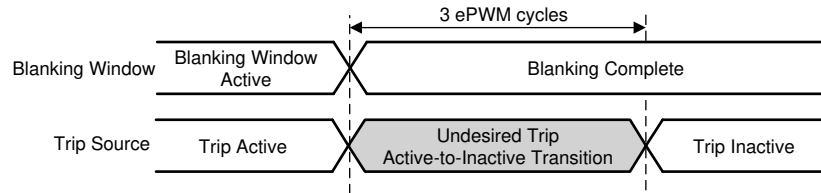
Figure 8. Undesired Trip Event and Blanking Window Expiration

Details The blanking window is typically used to mask any PWM trip events during transitions which would be false trips to the system. If an ePWM trip event remains active for less than three ePWM clocks after the end of the blanking window cycles, there can be an undesired glitch at the ePWM output.

Figure 8 illustrates the time period which could result in an undesired ePWM output.
