TMS320F28004x MCUs Silicon Errata Silicon Revisions B, A, 0

This document describes the silicon updates to the functional specifications for the TMS320F28004x (F28004x) microcontrollers (MCUs).

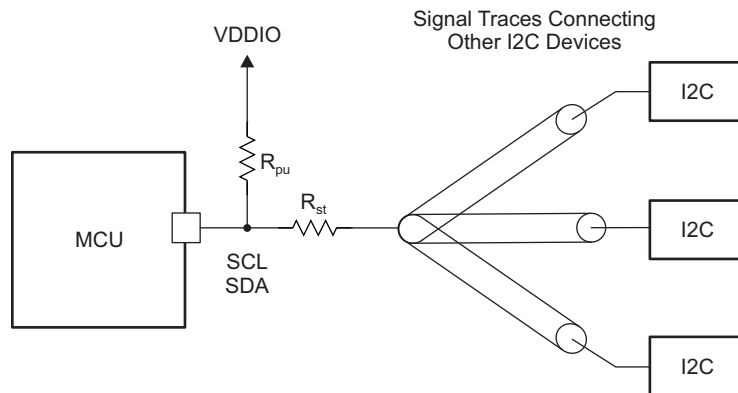
Figure 7. Placement of Series Termination Resistor and Pullup Resistor

Details The SDA and SCL outputs are implemented with push-pull 3-state output buffers rather than open-drain output buffers as required by I2C. While it is possible for the push-pull 3-state output buffers to behave as open-drain outputs, an internal timing skew issue causes the outputs to drive a logic-high for a duration of 0–5 ns before the outputs are disabled. The unexpected high-level pulse will only occur when the SCL or SDA outputs transition from a driven low state to a high-impedance state and there is sufficient internal timing skew on the respective I2C output.

This short high-level pulse injects energy in the I2C signals traces, which causes the I2C signals to sustain a period of ringing as a result of multiple transmission line reflections. This ringing should not cause an issue on the SDA signal because it only occurs at times when SDA is expected to be changing logic levels and the ringing will have time to damp before data is latched by the receiving device. The ringing may have enough amplitude to cross the SCL input buffer switching threshold several times during the first few nanoseconds of this ringing period, which may cause clock glitches. This ringing should not cause a problem if the amplitude is damped within the first 50 ns because I2C devices are required to filter their SCL inputs to remove clock glitches. Therefore, it is important to design the PCB signal traces to limit the duration of the ringing to less than 50 ns. One possible solution is to insert series termination resistors near the SCL and SDA terminals to attenuate transmission line reflections.

This issue may also cause the SDA output to be in contention with the slave SDA output for the duration of the unexpected high-level pulse when the slave begins its ACK cycle. This occurs because the slave may already be driving SDA low before the unexpected high-level pulse occurs. The glitch that occurs on SDA as a result of this short period of contention does not cause any I2C protocol issue but the peak current applies unwanted stress to both I2C devices and potentially increases power supply noise. Therefore, a series termination resistor located near the respective SDA terminal is required to limit the current during the short period of contention.

Workaround(s) Insert series termination resistors on the SCL and SDA signals and locate them near the SCL and SDA terminals. The SCL and SDA pullup resistors should also be located near the SCL and SDA terminals. The placement of the series termination resistor and pullup resistor should be connected as shown in [Figure 7](#).

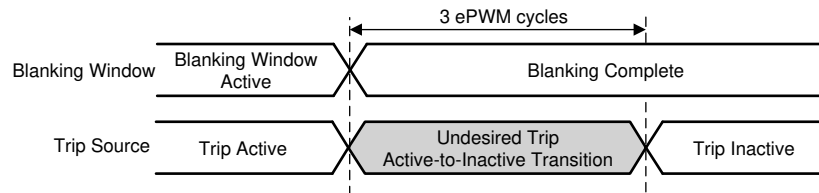
Figure 8. Undesired Trip Event and Blanking Window Expiration

Details The blanking window is typically used to mask any PWM trip events during transitions which would be false trips to the system. If an ePWM trip event remains active for less than three ePWM clocks after the end of the blanking window cycles, there can be an undesired glitch at the ePWM output.

Figure 8 illustrates the time period which could result in an undesired ePWM output.
