TMS320F28004x MCUs Silicon Errata

Silicon Revisions B, A, 0

This document describes the silicon updates to the functional specifications for the TMS320F28004x (F28004x) microcontrollers (MCUs).

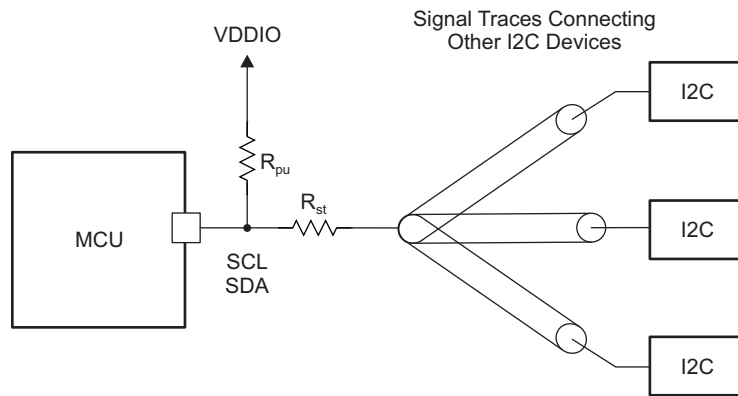
Figure 7. Placement of Series Termination Resistor and Pullup Resistor

The SDA and SCL outputs are implemented with push-pull 3-state output buffers rather than open-drain output buffers as required by I2C. While it is possible for the push-pull 3-state output buffers to behave as open-drain outputs, an internal timing skew issue causes the outputs to drive a logic-high for a duration of 0–5 ns before the outputs are disabled. The unexpected high-level pulse will only occur when the SCL or SDA outputs transition from a driven low state to a high-impedance state and there is sufficient internal timing skew on the respective I2C output.

This short high-level pulse injects energy in the I2C signals traces, which causes the I2C signals to sustain a period of ringing as a result of multiple transmission line reflections. This ringing should not cause an issue on the SDA signal because it only occurs at times when SDA is expected to be changing logic levels and the ringing will have time to damp before data is latched by the receiving device. The ringing may have enough amplitude to cross the SCL input buffer switching threshold several times during the first few nanoseconds of this ringing period, which may cause clock glitches. This ringing should not cause a problem if the amplitude is damped within the first 50 ns because I2C devices are required to filter their SCL inputs to remove clock glitches. Therefore, it is important to design the PCB signal traces to limit the duration of the ringing to less than 50 ns. One possible solution is to insert series termination resistors near the SCL and SDA terminals to attenuate transmission line reflections.

This issue may also cause the SDA output to be in contention with the slave SDA output for the duration of the unexpected high-level pulse when the slave begins its ACK cycle. This occurs because the slave may already be driving SDA low before the unexpected high-level pulse occurs. The glitch that occurs on SDA as a result of this short period of contention does not cause any I2C protocol issue but the peak current applies unwanted stress to both I2C devices and potentially increases power supply noise. Therefore, a series termination resistor located near the respective SDA terminal is required to limit the current during the short period of contention.

A similar contention problem can occur on SCL when connected to I2C slave devices that support clock stretching. This occurs because the slave is driving SCL low before the unexpected high-level pulse occurs. The glitch that occurs on SCL as a result of this short period of contention does not cause any I2C protocol issue because I2C devices are required to apply a glitch filter to their SCL inputs. However, the peak current applies unwanted stress to both I2C devices and potentially increases power supply noise. Therefore, a series termination resistor located near the respective SCL terminal is required to limit the current during the short period of contention.

Insert series termination resistors on the SCL and SDA signals and locate them near the SCL and SDA terminals. The SCL and SDA pullup resistors should also be located near the SCL and SDA terminals. The placement of the series termination resistor and pullup resistor should be connected as shown in [Figure 7](#).
