DRA78x SoC for Automotive Infotainment Silicon Revision 2.0A, 2.0

1 Introduction

This document describes the known exceptions to the functional specifications for the device.

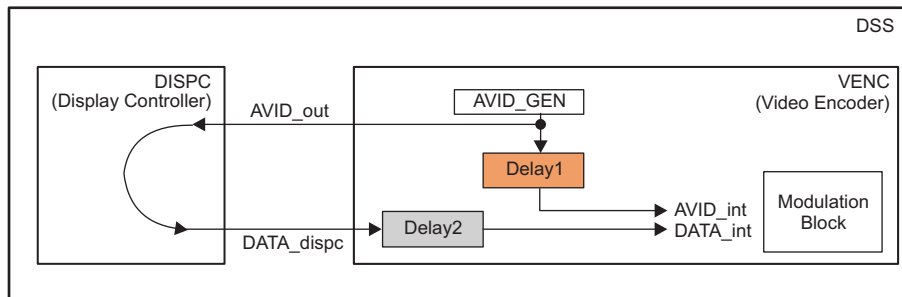
Figure 1. VENC and Display Controller

The issue is due to a two cycle difference in the expected versus actual delay between the VENC and the Display Controller (DISPC).

For the design to work, Delay1 should be equal to Delay2. In the hardware implementation it is Delay1 = Delay2 +2. This results in the first two pixels of every line being missed.

The system impact depends on the specific use-case. Most TVs have over-scan (the visible pixels on the display are less than the pixels transmitted), and in those cases the bug will not impact any functionality. In other cases, the display is missing the first two vertical columns of data which could be critical for the use-case.

A software work-around is readily available whereby the incoming frame data is padded with two extra pixels at every line inside the DISPC and then the extended window is sent to the VENC. The VENC will then display the correct frame onto the TV (the padded pixels get dropped by the VENC in place of actual pixels).
