AM574x, AM576x Sitara™ Processors Silicon Revision 1.0

1 Introduction

This document describes the known exceptions to the functional specifications for the device.

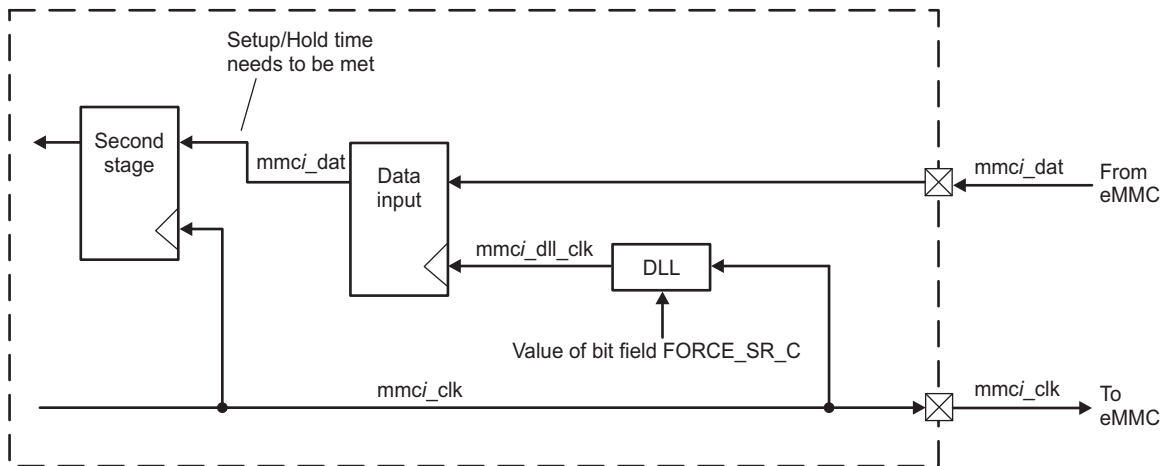
Figure 1. Simplified SoC 192-MHz Mode DLL Block Diagram

DESCRIPTION Internal to the MMC module, a second stage latch is used to recapture data captured by DLL delayed clock, `mmci_dll_clk`. The second stage latch captures with the original transmitting clock, `mmci_clk`.

`mmci_dll_clk` and `mmci_clk` both run at the same clock frequency. This results in a narrow range of tuning ratio elements, where the delayed `mmci_dll_clk` comes in phase with `mmci_clk`. If the clocks are in phase, the data captured by the first clock violates the setup and hold time requirements needed for the second stage latch, resulting in incorrectly read data. This is known as tuning re-timing errors.

For systems in which MMC DLL tuning algorithm* chooses a ratio less than 40, which is sufficiently far from the lowest re-timing error ratio element, no workaround is necessary.

WORKAROUND A DLL tuning algorithm has been implemented that can avoid the tuning re-timing errors. More details on this can be found in App Note [SPRACA9](#). The following notes summarize the updated algorithm:

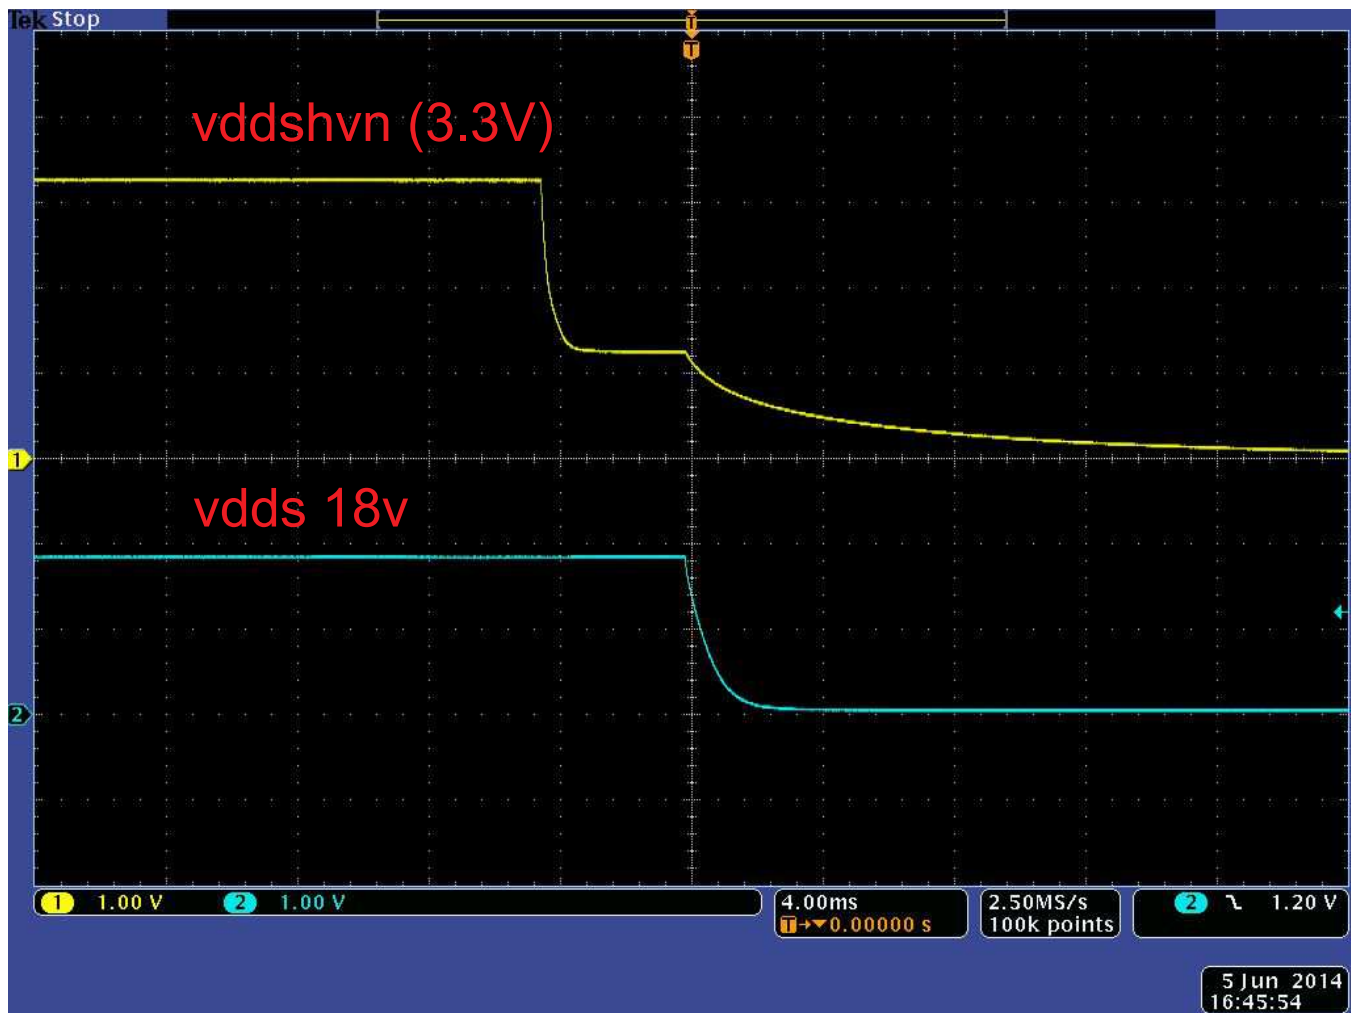
Figure 2. PAB_RevA

A subset of the SOC's LVC MOS IOs (refer to DM for details) have a pull-up resistor that is active by default, including during reset and power-down. The SOC's IOs that have internal or external pull-ups will stay at Plateau Level (<1.5V) during the power-down. If other ICs on the board that are interfaced to the SOC's LVC MOS signals use a separate supply then it's possible that the other IC's signals can be pulled to the Plateau Level while its power supply is off.

The root cause of the plateau is related to the LVC MOS IO buffer Dual Voltage detection circuitry. The LVC MOS Dual Voltage IO includes voltage comparator circuitry to determine if the IO is in 3.3V mode or 1.8V mode. During powerdown of vddshvn domains, a current path in the internal bias transistors results in the vddshvn rail being held to an intermediate voltage level (<1.5 V). This path can consume at most 500 uA per IO - worst case estimate is ~150 mA (based on 280 IOs) from the vdds18v supply

during power down. This path is not a reliability concern for the device.

In general, TI recommends using the same supply source for connected components. E.g., a single LDO should drive vddshvn and the related 3.3V external components.

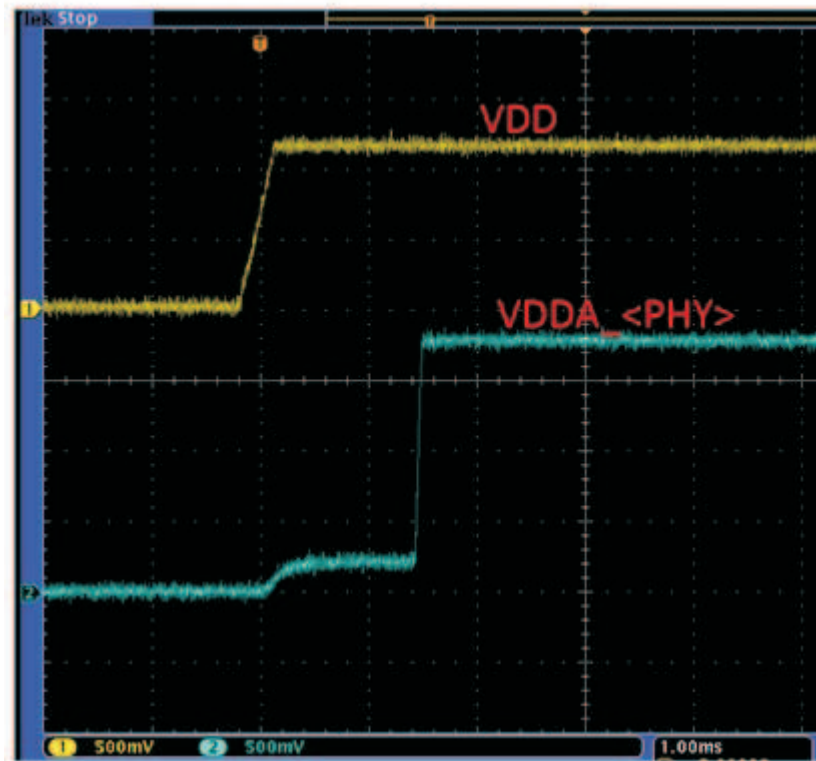
Figure 3. Leakage Voltage

The device-specific Data Manual requires Core AVS rail (VDD) to power up before the 1.8 V high speed analog PHY domain(s). When this sequence is followed, the high speed analog PHY domain will have a small step-up to a voltage plateau (< 0.5 V) that aligns to the beginning of the VDD ramp-up, and is maintained until the ramp-up of high speed analog PHY rail, as shown in Figure 3. Note the leakage value will differ from system to system, but will be less than 500 mV. The leakage voltage in the provided capture is approximately 250 mV.

A similar condition exists during supply power down sequence. The high speed analog PHY domain(s) are required to be powered down prior to Core AVS rail (VDD), and may cause a small plateau to exist until Core AVS rail (VDD) is ramped down.

The root cause of the voltage plateau during power-up/down sequencing is related to the parasitic diodes in logic blocks which have multiple power sources. This leakage path is not a reliability concern for this device.
