DRA75xP, DRA74xP, DRA77xP, DRA76xP SoC for Automotive Infotainment Silicon Revision 1.0

1 Introduction

This document describes the known exceptions to the functional specifications for the device.

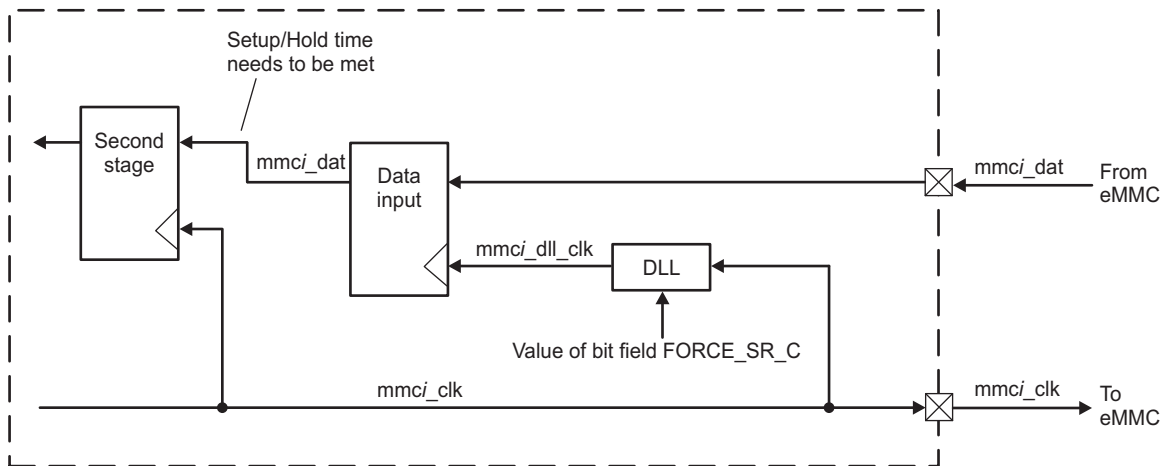
Figure 1. Simplified SoC 192-MHz Mode DLL Block Diagram

DESCRIPTION Internal to the MMC module, a second stage latch is used to recapture data captured by DLL delayed clock, `mmci_dll_clk`. The second stage latch captures with the original transmitting clock, `mmci_clk`.

`mmci_dll_clk` and `mmci_clk` both run at the same clock frequency. This results in a narrow range of tuning ratio elements, where the delayed `mmci_dll_clk` comes in phase with `mmci_clk`. If the clocks are in phase, the data captured by the first clock violates the setup and hold time requirements needed for the second stage latch, resulting in incorrectly read data. This is known as tuning re-timing errors.

For systems in which MMC DLL tuning algorithm* chooses a ratio less than 40, which is sufficiently far from the lowest re-timing error ratio element, no workaround is necessary.

WORKAROUND A DLL tuning algorithm has been implemented that can avoid the tuning re-timing errors. More details on this can be found in App Note [SPRACA9](#). The following notes summarize the updated algorithm:

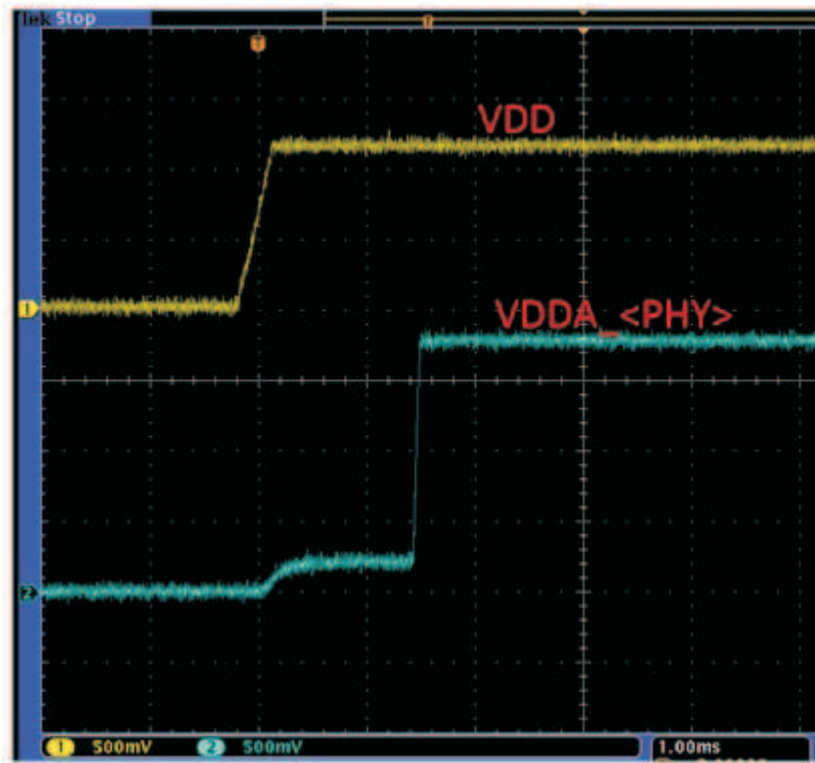
Figure 3. Leakage Voltage

The device-specific Data Manual requires Core AVS rail (VDD) to power up before the 1.8 V high speed analog PHY domain(s). When this sequence is followed, the high speed analog PHY domain will have a small step-up to a voltage plateau (< 0.5 V) that aligns to the beginning of the VDD ramp-up, and is maintained until the ramp-up of high speed analog PHY rail, as shown in Figure 1. Note the leakage value will differ from system to system, but will be less than 500 mV. The leakage voltage in the provided capture is approximately 250 mV.

The reverse is true on the power down sequence. The high speed analog PHY domain(s) are required to be powered down prior to Core AVS rail (VDD), and such sequence may cause a small plateau to exist during the period.

The root cause of the plateau is related to the parasitic diodes in logic blocks which have multiple power sources. This leakage path is not a reliability concern for this device.
