Errata
AM65x Processors
Silicon Revision 2.1, 2.0, 1.0

ABSTRACT

This document describes the known exceptions to the functional specifications (advisories). This document may also contain usage notes. Usage notes describe situations where the device's behavior may not match presumed or documented behavior. This may include behaviors that affect device performance or functional correctness.

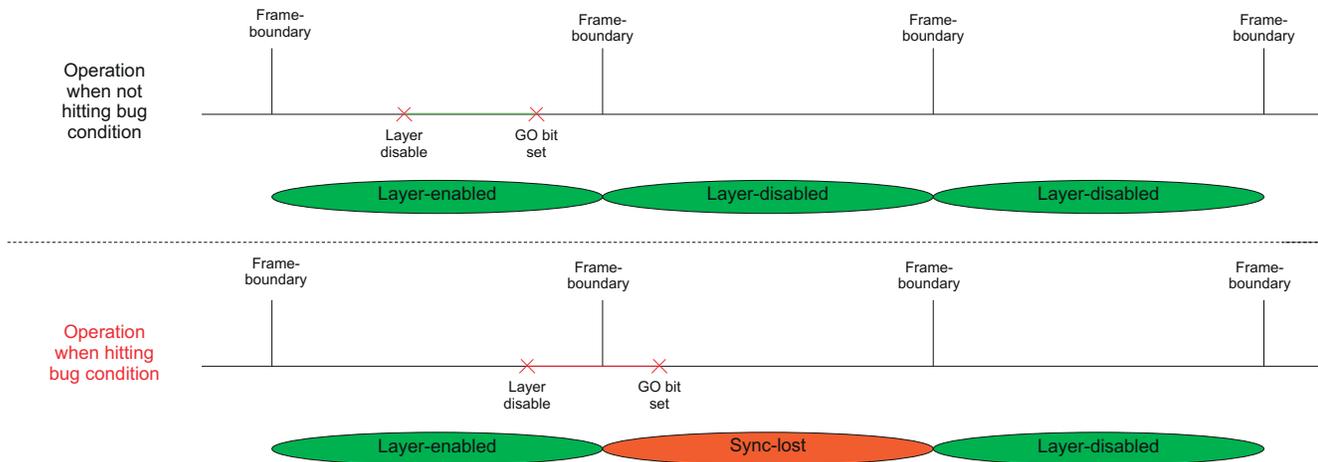
Figure 3-1. Bug Condition

i2097 *DSS: Disabling a Layer Connected to Overlay May Result in Synclost During the Next Frame*

Details: Disabling a layer (for example VID1) connected to an OVR (that is toggling DSS_VID_ATTRIBUTESx[0] ENABLE from 1 to 0) may result in synclost during the next frame. The synclost may result in a corrupted or blank frame (all pixel data sent out of DSS during the frame is 0x0). The occurrence of synclost is dependent on the timing of setting the GO bit (that is DSS_VP_CONTROL[5] GOBIT to 1) vis-à-vis the disabling of the layer. If the “disable layer” MMR write operation and “set GO bit” MMR write operation happens within the same frame boundary, no synclost occurs. If the operations happen across the frame boundary, then synclost occurs (for one frame). The design automatically recovers and returns to normal operation from the next frame after GO bit is set, see [Figure 3-1](#).

Workaround(s): A simple software workaround exists. In the workaround, prior to disabling a layer on the OVR, it is moved to the “non-visible” area of the OVR (for example: DSS_OVR_ATTRIBUTES_x[17-6] POSX = max_value_of_posx or DSS_OVR_ATTRIBUTES_x[30-19] POSY = max_value_of_posy). This avoids the synclost when the layer is disabled.

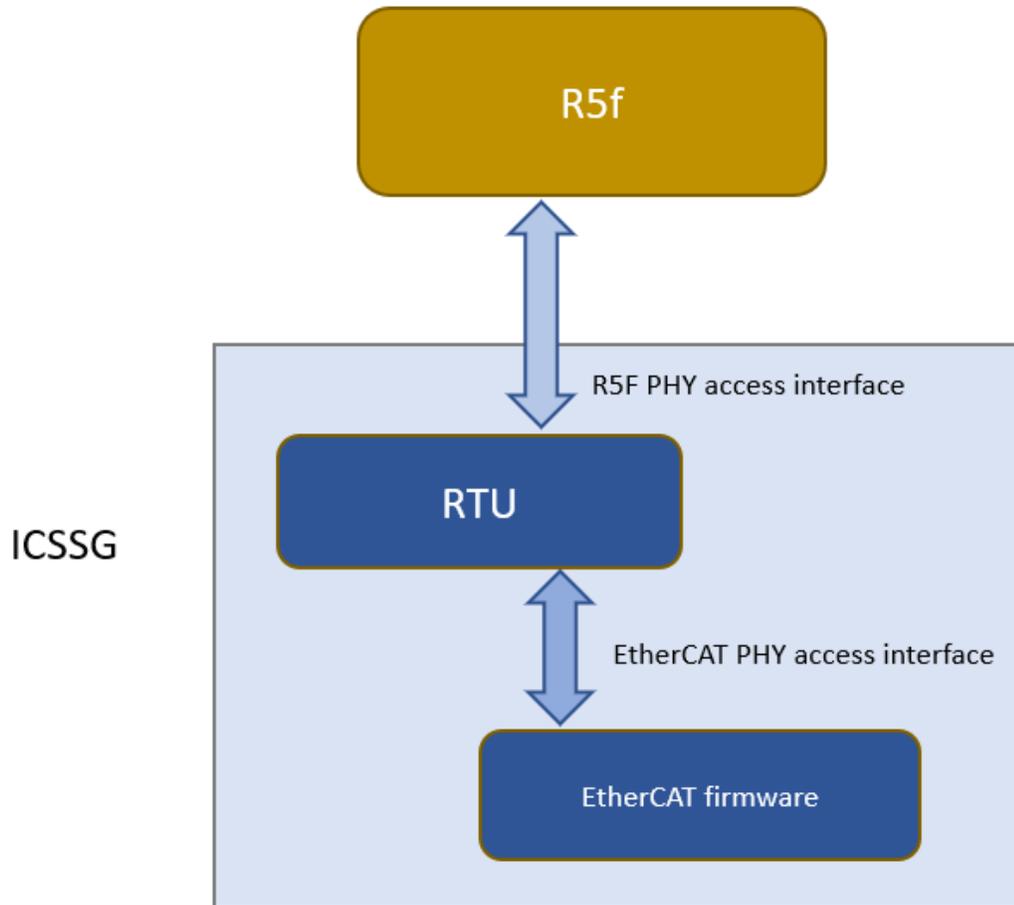
Figure 3-4. MDIO Emulation via Manual Mode using PRU Core

i2329 (continued) **MDIO: MDIO interface corruption (CPSW and PRU-ICSS)**

EtherCAT will continue to use PHY fast link detection via MDIO MLINK bypassing state m/c for link status (as this path is not affected by errata). This makes sure that cable redundancy related latency requirements are still met.
