J721E DRA829/TDA4VM Processors Silicon Revision 2.0/1.1/1.0

ABSTRACT

This document describes the known exceptions to the functional specifications (advisories). This document may also contain usage notes. Usage notes describe situations where the device's behavior may not match presumed or documented behavior. This may include behaviors that affect device performance or functional correctness.

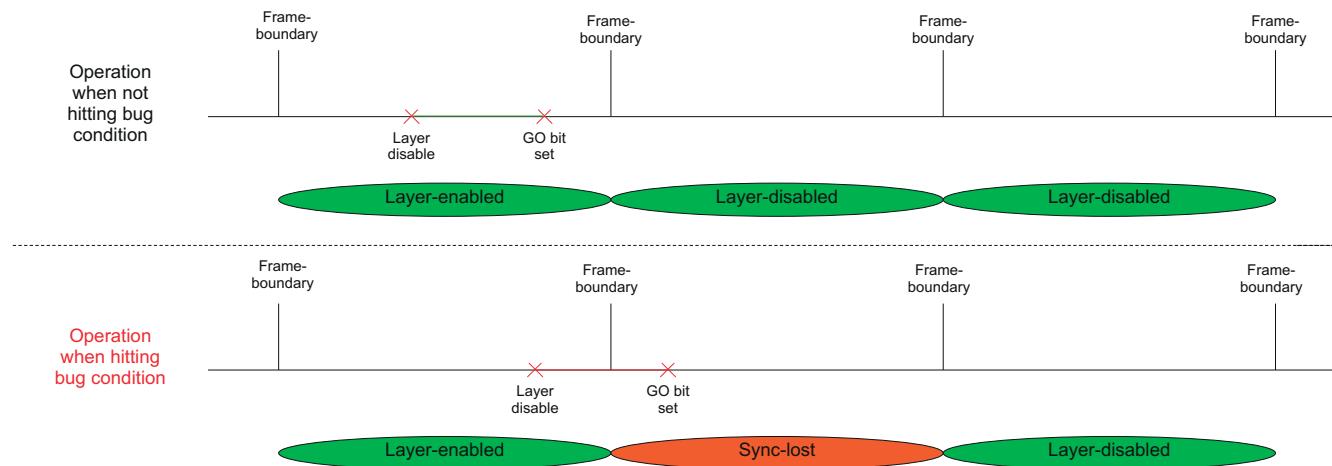
Figure 3-2. Bug Condition

DSS: Disabling a Layer Connected to Overlay May Result in Synclost During the Next Frame

of setting the GO bit (that is DSS_VP_CONTROL[5] GOBIT to 1) vis-à-vis the disabling of the layer. If the “disable layer” MMR write operation and “set GO bit” MMR write operation happens within the same frame boundary, no synclost occurs. If the operations happen across the frame boundary, then synclost occurs (for one frame). The design automatically recovers and returns to normal operation from the next frame after GO bit is set, see [Figure 3-2](#).

A sample software workaround pseudo-code is shown on [Figure 3-3](#). In this case, the regular “disable layer” MMR write operation and “set GO bit set” MMR write operation are replaced with macros which implement the software workaround.

- Replace layer disable MMR write operation with a macro which positions the layer to the non-visible area of the OVR
- Track which layers are disabled. This will be used while GO bit is set
- Replace GO bit set MMR write operation with this macro
 - First, set GO Bit for the changes in “disable_layer” macro (and any other earlier changes) to take effect
 - After the first GO bit set, few idle_cycles (10 DSS functional clock cycles) are necessary before we move to the second step
- In the second step, actually disable the layers based on the previously tracked information
- Set the GO bit for the second time for the disable of the layers to take effect
