# AM64x/AM243x Processor Silicon Revision 1.0, 2.0

## ABSTRACT

This document describes the known exceptions to the functional specifications (advisories). This document may also contain usage notes. Usage notes describe situations where the device's behavior may not match presumed or documented behavior. This may include behaviors that affect device performance or functional correctness.

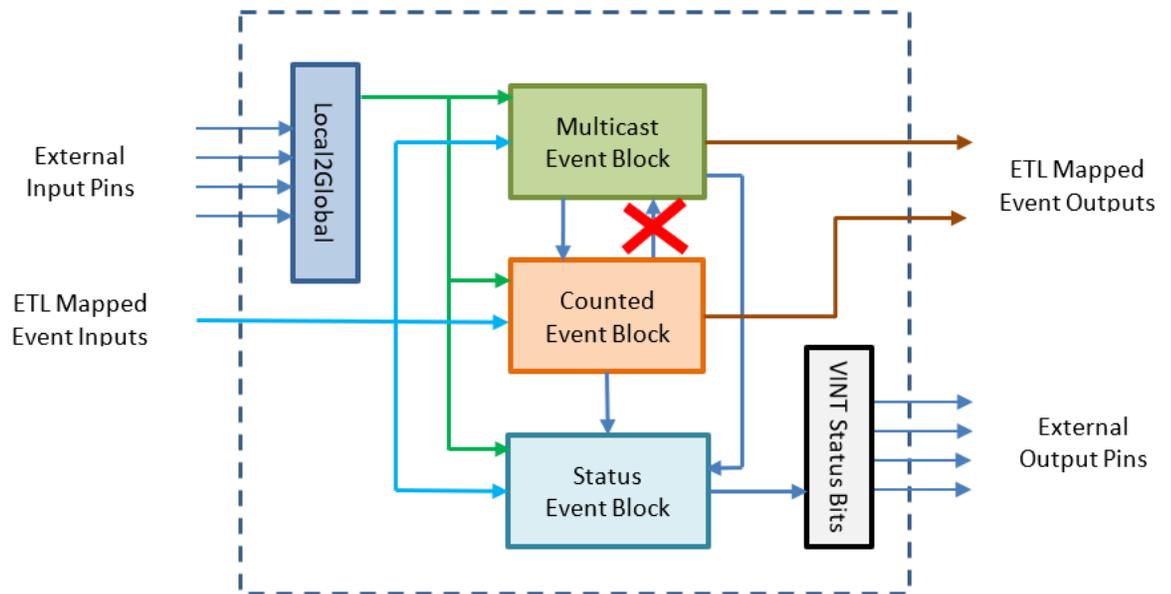
**Figure 2-1. Interrupt Aggregator Version 1.0**

An issue was found after design that could cause the IA to deadlock. The issue occurs when event “loops” occur between these three processing blocks. It is possible to create a situation where a processing block can not output an event because the path is blocked, and since it can not output an event, it can not take any new input events. This inability to take input events prevents the output path from being able to unwind, and thus both paths remain blocked.

Figure 2-1 shows the conceptual block diagram of IA 1.0. Potential loops are avoided by adopting the policy of not allowing the counted event block to send events to the multicast block. This method was chosen because it is more common to split an event first, and then count one while sending the other elsewhere. With this path blocked by convention, it is not possible for a single event to visit any block more than once and thus not possible for paths to become blocked so long as the outputs remain unblocked.

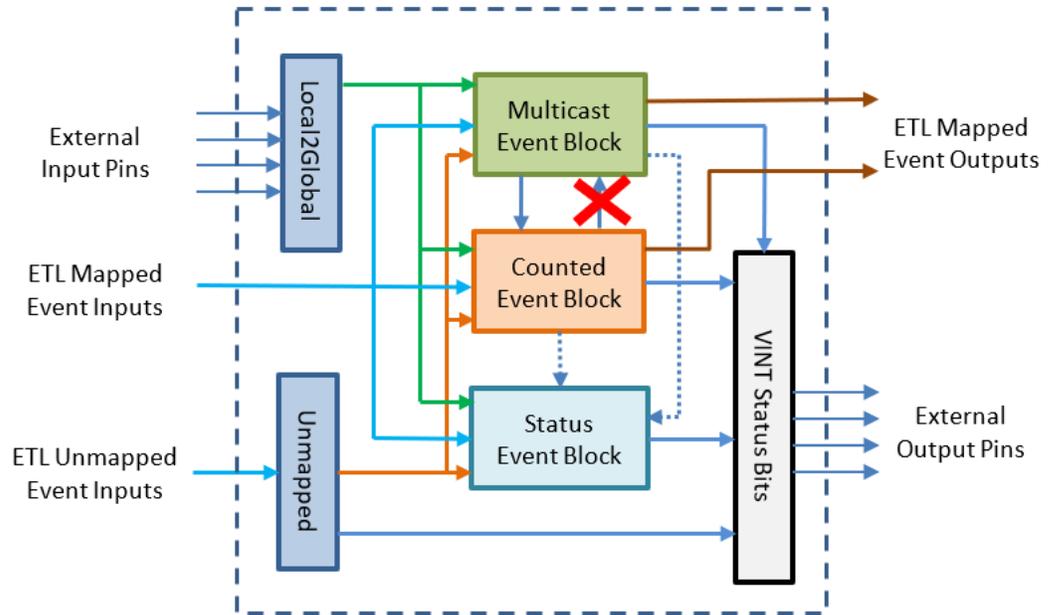
**Figure 2-2. Interrupt Aggregator Version 1.1**

Figure 2-2 shows the diagram of IA 1.1. Note that the same policy applies to avoid deadlock. In addition, the paths shown as dotted lines (sending ETL events from the multicast or counted blocks to the status event block) is now discouraged. These paths still function as before for backward compatibility, but are rendered obsolete as all blocks are now able to directly set status event bits.

By following the conventions outlined here, the system is safe from looping hazards that can create a deadlock scenario.
