TMS320F2838x MCUs Silicon Errata

Silicon Revision 0

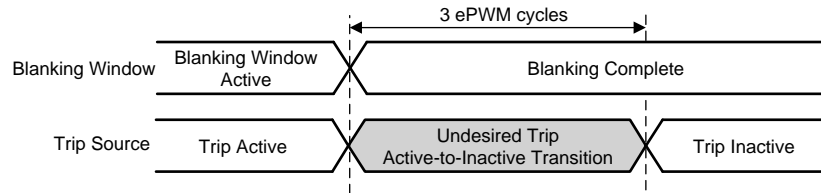
Figure 2. Undesired Trip Event and Blanking Window Expiration

Details The blanking window is typically used to mask any PWM trip events during transitions which would be false trips to the system. If an ePWM trip event remains active for less than three ePWM clocks after the end of the blanking window cycles, there can be an undesired glitch at the ePWM output.

Figure 2 illustrates the time period which could result in an undesired ePWM output.

Workaround(s) Extend or reduce the blanking window to avoid any undesired trip action.
