TMS320F28002x MCUs Silicon Errata Silicon Revision 0

This document describes the known exceptions to the functional specifications (advisories). This document may also contain usage notes. Usage notes describe situations where the device's behavior may not match presumed or documented behavior. This may include behaviors that affect device performance or functional correctness.

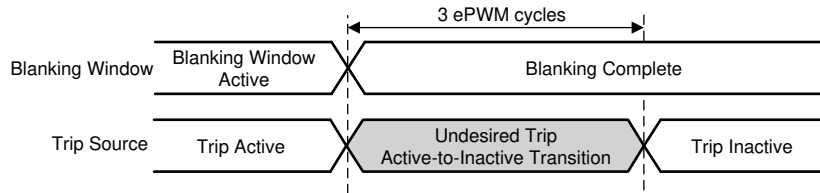
Figure 3. Undesired Trip Event and Blanking Window Expiration

Details The blanking window is typically used to mask any PWM trip events during transitions which would be false trips to the system. If an ePWM trip event remains active for less than three ePWM clocks after the end of the blanking window cycles, there can be an undesired glitch at the ePWM output.

Figure 3 illustrates the time period which could result in an undesired ePWM output.

Workaround(s) Extend or reduce the blanking window to avoid any undesired trip action.
