## Errata

# TMS320F28002x Real-Time MCUs Silicon Errata Silicon Revisions A, 0

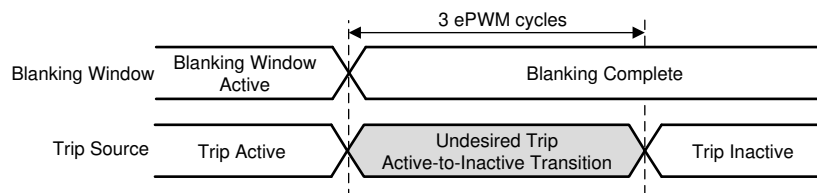
**Figure 3-1. Undesired Trip Event and Blanking Window Expiration**

**Details** The blanking window is typically used to mask any PWM trip events during transitions which would be false trips to the system. If an ePWM trip event remains active for less than three ePWM clocks after the end of the blanking window cycles, there can be an undesired glitch at the ePWM output.

Figure 3-1 illustrates the time period which could result in an undesired ePWM output.

**Workaround(s)** Extend or reduce the blanking window to avoid any undesired trip action.
