Errata

# AM62x Processor Silicon Revision 1.0

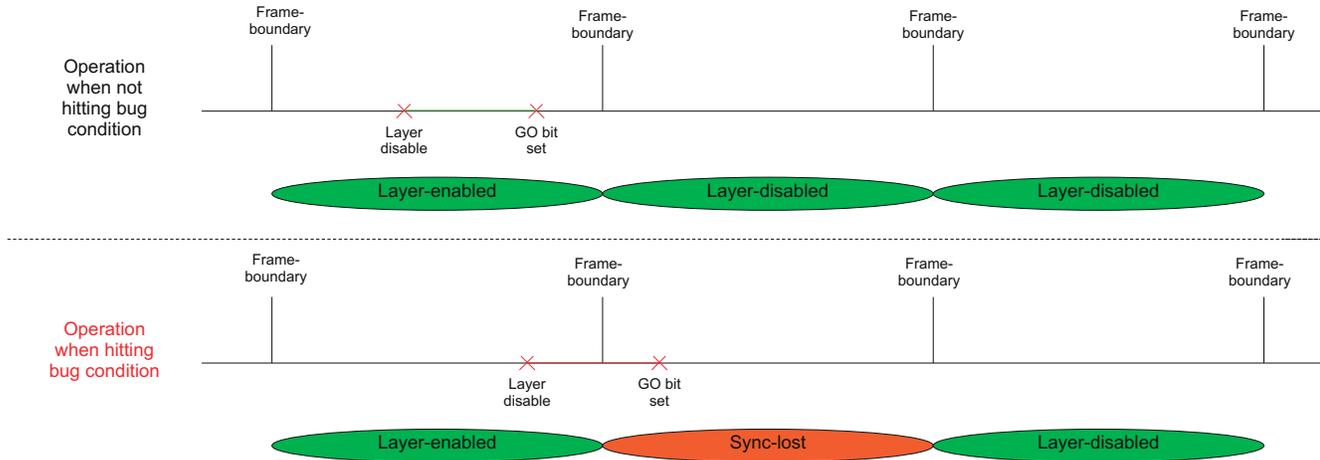
**Figure 2-1. Bug Condition**

Disabling a layer (for example VID1) connected to an OVR (that is toggling DSS\_VID\_ATTRIBUTESx[0] ENABLE from 1 to 0) may result in synclost during the next

frame. The synclost may result in a corrupted or blank frame (all pixel data sent out of DSS during the frame is 0x0). The occurrence of synclost is dependent on the timing of setting the GO bit (that is DSS\_VP\_CONTROL[5] GOBIT to 1) vis-à-vis the disabling of the layer. If the “disable layer” MMR write operation and “set GO bit” MMR write operation happens within the same frame boundary, no synclost occurs. If the operations happen across the frame boundary, then synclost occurs (for one frame). The design automatically recovers and returns to normal operation from the next frame after GO bit is set, see Figure 2-1.

A simple software workaround exists. In the workaround, prior to disabling a layer on the OVR, it is moved to the “non-visible” area of the OVR (for example: DSS\_OVR\_ATTRIBUTES\_x[17-6] POSX = max\_value\_of\_posx or DSS\_OVR\_ATTRIBUTES\_x[30-19] POSY = max\_value\_of\_posy). This avoids the synclost when the layer is disabled.

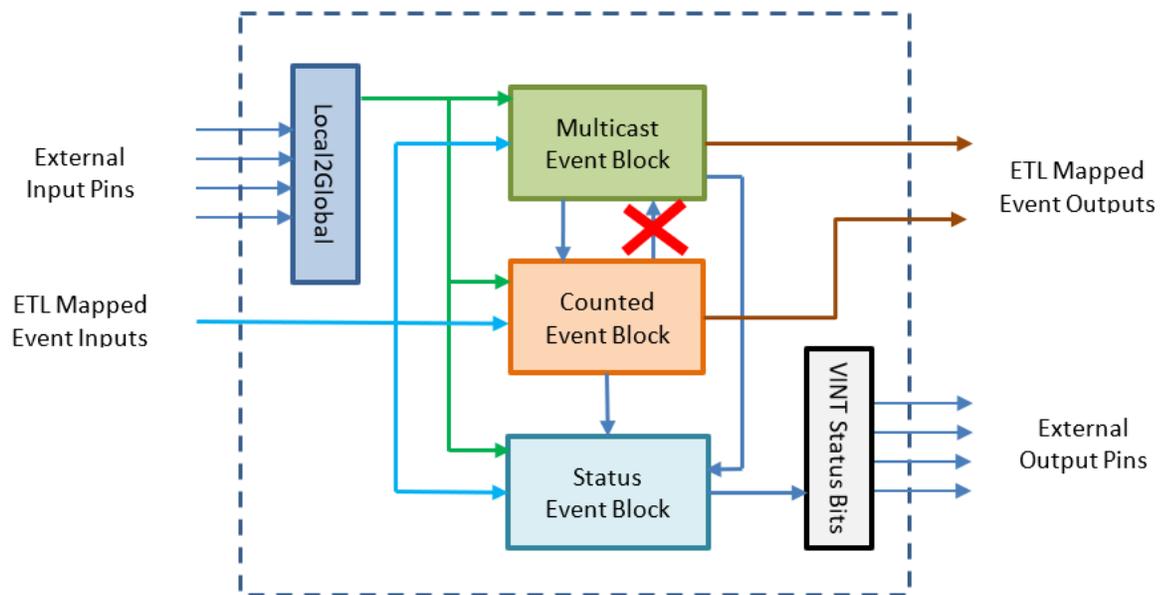
**Figure 2-3. Interrupt Aggregator Version 1.0**

An issue was found after design that could cause the IA to deadlock. The issue occurs when event “loops” occur between these three processing blocks. It is possible to create a situation where a processing block can not output an event because the path is blocked, and since it can not output an event, it can not take any new input events. This inability to take input events prevents the output path from being able to unwind, and thus both paths remain blocked.

Figure 2-3 shows the conceptual block diagram of IA 1.0. Potential loops are avoided by adopting the policy of not allowing the counted event block to send events to the multicast block. This method was chosen because it is more common to split an event first, and then count one while sending the other elsewhere. With this path blocked by convention, it is not possible for a single event to visit any block more than once and thus not possible for paths to become blocked so long as the outputs remain unblocked.

By following the conventions outlined here, the system is safe from looping hazards that can create a deadlock scenario.
