ABSTRACT

This document describes the known exceptions to the functional specifications (advisories). This document may also contain usage notes. Usage notes describe situations where the device's behavior may not match presumed or documented behavior. This may include behaviors that affect device performance or functional correctness.

- AM62x
- AM625SIP

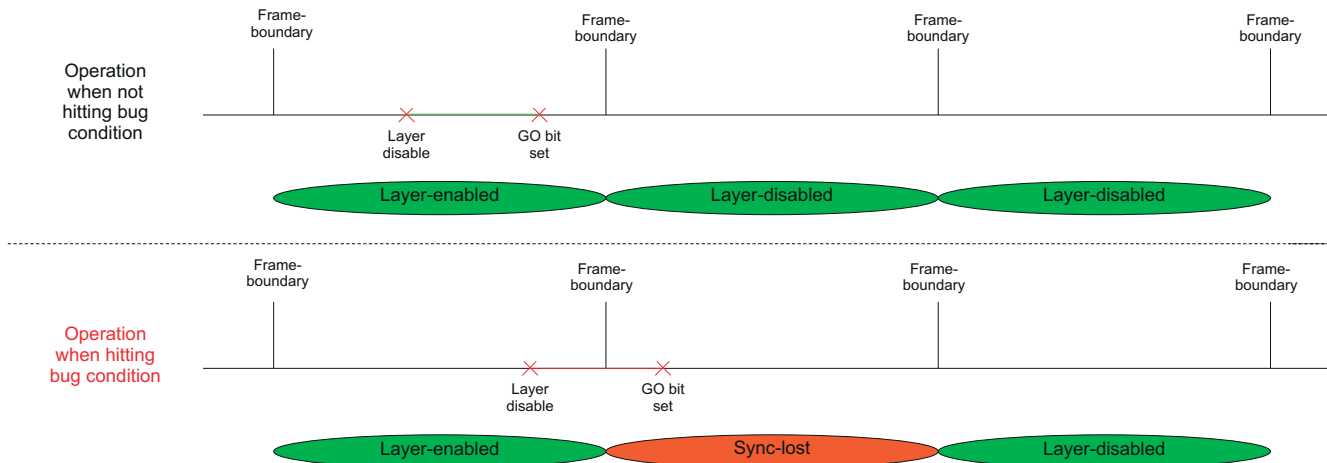
Figure 2-1. Bug Condition

Disabling a layer (for example VID1) connected to an OVR (that is toggling DSS_VID_ATTRIBUTESx[0] ENABLE from 1 to 0) may result in synclost during the next frame. The synclost may result in a corrupted or blank frame (all pixel data sent out of DSS during the frame is 0x0). The occurrence of synclost is dependent on the timing of setting the GO bit (that is DSS_VP_CONTROL[5] GOBIT to 1) vis-à-vis the disabling of the layer. If the “disable layer” MMR write operation and “set GO bit” MMR write operation happens within the same frame boundary, no synclost occurs. If the operations happen across the frame boundary, then synclost occurs (for one frame). The design automatically recovers and returns to normal operation from the next frame after GO bit is set, see [Figure 2-1](#).

A simple software workaround exists. In the workaround, prior to disabling a layer on the OVR, it is moved to the “non-visible” area of the OVR (for example: DSS_OVR_ATTRIBUTES_x[17-6] POSX = max_value_of_posx or DSS_OVR_ATTRIBUTES_x[30-19] POSY = max_value_of_posy). This avoids the synclost when the layer is disabled.

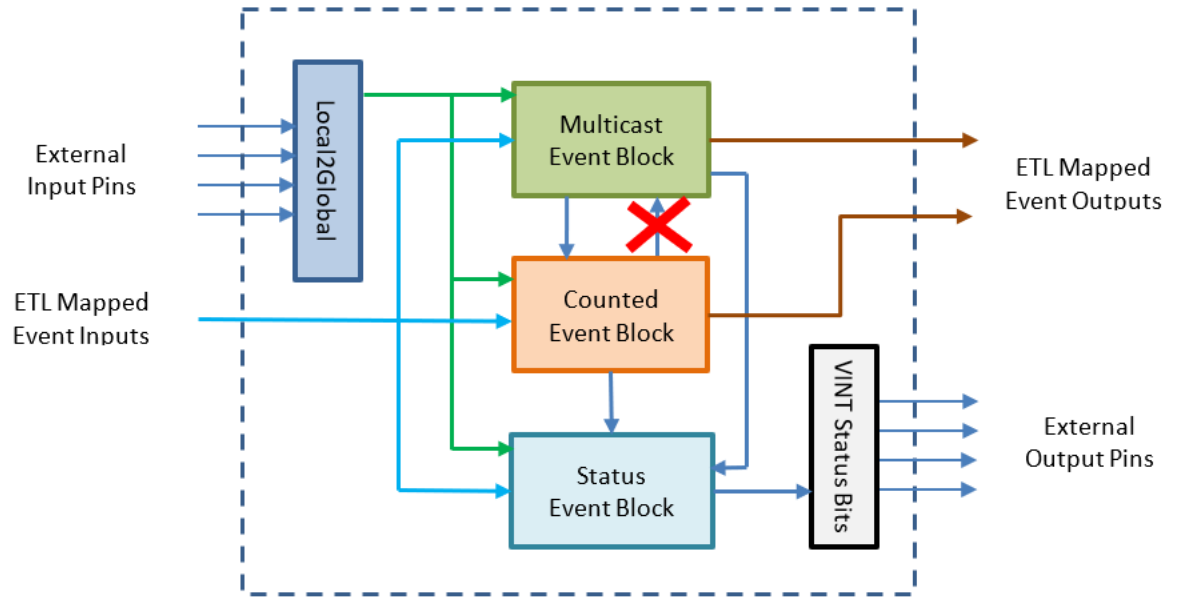
Figure 2-3. Interrupt Aggregator Version 1.0

An issue was found after design that could cause the IA to deadlock. The issue occurs when event “loops” occur between these three processing blocks. It is possible to create a situation where a processing block can not output an event because the path is blocked, and since it can not output an event, it can not take any new input events. This inability to take input events prevents the output path from being able to unwind, and thus both paths remain blocked.

Figure 2-3 shows the conceptual block diagram of IA 1.0. Potential loops are avoided by adopting the policy of not allowing the counted event block to send events to the multicast block. This method was chosen because it is more common to split an event first, and then count one while sending the other elsewhere. With this path blocked by convention, it is not possible for a single event to visit any block more than once and thus not possible for paths to become blocked so long as the outputs remain unblocked.

By following the conventions outlined here, the system is safe from looping hazards that can create a deadlock scenario.

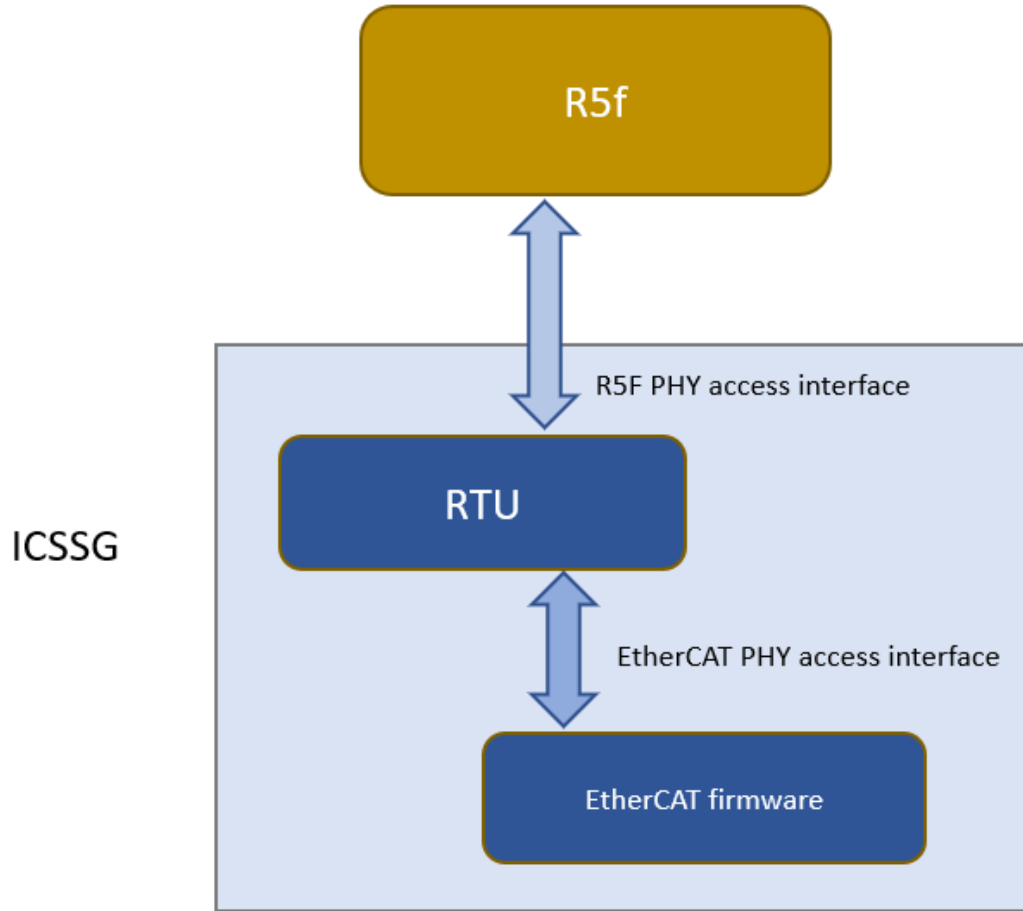
Figure 2-4. MDIO Emulation via Manual Mode using PRU Core

It is possible that the MDIO interface of all instances of CPSW and PRU-ICSS peripherals (if present) returns corrupt read data on MDIO reads (e.g. returning stale or previous data), or sends incorrect data on MDIO writes. It is also possible that the MDIO interface becomes unavailable until the next peripheral reset (either by LPSC reset or global device reset with reset isolation disabled in case of CPSW).

Possible system level manifestations of this issue could be (1) erroneous ethernet PHY link down status (2) inability to properly configure an ethernet PHY over MDIO (3) incorrect PHY detection (e.g. wrong address) (4) read or write timeouts when attempting to configure PHY over MDIO.

MDIO protocol can be emulated by reading and writing to the appropriate bits within the MDIO_MANUAL_IF_REG register of the MDIO peripheral to directly manipulate the MDIO

clock and data pins. Refer to TRM for full details of manual mode register bits and their function.

In this case the device pin multiplexing should be configured to allow the IO to be controlled by the CPSW or PRU-ICSS peripherals (same as in normal intended operation), but the MDIO state machine must be disabled by ensuring MDIO_CONTROL_REG.ENABLE bit is 0 in the MDIO_CONTROL_REG and enable manual mode by setting MDIO_POLL_REG.MANUALMODE bit to 1.
