# AM263x Sitara™ Microcontroller

## Silicon Revision 1.0A, 1.1, 1.3

This document describes the known exceptions to the functional specifications (advisories). This document may also contain usage notes. Usage notes describe situations where the device's behavior may not match presumed or documented behavior. This may include behaviors that affect device performance or functional correctness.

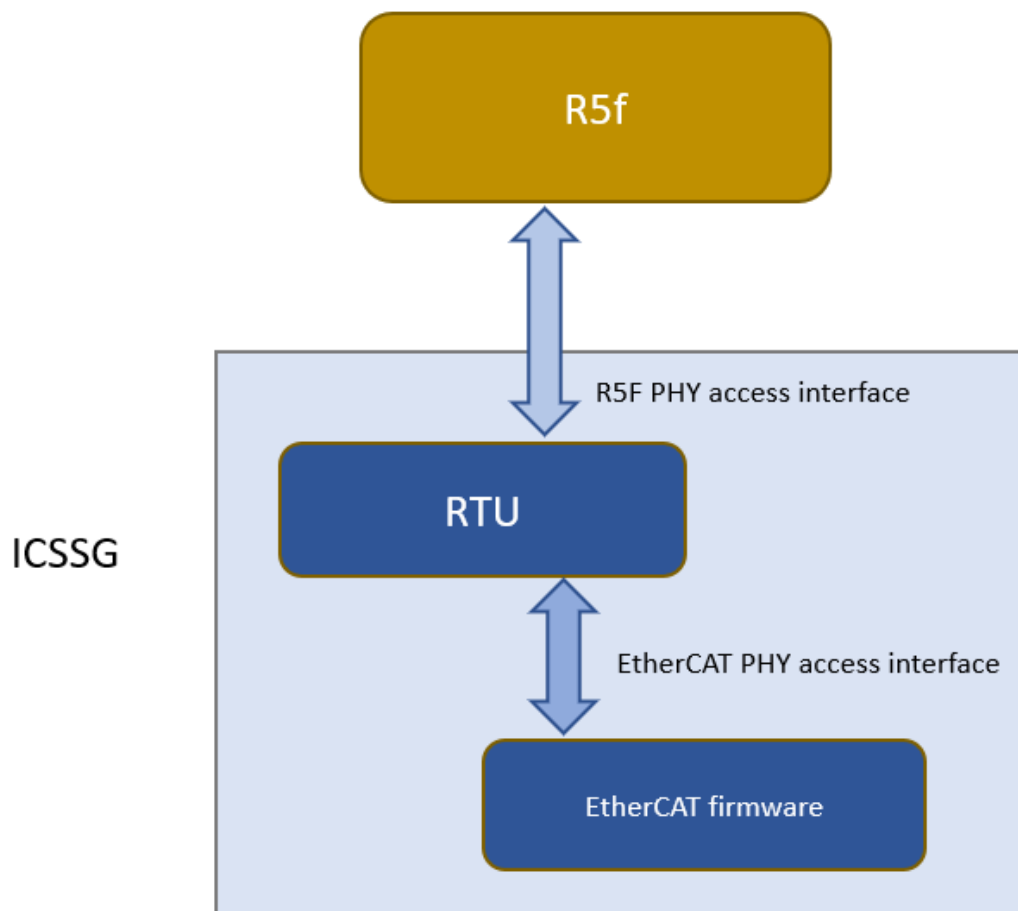
**Figure 3-1. MDIO Emulation via Manual Mode using PRU Core**

**i2329 (continued) MDIO: MDIO interface corruption (CPSW and PRU-ICSS)**

EtherCAT will continue to use PHY fast link detection via MDIO MLINK bypassing state m/c for link status (as this path is not affected by errata). This makes sure that cable redundancy related latency requirements are still met.

MDIO protocol can be emulated by reading and writing to the appropriate bits within the MDIO\_MANUAL\_IF\_REG register of the MDIO peripheral to directly manipulate the MDIO clock and data pins. Refer to TRM for full details of manual mode register bits and their function.

For EtherCAT implementation on PRU-ICSS, the software workaround will be done in RTUx/ TX\_PRUx Core. The core will have to be dedicated for workaround, which means this can't be used for other purpose. The implementation will support two user access

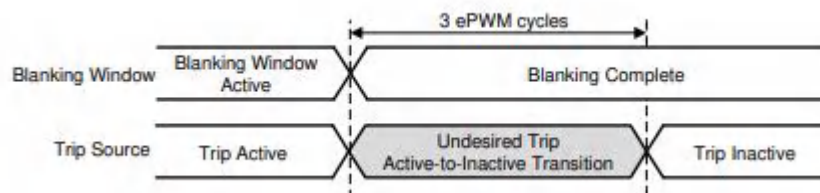
The blanking window is typically used to mask any PWM trip events during transitions which would be false trips to the system. If an ePWM trip event remains active for less than three ePWM clocks after the end of the blanking window cycles, there can be an undesired glitch at the ePWM output.

The following picture illustrates the time period which could result in an undesired ePWM output.

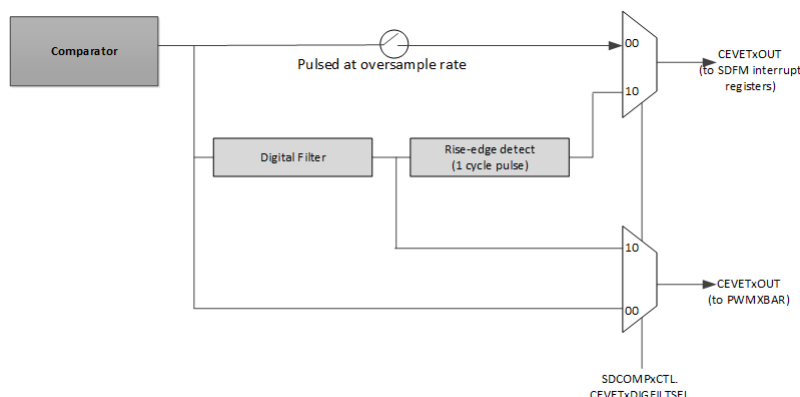
***SDFM module event flags (SDIFLG.FLTx\_FLG\_CEVTx) do not get set again if the comparator event is still active and digital filter path (using SDCOMPxCTL.CEVTxDIGFILTSEL) is being selected***

If SDFM digital filter is used in application the following workaround options can be considered:

- **Option 1**
  - XBAR status can be observed instead of the event flag register.
- **Option 2**
  1. After selecting the digital filter, wait for the interrupt/Trip.
  2. When the interrupt occurs, read the event flag and take appropriate application action to rectify the cause of comparator trip.
  3. Before clearing the event flag register, program the unfiltered path.
  4. Clear the event flag.
  5. Read the event flag and if it stays cleared for at-least one oversampling duration, reprogram the digital filter path.

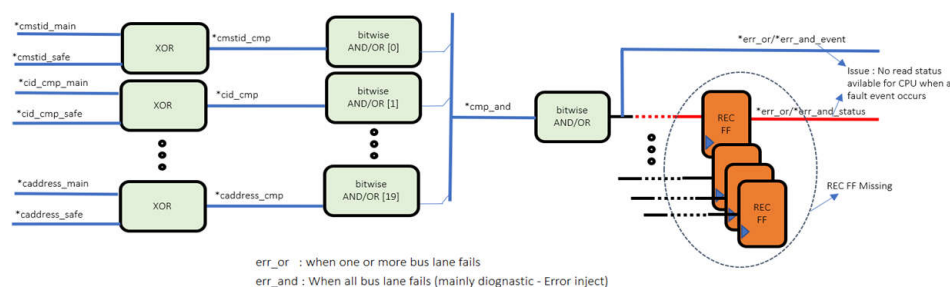
**Figure 3-2.**

Case 2: Log Registers have all zeros

Here the granular logs are not captured correctly and possible entities affected are R5F and L2 memory.

Case 2: In the case where the logs are not captured correctly then for a) diagnostics no action needed and b) in case of actual failure in the application WarmResethn should be used.

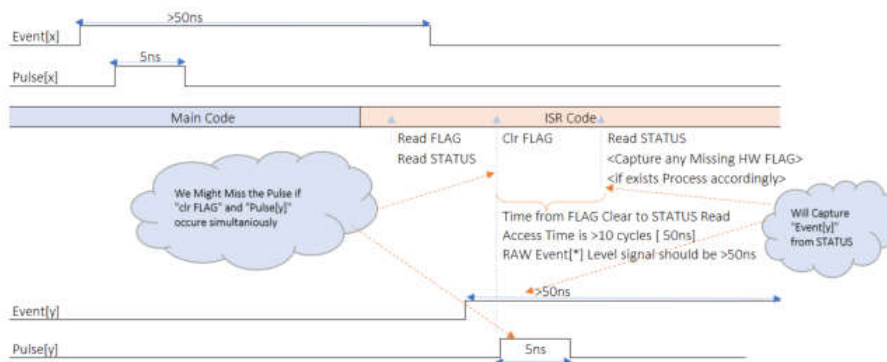
Potential race condition in capture registers resulting in events getting lost while other events in the same register are being cleared by writing to the register. Following registers are impacted by this issue:

Capture any missing HW event FLAG

If exists, process accordingly

WA -2 (For any event widths):

Enable OUTPUTXBAR with the same events in the ISR and then "Clr PWMXBAR FLAG".

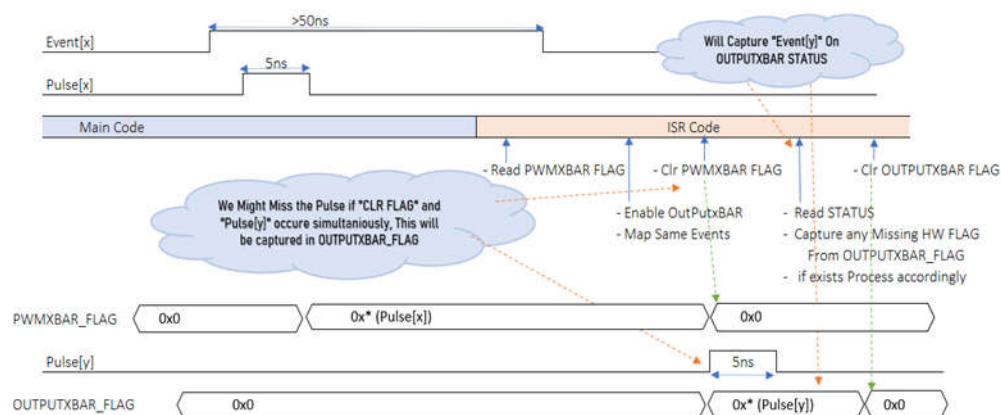
## i2405 (continued) **CONTROLSS: Race condition OUTPUT\_XBAR and PWM\_XBAR resulting in event miss**

- Capture any Missing HW event FLAG

if exists Process accordingly

- Clr FLAG, Event[y] OutputXBAR

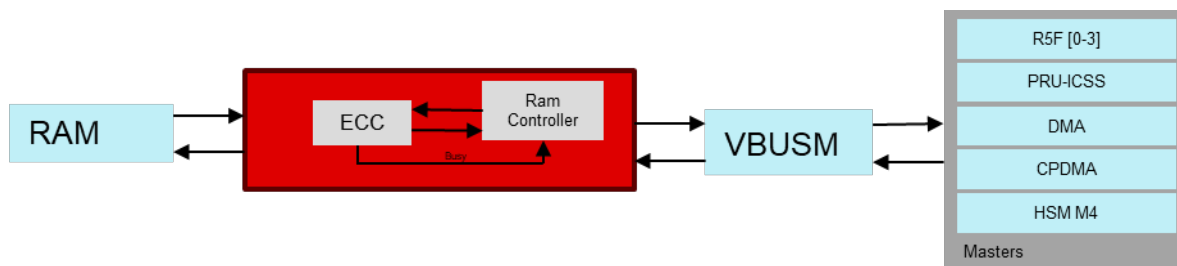
- When a single-bit error is detected during a burst read, the ECC module inserts a BUSY cycle in between.
- In this BUSY cycle, the next read from memory is halted and a corrected write back is performed to fix the error in RAM.
- The BUSY signal generated during this process is improperly handled by the Bus Protocol logic.
- Upon resuming the burst read, the data pipeline becomes misaligned.

- Incorrect data is returned to the master for reads following error correction.
- May cause program execution failures and abort exceptions.

This issue affects only L2 and MBOX RAM read operations.

The physical RAM contents remain properly corrected (no memory corruption) and write operations function normally. Below is the high level block diagram.

**Workaround(s):**

Based on system requirements and safety needs, consider the following solutions:
