J7200 DRA821 Processor Silicon Revision 1.0

ABSTRACT

This document describes the known exceptions to the functional specifications (advisories). This document may also contain usage notes. Usage notes describe situations where the device's behavior may not match presumed or documented behavior. This may include behaviors that affect device performance or functional correctness.

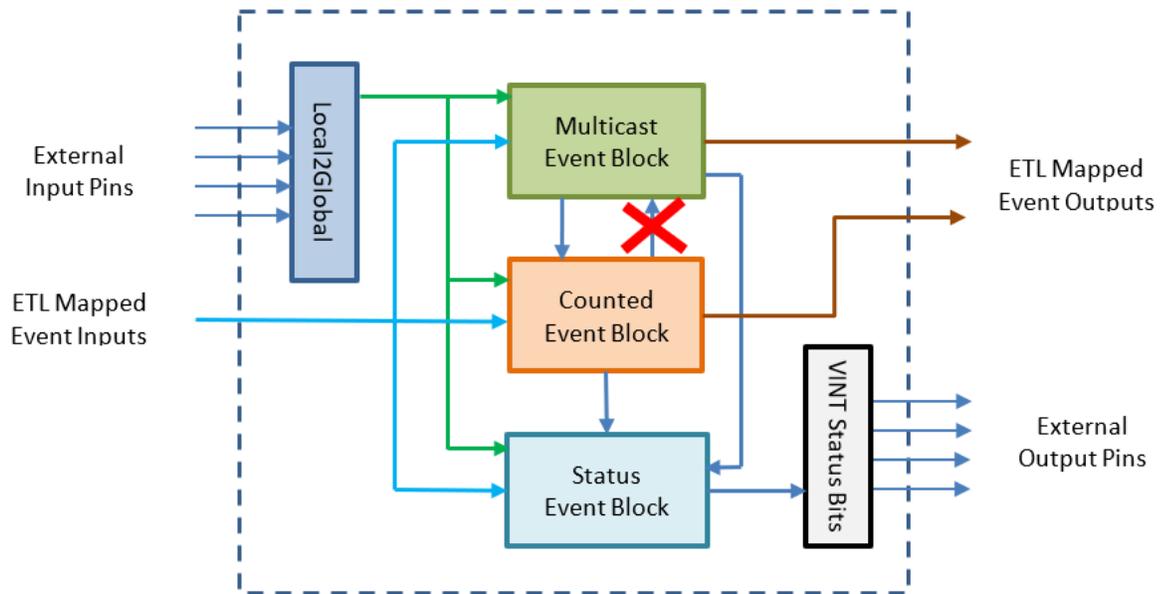
Figure 3-1. Interrupt Aggregator Version 1.0

An issue was found after design that could cause the IA to deadlock. The issue occurs when event “loops” occur between these three processing blocks. It is possible to create a situation where a processing block can not output an event because the path is blocked, and since it can not output an event, it can not take any new input events. This inability to take input events prevents the output path from being able to unwind, and thus both paths remain blocked.

it is not possible for a single event to visit any block more than once and thus not possible for paths to become blocked so long as the outputs remain unblocked.

By following the conventions outlined here, the system is safe from looping hazards that can create a deadlock scenario.
