TMS320F280013x Real-Time MCUs Silicon Errata

Silicon Revisions C, B, A, 0

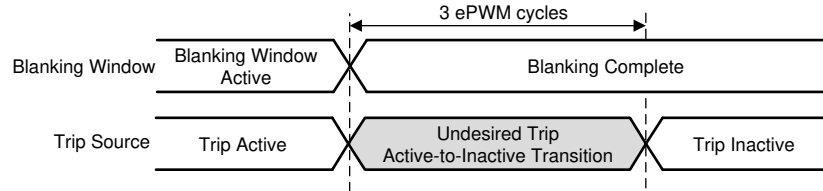
Figure 3-1. Undesired Trip Event and Blanking Window Expiration

Advisory *ePWM: An ePWM Glitch can Occur if a Trip Remains Active at the End of the Blanking Window*

Details The blanking window is typically used to mask any PWM trip events during transitions which would be false trips to the system. If an ePWM trip event remains active for less than three ePWM clocks after the end of the blanking window cycles, there can be an undesired glitch at the ePWM output.

Figure 3-1 illustrates the time period which could result in an undesired ePWM output.

Workaround Extend or reduce the blanking window to avoid any undesired trip action.
