Errata

J721S2, TDA4VE, TDA4AL, TDA4VL Processor Silicon Revision 1.0

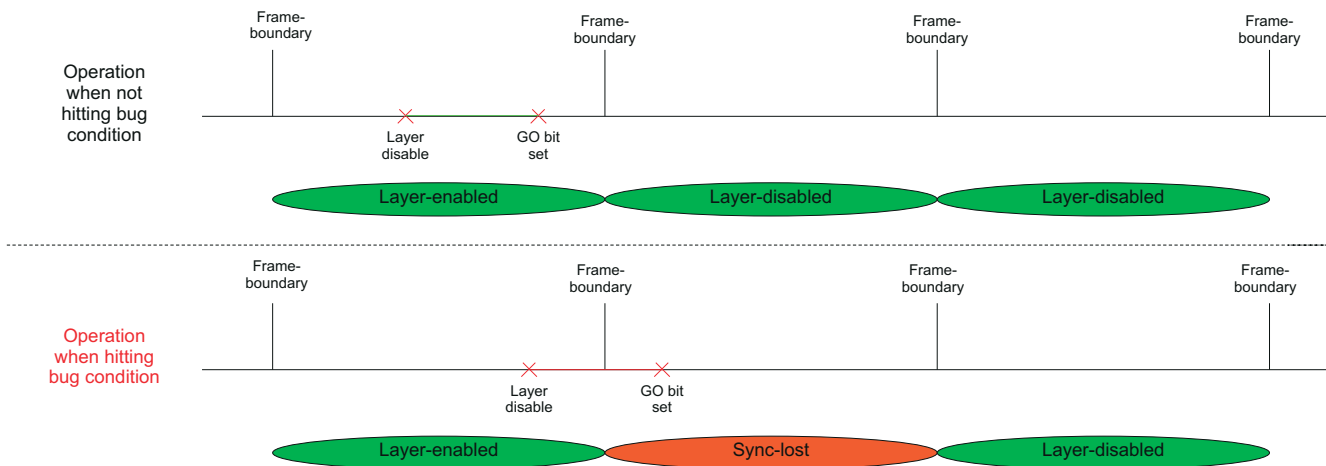
Figure 3-1. Bug Condition

i2097 DSS: Disabling a Layer Connected to Overlay May Result in Synclost During the Next Frame

Details: Disabling a layer (for example VID1) connected to an OVR (that is toggling DSS_VID_ATTRIBUTESx[0] ENABLE from 1 to 0) may result in synclost during the next frame. The synclost may result in a corrupted or blank frame (all pixel data sent out of DSS during the frame is 0x0). The occurrence of synclost is dependent on the timing of setting the GO bit (that is DSS_VP_CONTROL[5] GOBIT to 1) vis-à-vis the disabling of the layer. If the “disable layer” MMR write operation and “set GO bit” MMR write operation happens within the same frame boundary, no synclost occurs. If the operations happen across the frame boundary, then synclost occurs (for one frame). The design automatically recovers and returns to normal operation from the next frame after GO bit is set, see [Figure 3-1](#).

Workaround(s): A simple software workaround exists. In the workaround, prior to disabling a layer on the OVR, it is moved to the “non-visible” area of the OVR (for example: `DSS_OVR_ATTRIBUTES_x[17-6] POSX = max_value_of_posx` or `DSS_OVR_ATTRIBUTES_x[30-19] POSY = max_value_of_posy`). This avoids the synclost when the layer is disabled.

A sample software workaround pseudo-code is shown on [Figure 3-2](#). In this case, the regular “disable layer” MMR write operation and “set GO bit set” MMR write operation are replaced with macros which implement the software workaround.

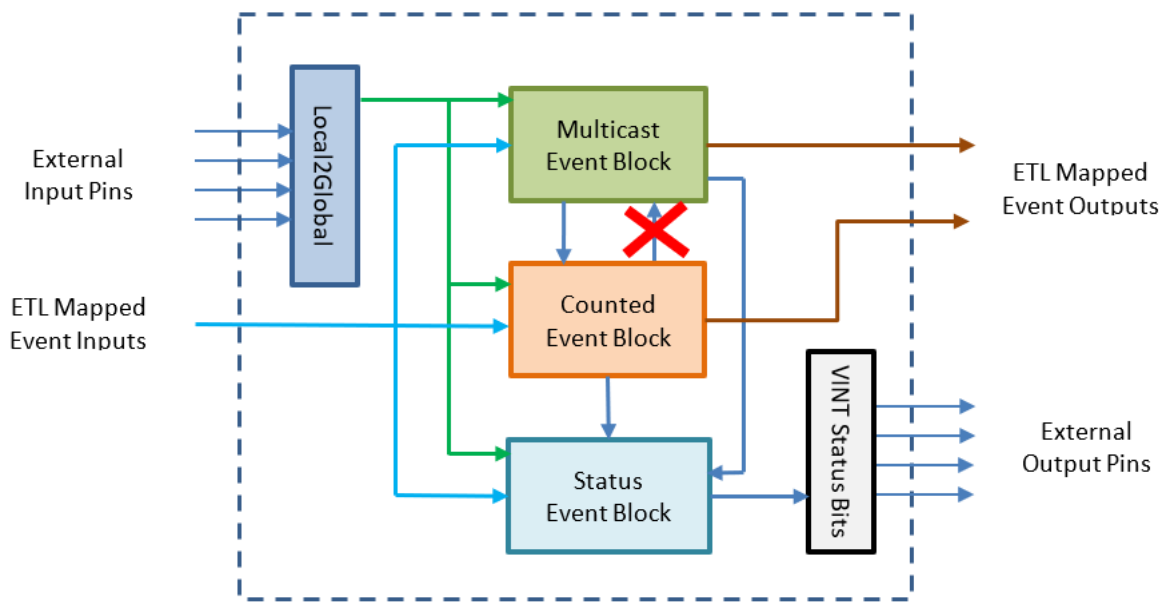
Figure 3-3. Interrupt Aggregator Version 1.0

An issue was found after design that could cause the IA to deadlock. The issue occurs when event “loops” occur between these three processing blocks. It is possible to create a situation where a processing block can not output an event because the path is blocked, and since it can not output an event, it can not take any new input events. This inability to take input events prevents the output path from being able to unwind, and thus both paths remain blocked.

Figure 3-3 shows the conceptual block diagram of IA 1.0. Potential loops are avoided by adopting the policy of not allowing the counted event block to send events to the multicast block. This method was chosen because it is more common to split an event first, and then count one while sending the other elsewhere. With this path blocked by convention, it is not possible for a single event to visit any block more than once and thus not possible for paths to become blocked so long as the outputs remain unblocked.

By following the conventions outlined here, the system is safe from looping hazards that can create a deadlock scenario.
