Errata

AM62Ax Sitara™ Processors Silicon Errata, Silicon Revision 1.0

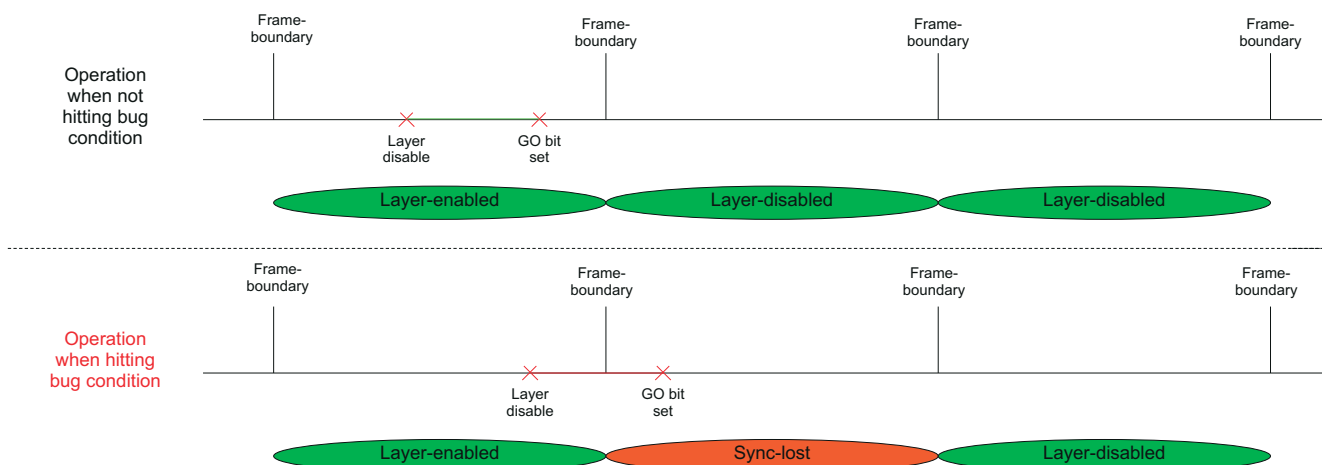
Figure 2-1. Bug Condition

Details: Disabling a layer (for example VID1) connected to an OVR (that is toggling DSS_VID_ATTRIBUTESx[0] ENABLE from 1 to 0) may result in synclost during the next frame. The synclost may result in a corrupted or blank frame (all pixel data sent out of DSS during the frame is 0x0). The occurrence of synclost is dependent on the timing of setting the GO bit (that is DSS_VP_CONTROL[5] GOBIT to 1) vis-à-vis the disabling of the layer. If the “disable layer” MMR write operation and “set GO bit” MMR write operation happens within the same frame boundary, no synclost occurs. If the operations happen across the frame boundary, then synclost occurs (for one frame). The design automatically recovers and returns to normal operation from the next frame after GO bit is set, see [Figure 2-1](#).

A simple software workaround exists. In the workaround, prior to disabling a layer on the OVR, it is moved to the “non-visible” area of the OVR (for example: DSS_OVR_ATTRIBUTES_x[17-6] POSX = max_value_of_posx or DSS_OVR_ATTRIBUTES_x[30-19] POSY = max_value_of_posy). This avoids the synclost when the layer is disabled.

A sample software workaround pseudo-code is shown on [Figure 2-2](#). In this case, the regular “disable layer” MMR write operation and “set GO bit set” MMR write operation are replaced with macros which implement the software workaround.

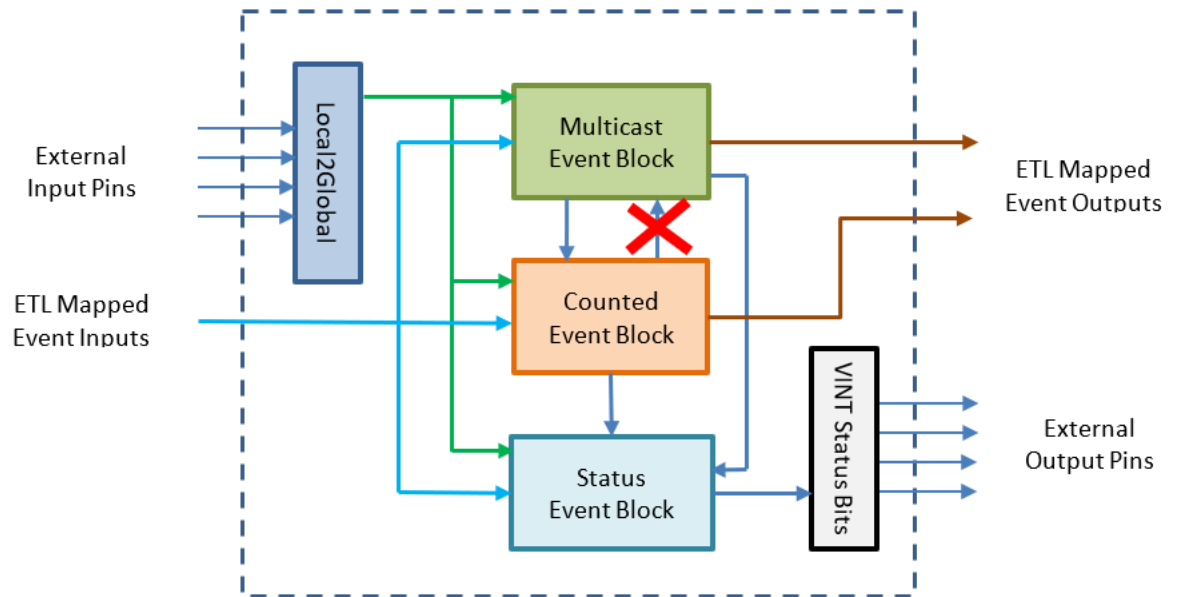
Figure 2-3. Interrupt Aggregator Version 1.0

An issue was found after design that could cause the IA to deadlock. The issue occurs when event "loops" occur between these three processing blocks. It is possible to create a situation where a processing block can not output an event because the path is blocked, and since it can not output an event, it can not take any new input events. This inability to take input events prevents the output path from being able to unwind, and thus both paths remain blocked.

Workaround(s): [Figure 2-3](#) shows the conceptual block diagram of IA 1.0. Potential loops are avoided by adopting the policy of not allowing the counted event block to send events to the multicast block. This method was chosen because it is more common to split an event first, and then count one while sending the other elsewhere. With this path blocked by convention,

it is not possible for a single event to visit any block more than once and thus not possible for paths to become blocked so long as the outputs remain unblocked.

By following the conventions outlined here, the system is safe from looping hazards that can create a deadlock scenario.
