Errata

F29H85x, F29P58x, and F29P32x Real-Time MCUs Silicon Errata (Silicon Revisions B, A, 0)

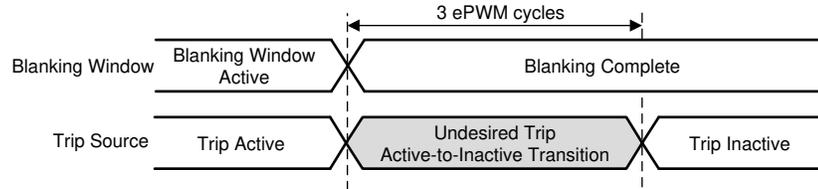
Figure 3-1. Undesired Trip Event and Blanking Window Expiration

The blanking window is typically used to mask any PWM trip events during transitions which would be false trips to the system. If an ePWM trip event remains active for less than three ePWM clocks after the end of the blanking window cycles, there can be an undesired glitch at the ePWM output.

Figure 3-1 illustrates the time period which could result in an undesired ePWM output.

Extend or reduce the blanking window to avoid any undesired trip action.

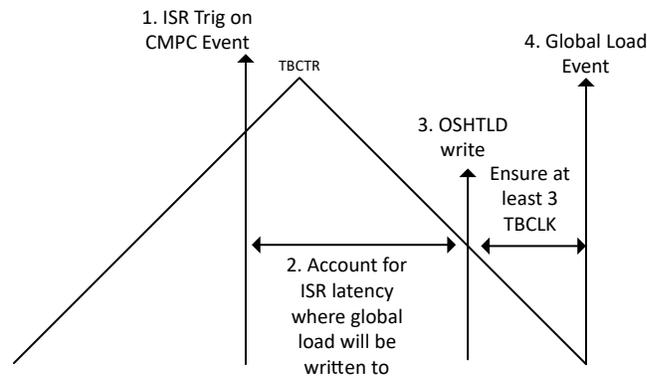
Figure 3-3. Example of Synchronous ISR Loading Method

When a write to the GLDCTL2.OSHTLD register bit occurs within 3 TBCLKs of the global load event (configured by GLDCTL.GLDMODE), the global load of registers (configured by GLDCFG) may get delayed, which can create unintended waveforms.

To avoid this issue, any writes to the GLDCTL2.OSHTLD register bit needs to be a minimum of 3 TBCLK cycles before the configured global load event.

Workaround 1 (Recommended): Synchronous ISR to PWMs

1. Generate an ISR on a known Event Trigger Interrupt event (that is, CMPC, CMPD event, and so forth).
2. Ensure a minimum of 3 TBCTR cycles are kept between the global load event and when the ISR writes to GLDCTL2.OSHTLD.
 - a. When writing to the OSHTLD bit, ensure this is non-interruptible code by disabling the interrupts.

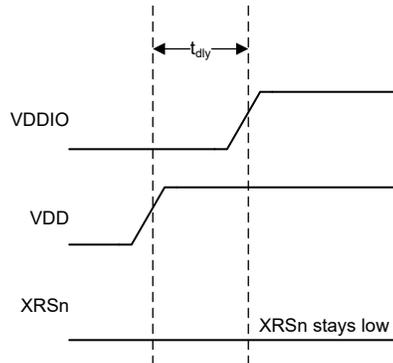
Figure 3-4. Incorrect Power-up Sequence Leading to Stuck Reset

The device XRSn reset signal can remain in a low (reset asserted) state when the VDD supply voltage is ramped up before or simultaneously with the VDDIO supply. As a result, the device fails to boot.

Ensure the VDDIO supply is fully ramped up at least 1ms before ramping up the VDD supply voltage.
