Errata

J722S/TDA4VEN/TDA4AEN/AM67 Processor Silicon Revision 1.0 Errata

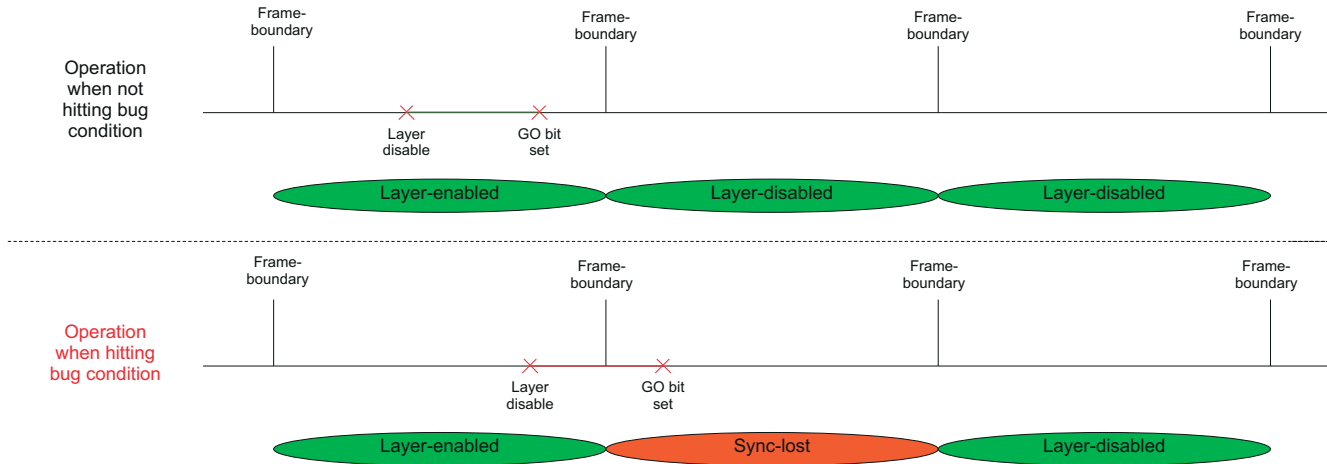
Figure 3-1. Bug Condition

i2097 ***DSS: Disabling a Layer Connected to Overlay May Result in Synclost During the Next Frame***

Disabling a layer (for example VID1) connected to an OVR (that is toggling DSS_VID_ATTRIBUTESx[0] ENABLE from 1 to 0) may result in synclost during the next frame. The synclost may result in a corrupted or blank frame (all pixel data sent out of DSS during the frame is 0x0). The occurrence of synclost is dependent on the timing of setting the GO bit (that is DSS_VP_CONTROL[5] GOBIT to 1) vis-à-vis the disabling of the layer. If the “disable layer” MMR write operation and “set GO bit” MMR write operation happens within the same frame boundary, no synclost occurs. If the operations happen across the frame boundary, then synclost occurs (for one frame). The design

automatically recovers and returns to normal operation from the next frame after GO bit is set, see [Figure 3-1](#).

A simple software workaround exists. In the workaround, prior to disabling a layer on the OVR, it is moved to the “non-visible” area of the OVR (for example: `DSS_OVR_ATTRIBUTES_x[17-6] POSX = max_value_of_posx` or `DSS_OVR_ATTRIBUTES_x[30-19] POSY = max_value_of_posy`). This avoids the synclost when the layer is disabled.

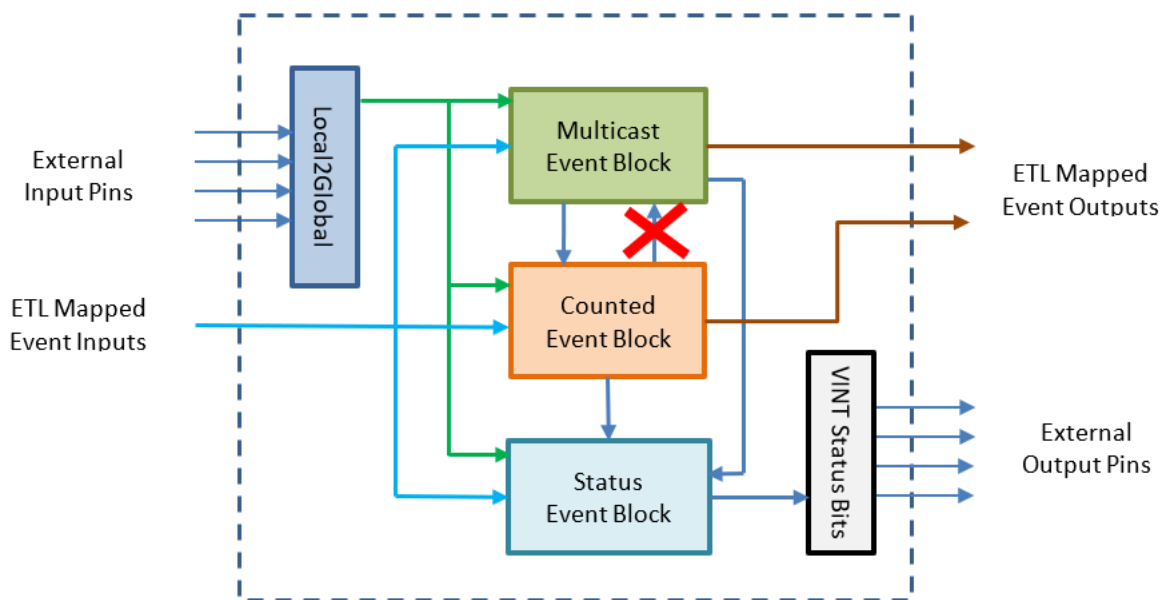
Figure 3-3. Interrupt Aggregator Version 1.0

An issue was found after design that could cause the IA to deadlock. The issue occurs when event “loops” occur between these three processing blocks. It is possible to create a situation where a processing block can not output an event because the path is blocked, and since it can not output an event, it can not take any new input events. This inability to take input events prevents the output path from being able to unwind, and thus both paths remain blocked.

Figure 3-3 shows the conceptual block diagram of IA 1.0. Potential loops are avoided by adopting the policy of not allowing the counted event block to send events to the multicast block. This method was chosen because it is more common to split an event first, and then count one while sending the other elsewhere. With this path blocked by convention, it is not possible for a single event to visit any block more than once and thus not possible for paths to become blocked so long as the outputs remain unblocked.

By following the conventions outlined here, the system is safe from looping hazards that can create a deadlock scenario.
