ERRATA NOTES

CC2500

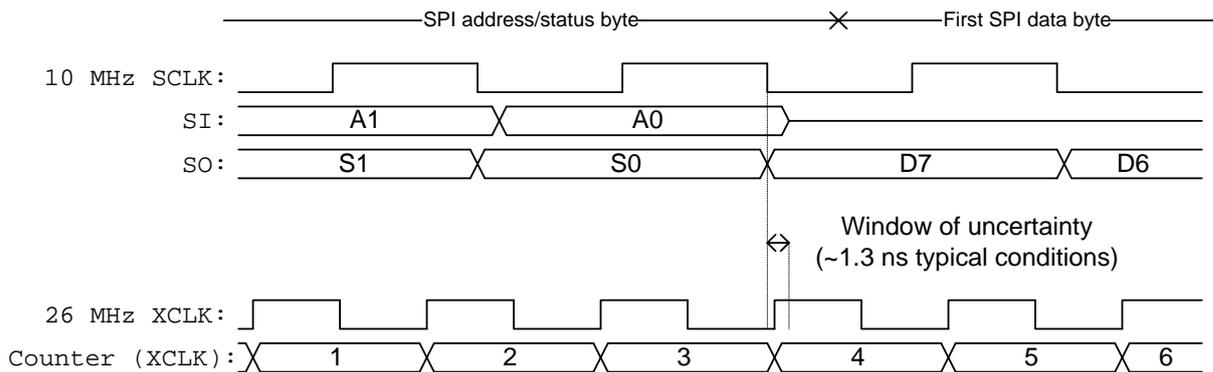
Figure 1 Window of uncertainty (drawing not to scale)

The erroneous value read is highlighted in red. The register read is changing from the value 64 (01000000b) to the value 63 (00111111b) on the XCLK clock at the same time that its value is latched into the SPI output shift register on the SCLK clock. If the two clock edges occur sufficiently close in time, the improper synchronization mechanism will latch some bit values from the previous register value and some bits from the next register value, resulting in the erroneous value 89 (01011001b).

Due to this synchronization issue, if the register being read changes value (synchronously with XCLK) during a certain period of time after this falling edge of SCLK then some of the bits in the read value will come from the **previous** value and some from the **next** value. This so-called window of uncertainty is about 1.3 ns for typical conditions and increases to about 2.0 ns for worst-case conditions (1.8 V VDD, 85 °C).

Figure 1 shows a timing diagram of an SPI read that fails when reading a fictitious counter being updated internally each **XCLK**. Since the counter update from value 3 (011b) to 4 (100b) within the window of uncertainty, the read value could be any one of 0-7 (000b, 001b, 010b, 011b, 100b, 101b, 110b, 111b) depending on exactly when the positive edge of **XCLK** falls within the window of uncertainty.

If it is important to **ensure** that read values are not corrupted, reading of one of the affected registers should be done repeatedly until the same value is read twice in succession. If the rate at which the register is read is guaranteed to be at least twice as fast as the expected register update rate, then an upper bound on the number of required reads is four and the average number of reads slightly more than two.
