## **CC1150 Silicon Errata**

**Table 1. Advisory List**

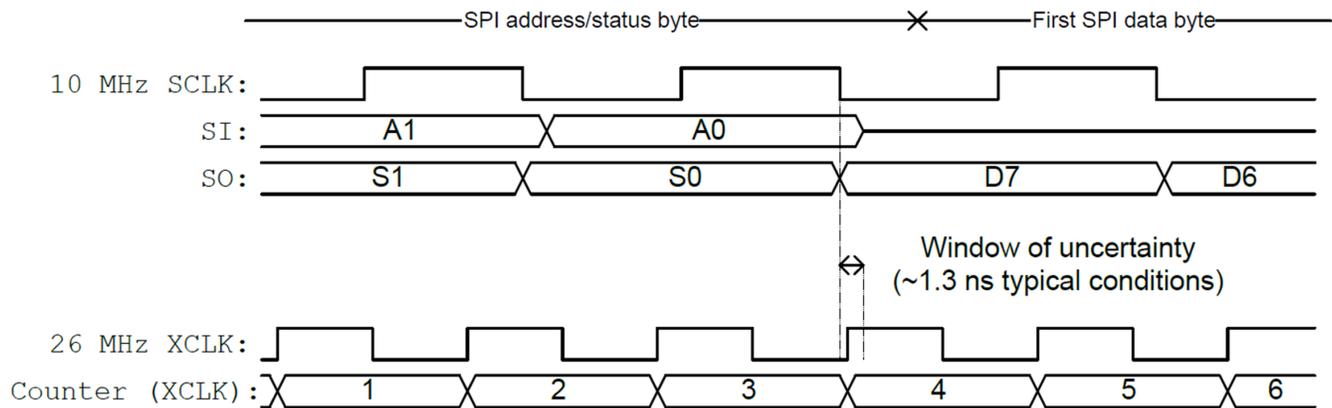
**Figure 1. Window of Uncertainty (drawing not to scale)**

Due to this synchronization issue, if the register being read changes value (synchronously with XCLK) during a certain period of time after this falling edge of SCLK then some of the bits in the read value will come from the **previous** value and some from the **next** value. This so-called window of uncertainty is about 1.3 ns for typical conditions and increases to about 2.0 ns for worst-case conditions (1.8 V VDD, 85 °C).

Figure 1 shows a timing diagram of an SPI read that fails when reading a fictitious counter being updated internally each XCLK. Since the counter update from value 3 (011b) to 4 (100b) within the window of uncertainty, the read value could be any one of 0-7 (000b, 001b, 010b, 011b, 100b, 101b, 110b, 111b) depending on exactly when the positive edge of XCLK falls within the window of uncertainty.

If it is important to ensure that read values are not corrupted, reading of one of the affected registers should be done repeatedly until the same value is read twice in succession. If the rate at which the register is read is specified to be at least twice as fast as the expected register update rate, then an upper bound on the number of required reads is four and the average number of reads slightly more than two.
