## **CC1101 Silicon Errata**

**Table 1. Advisory List**

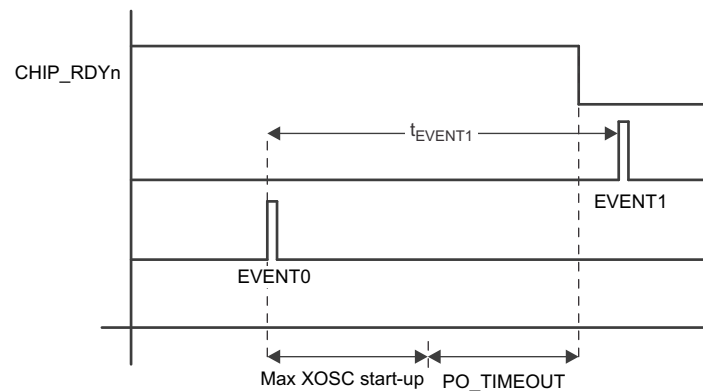
**Details** If EVENT1 occurs after the XOSC has stabilized but before CHP\_RDYn goes low (during the PO\_TIMEOUT period), there is a small probability that the radio enters an illegal state, causing the radio to miss EVENT1. If this happens, the internal SRX strobe never takes place and the chip does not enter RX mode. On the next EVENT1, the crystal is running and CHP\_RDYn is already asserted, so the radio will enter RX as it should, and then go back to SLEEP (if no packets are received).

**Workaround(s)** To avoid this happening,  $t_{Event1}$  must be programmed to be larger than the maximum startup time of the crystal + PO\_TIMEOUT.

$$t_{Event1} > \text{Max XOSC Startup} + \text{PO\_TIMEOUT} \quad (2)$$
