ERRATA NOTES

CC115L

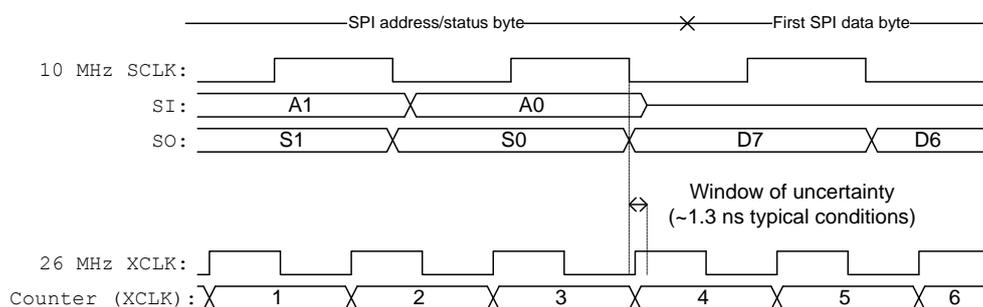
Figure 1: Window of Uncertainty (drawing not to scale)

Due to this synchronization issue, if the register being read changes value (synchronously with XCLK) during a certain period of time after this falling edge of SCLK then some of the bits in the read value will come from the **previous** value and some from the **next** value. This so-called window of uncertainty is about 1.3 ns for typical conditions and increases to about 2.0 ns for worst-case conditions (1.8 V VDD, 85 °C).

Figure 1 shows a timing diagram of an SPI read that fails when reading a fictitious counter being updated internally each XCLK. Since the counter update from value 3 (011b) to 4 (100b) within the window of uncertainty, the read value could be any one of 0-7 (000b, 001b, 010b, 011b, 100b, 101b, 110b, 111b) depending on exactly when the positive edge of XCLK falls within the window of uncertainty.

If it is important to **ensure** that read values are not corrupted, reading of one of the affected registers should be done repeatedly until the same value is read twice in succession. If the rate at which the register is read is specified to be at least twice as fast as the expected register update rate, then an upper bound on the number of required reads is four and the average number of reads slightly more than two.
