Errata
MSP430F46171 Microcontroller

This document describes the known exceptions to the functional specifications (advisories).

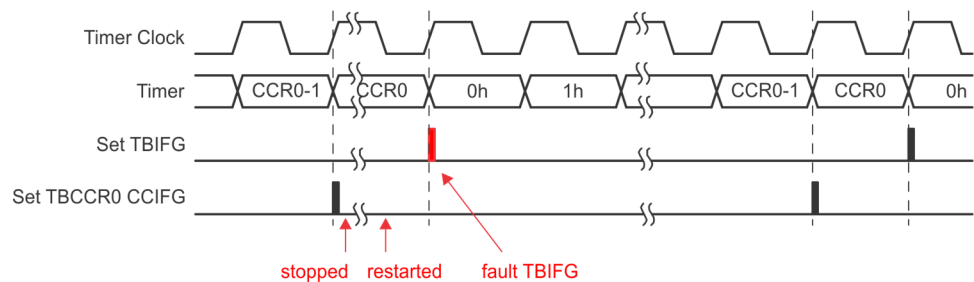
TB24 *TB Module*

Category	Functional
Function	TBIFG Flag is erroneously set after Timer B restarts in Up Mode
Description	In Up Mode, the TBIFG flag should only be set when the timer resets from TBCCR0 to zero. However, if the Timer B is stopped at TBR = TBCCR0, then cleared (TBR=0) by setting the TBCLR bit, and finally restarted in Up Mode, the next rising edge of the TBCLK will erroneously set the TBIFG flag.

Workaround	None.
-------------------	-------
