Stellaris[®] LM3S1G58 RevA2 Errata

This document contains known errata at the time of publication for the Stellaris LM3S1G58 microcontroller. The table below summarizes the errata and lists the affected revisions. See the data sheet for more details.

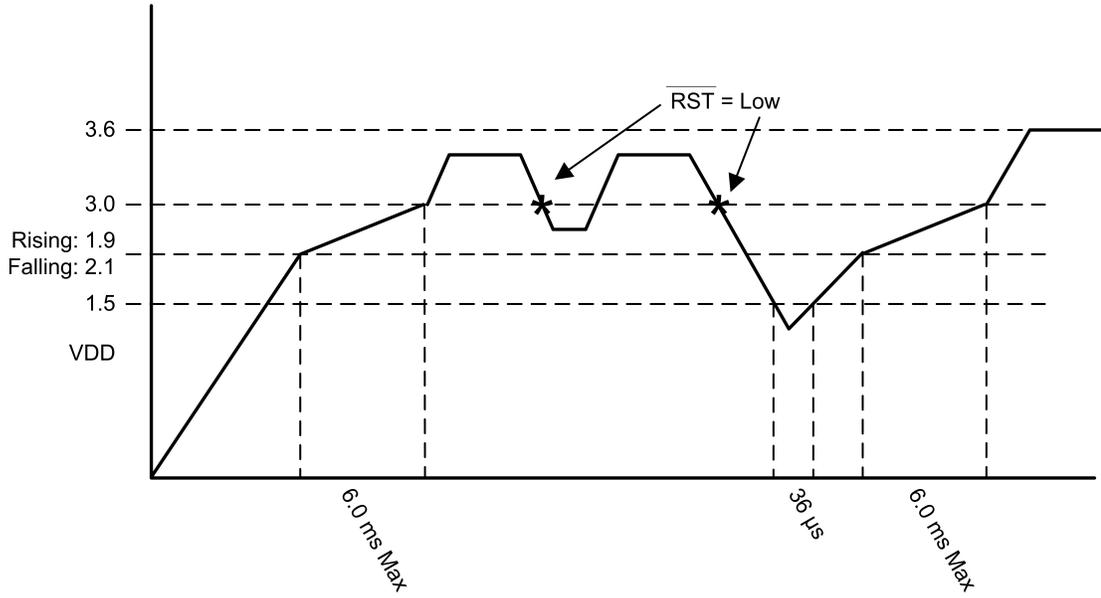
Figure 1. VDD Waveform Signature Limits

The Power-On Reset gap occurs because the supervisor can release internal state machine operation as soon as 6.0 ms after the VDD supply reaches 1.9 V. If VDD is still below the minimum operating voltage of 3.0 V after 6.0 ms, the power-up state machine may not function correctly, resulting in the effects described above. The $\overline{\text{RST}}$ pin of the device has no effect on the initialization state machine, therefore, a complete power-cycle is required to restore the initialization state machine.

The Brown-Out Reset threshold (V_{BTH}) gap occurs because the brown-out supervisor has a threshold as low as 2.85 V, which is less than the minimum operating voltage on VDD, and also because it can take several microseconds to respond. BOR gaps can be encountered after power up, during steady state operation power-on, if the VDD rail has glitches, and also during power-down.

After initial power-up, any processor operation with VDD below 3.0 V may result in unexpected code execution resulting in the effects described above. The processor must be halted or the \overline{RST} signal must be driven Low prior to VDD dropping below 3.0 V and stay in that state until VDD is above 3.0 V.

If VDD falls below 2.1 V, it must continue to fall until it reaches 1.5 V. VDD must stay below 1.5 V for at least 36 μ s to ensure that a POR is triggered correctly. Additionally, the VDD power-up time between 1.9 V and 3.0 V must be at most 6.0 ms. If VDD falls below 3.0 V but stays above 2.1 V, it is not necessary for the voltage to continue falling below 2.1 V. VDD can come back up to 3.0 V without any additional timing requirements.

1. The VDD power-up, steady state, and power-down waveform meets the timing requirements shown in Figure 1 on page 12.
2. The power-up transition of VDD between 1.9 V and 3.0 V must not have any points where it decreases in voltage (must be monotonic).
3. The power-down transition of VDD between 3.0 V and 1.5 V must not have any points where it increases in voltage (must be monotonic).
4. Once steady-state operation between 3.0 V and 3.6 V is achieved, \overline{RST} must go Low or the CPU execution must be halted prior to VDD falling below 3.0 V.
5. The **Brown-Out Reset Control (PBORCTL)** register must be set so that a brown-out event causes a reset.
